INTERNATIONAL COURT OF JUSTICE

CONSTRUCTION OF A ROAD IN COSTA RICA ALONG THE SAN JUAN RIVER (NICARAGUA V. COSTA RICA)

REPLY

ANNEX 1

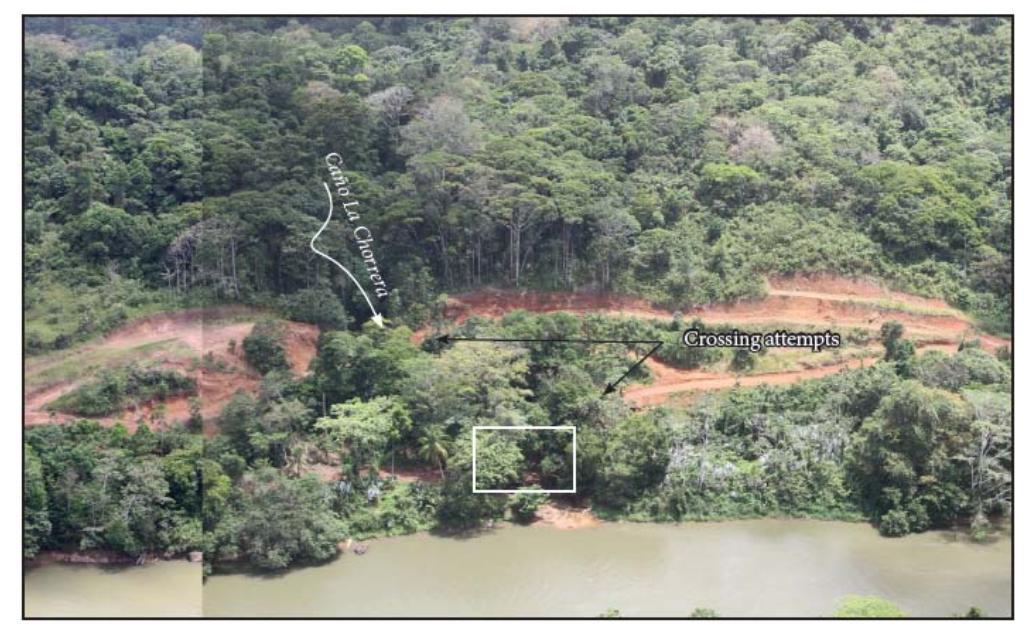
In the section from Rkm 23.6 to 24.4 (known locally as "La Chorrera"), contractors made multiple failed attempts to cross Caño La Chorrera: four different attempted routes appear as eroding scars on the hillslope (Figure 4). The most recently used crossing was constructed by filling across what used to be an embayment off the main river, a pool under a canopy of trees, which formerly provided off-channel habitat for fish but is now filled by an earthen stream crossing (Figure 5).

Figure 4. Oblique aerial view of Caño La Chorrera, showing multiple attempts to cross the stream, 23.9 km downstream of Mojon II border marker. White box shows location of the embayment off the main Río San Juan that was formerly a pool under a canopy of trees (as shown in Figure 5a but which is now filled for most recent attempted stream crossing for Rte 1856 (Figure 5b). Photo date: May 2, 2014.

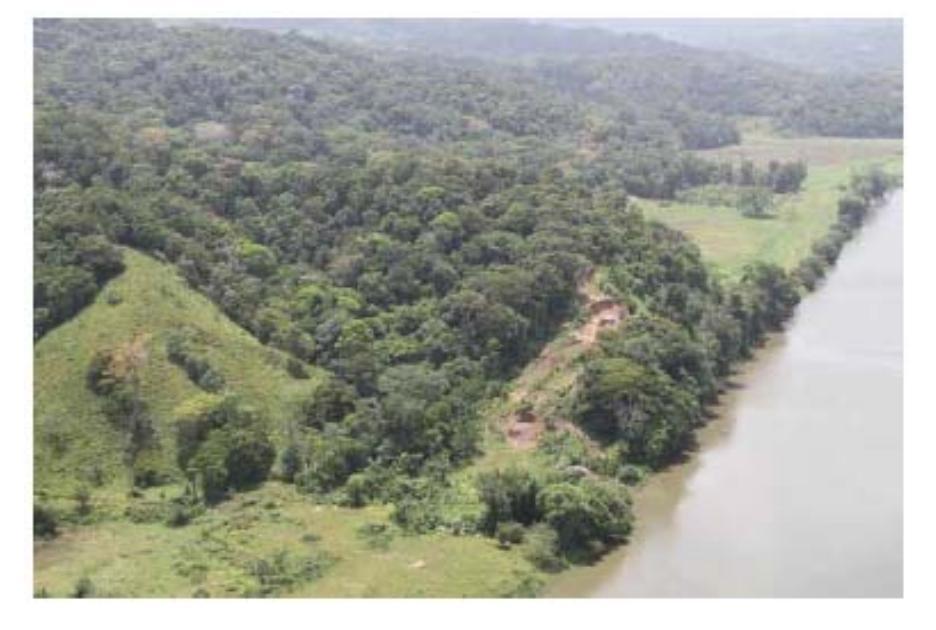
Figure 8. May 2014 oblique aerial view of the failing slope 1 km downstream of El Jardin (Rkm 36.4)

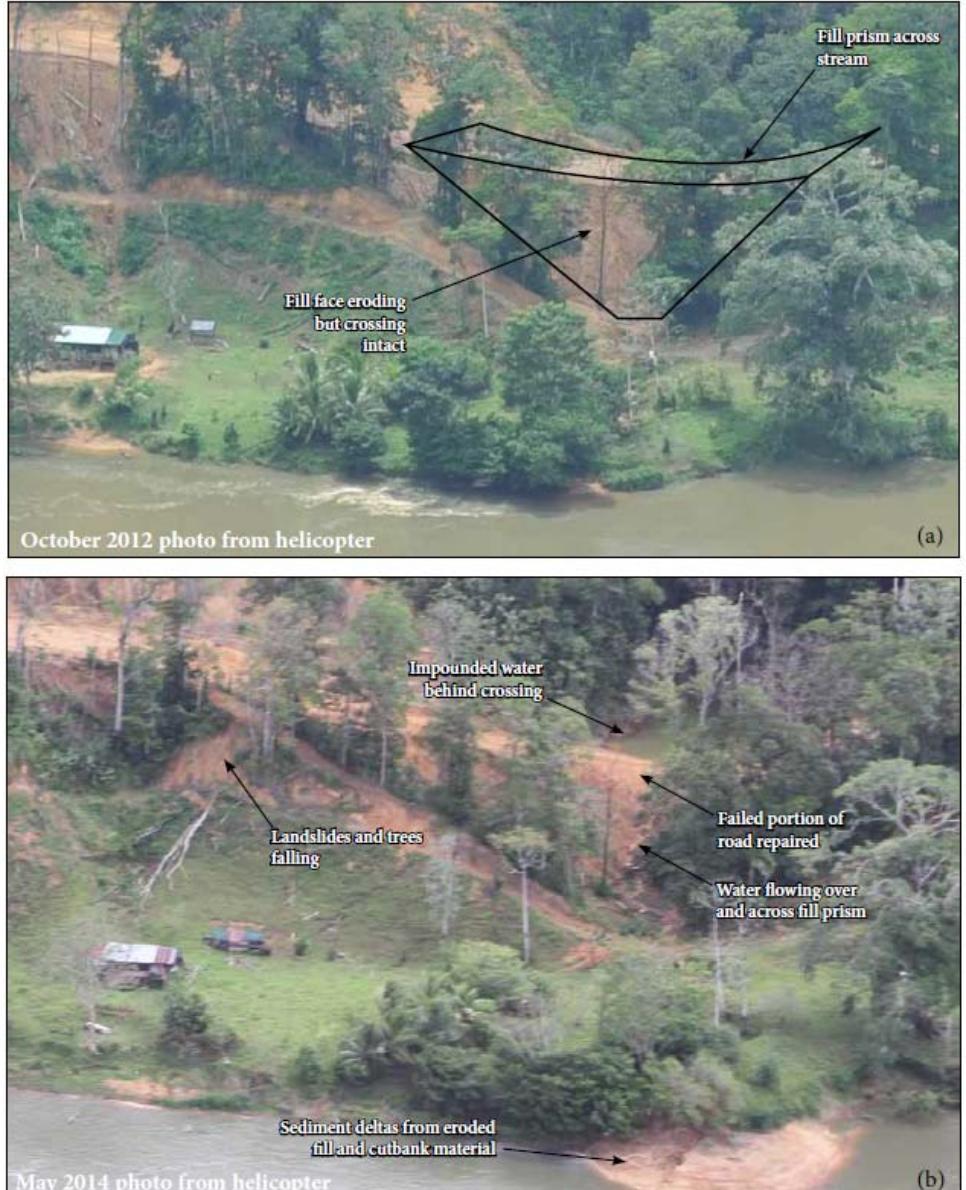
The fill prism for this stream crossing, as I first viewed it from a helicopter in October 2012, was at least 15 m high and 70 m of road length across at the top, totaling approximately 21,900 m³ in volume (Figure 10a). The fill face was visibly eroding (by rills, gullies, and sheet erosion), but the fill prism was intact. The culvert for this fill is not visible in the 2012 photograph, probably obscured by trees. However, it was apparently undersized and/or poorly located, because it ultimately failed.

Figure 10. Eroding Site 9.4, 18 km downstream of Mojon II. Oblique aerial views from October 2012 (a) and May 2014 (b).

By December 2013, the crossing had failed, leaving a void space approximately 1,722 m^3 in volume, representing a volume of sediment eroded from the crossing and carried down the slope towards the river. This is a significant volume of sediment, the equivalent of roughly 215 standard dump truck loads (of 8 m^3). The path of the sediment traveling from the failed crossing to the river is visible on the high-resolution satellite image (Figure 11), as is the delta built of this sediment that has entered the Río San Juan.

A subsequent photograph taken in May 2014 shows that the failed part of the road crossing has been refilled (Figure 10b). However, the crossing is not properly drained, as water has ponded behind the crossing and is flowing down across the face of the fill, which will erode and destabilize the fill. Also visible in this view are continued landsliding on the slope below the road and trees freshly fallen as a consequence. Clearly, this is not a section of road suitable for traffic, especially heavy trucks carrying potentially hazardous materials, as discussed in Section 5, below. The delta built of sediments eroded from this failed crossing is also visible. The delta is larger in this view than in the October 2012 view, both because it has received material from the 1,722 m³ sediment pulse caused by the failure of the road crossing fill prism, and because the photo was taken at lower water, so more of the delta is exposed than at high river levels.

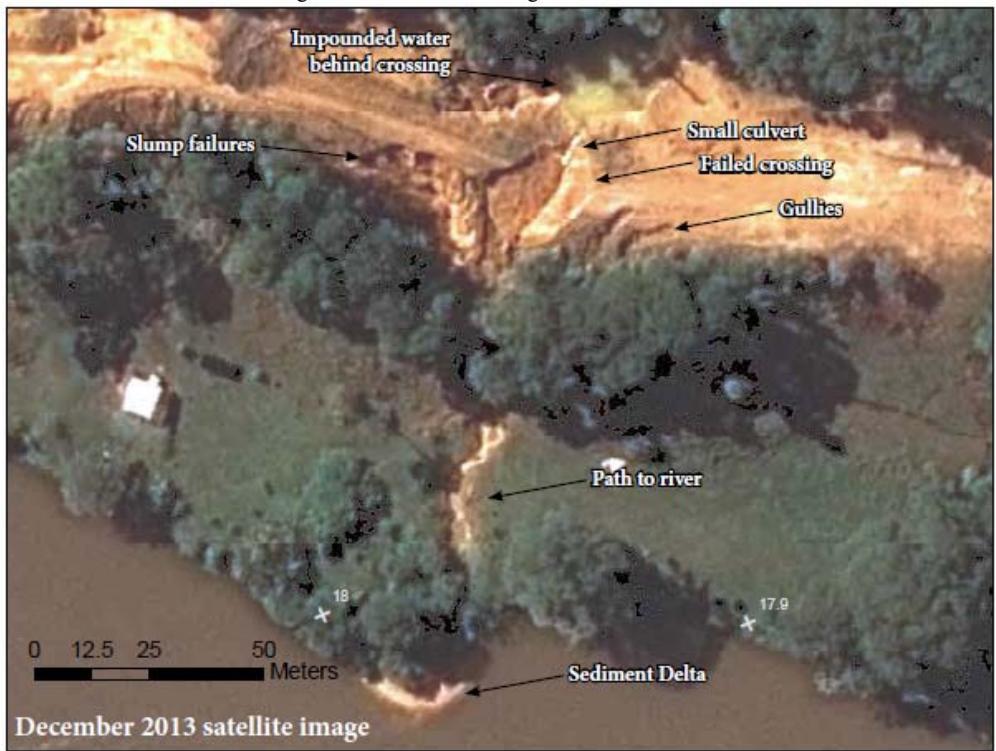
Figure 11. Eroding Site 9.4, 18 km downstream of Mojon II. High-resolution satellite image of December 2013.

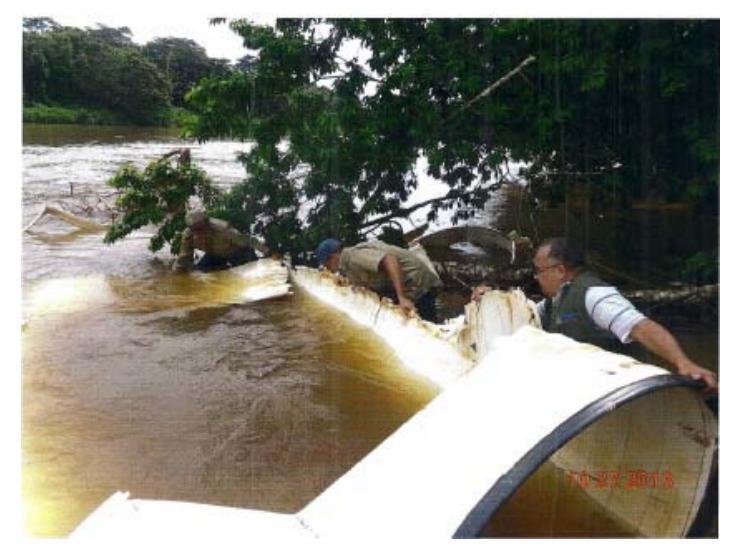
Figure 12. Nicaraguan staff working in delta prograding into Río San Juan to remove plastic pipe washed out of stream crossing fill at Eroding Site 9.4. Photograph date: October 27, 2013. Provided by the Government of Nicaragua.

The pieces of culvert were the most visible indication of the failure, but most of the 1,722 m³ of sediment was carried into the river, some remaining behind as part of the newly expanded delta deposit. This failure was only one component of erosion from the crossing; the total erosion, which included the sheet, rill, gully, and landslide erosion, is considerably more. Hagans and Weaver (2014) estimate that the site is experiencing an additional 1,145 m³/yr of additional rill, gully and landslide erosion, and an additional 517 m³/yr in surface erosion, for a total of 3,384 m³/yr from the entirety of Severely Eroding Site 9.4.

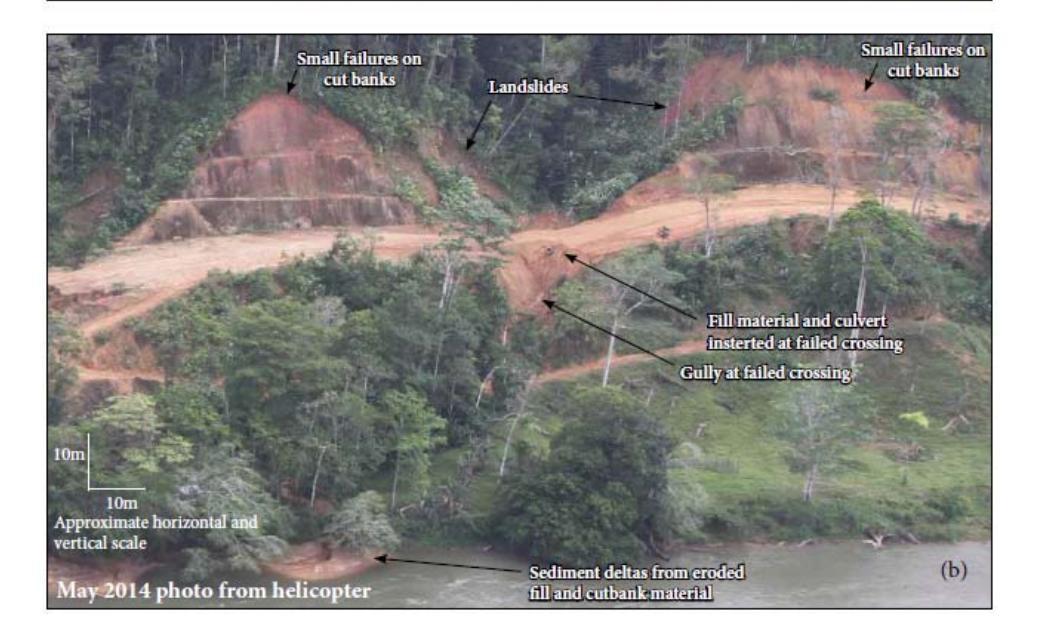
Figure 13. Eroding Site 9.5, 18.1 km downstream of Mojon II. Oblique aerial views from October 2012 (a) and May 2014 (b).

By May 2014, when I took the photograph in Figure 13b, the fill failure had been filled in and a new culvert placed in the fill. The refilled crossing as reconstructed is not as wide as the original crossing, or it may have been rebuilt to the same width and partially failed by May 2014. A small culvert is visible within the prism of the rebuilt crossing. This culvert appears to be grossly undersized and is improperly located such that it is perched far up in the fill prism, likely because landslides on the slopes upstream of the crossing have filled the former stream valley with sediment and blocked the original culvert (if one existed), which was presumably at a lower elevation. The crossing perched high in the fill is an inherently unstable location because of the likelihood that water will seep around the pipe and cause it to fail again. This poses a severe risk for any vehicles attempting to drive over the fill, let alone transport hazardous materials here, as discussed in Section 5, below.

The fill for this crossing was evidently not engineered, its slopes were not stabilized, and if a culvert was used, it was evidently too small for the flows and not protected from debris jams, as demonstrated by its failure. The reconstructed road crossing appears to be comparably deficient and thus vulnerable to similar failure in the near future.

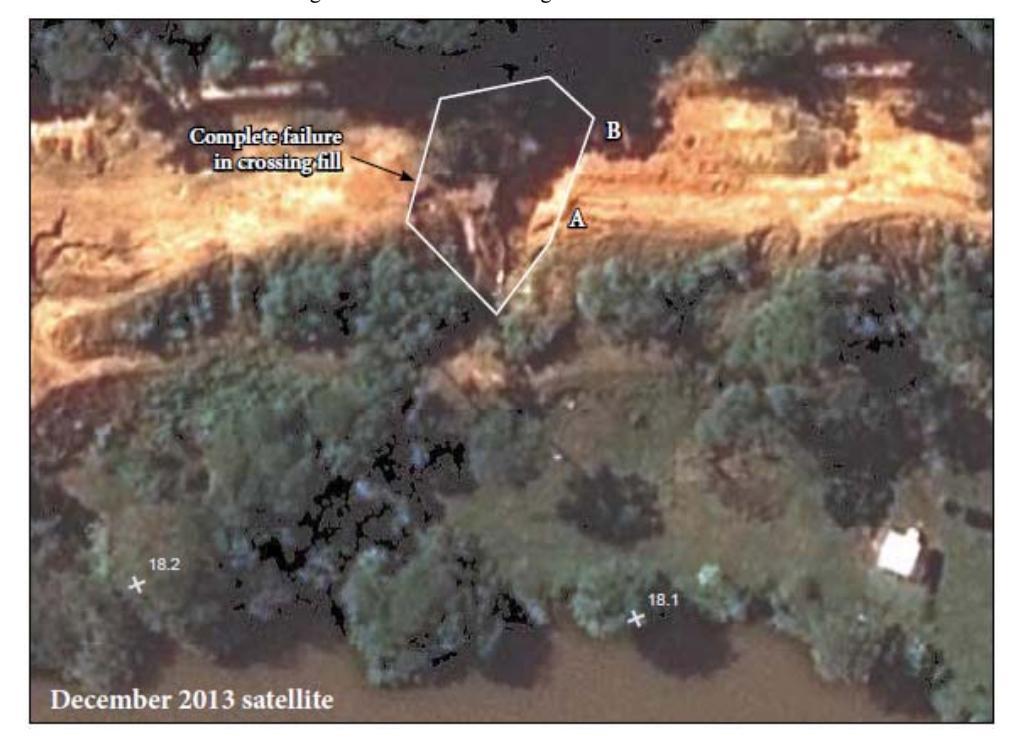
In the December 2013 vertical aerial imagery, large-scale failure of the fill is evident (Figure 14).

Figure 14. Eroding Site 9.5, 18.1 km downstream of Mojon II. High-resolution satellite image of December 2013.

Most of the 2,860 m³ of sediment from this failure (the equivalent of approximately 357 dump trucks) was carried into the river, with some contribution to the newly expanded delta deposit. Once again, this failure is only one component of erosion from this crossing; the total erosion, which includes all sheet, rill, gully, and landslide erosion, is considerably more. Hagans and Weaver (2014) estimate that the site is experiencing an additional 775 m³/yr of additional rill, gully and landslide erosion, and an additional 350 m³/yr in surface erosion, for a total of 3,985 m³/yr from the entirety of Severely Eroding Site 9.5.

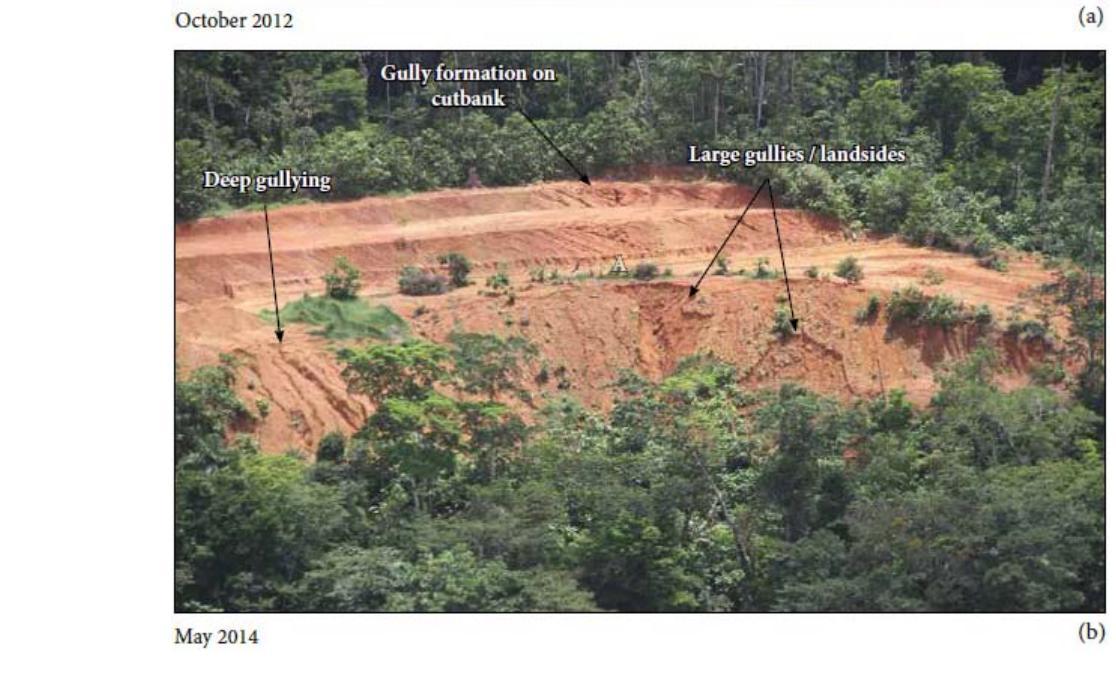
When I first viewed the cut and fill slopes at this site, in October 2012, the cuts appeared relatively fresh, and the cut slope had experienced a shallow failure, evidenced by an arcuate headscarp (i.e., a gently arc-shaped scarp marking the point of detachment of a landslide) over 70 m across, i.e., parallel to the river (Figure 17a). Hagans and Weaver (2014) report the landslide area as measured in GIS to be $1,300 \text{ m}^2$. Conservatively estimating the landslide to be at least 2 m in depth and using the average slope height of 25 m reported by Mende and Astorga (2013, Annex 6), the volume of the landslide (which occurred between the time of construction and October 2012) would be approximately 2,600 m³.

Figure 17. Eroding Site 8.1, 16.1 km downstream of Mojon II. Oblique aerial views from October 2012 (a) and May 2014 (b).

The fill material had been sidecast, i.e, pushed over the side by the bulldozer blade, rather than being engineered. This is evident from the loose texture of the fill material exposed, and the arcuate pattern of failure. To the right and left of this fresh failure, closely-spaced rills and gullies are visible in the fill slope. At this time (October 2012) the cutslope above the fill appeared to be intact. Already, the site appears to be impassable by vehicles. It is not clear where vehicles are intended to go: presumably the top of the fill, but with the failure, that surface is too narrow to support traffic, and even if it were wider, it would be too unstable to support heavy loads. The fact that failure was already in evidence in October 2012 demonstrates the fill's loose, uncompacted nature: much like a sand pile, unsuited to support vehicular traffic.

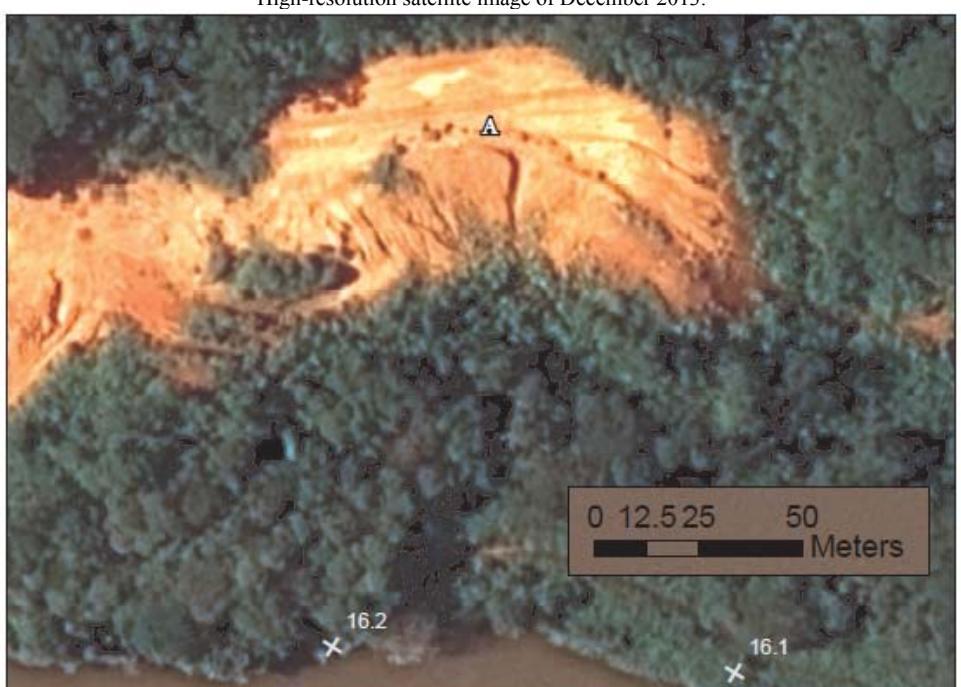
The high-resolution aerial image of December 2013 shows development of multiple gullies, including a large one under the letter A, with a surface area of approximately 110 m^2 and depth of about 3 m. This indicates the volume that eroded over the preceding year from this feature alone was approximately 330 m³ (Figure 18).

Figure 18. Eroding Site 8.1, 16.1 km downstream of Mojon II. High-resolution satellite image of December 2013.

It is clear that no erosion control or slope stabilization measures have been undertaken at this site, which continues to worsen and to deliver sediment to the Río San Juan. Any attempt to pass vehicles over this site would be extremely unsafe.

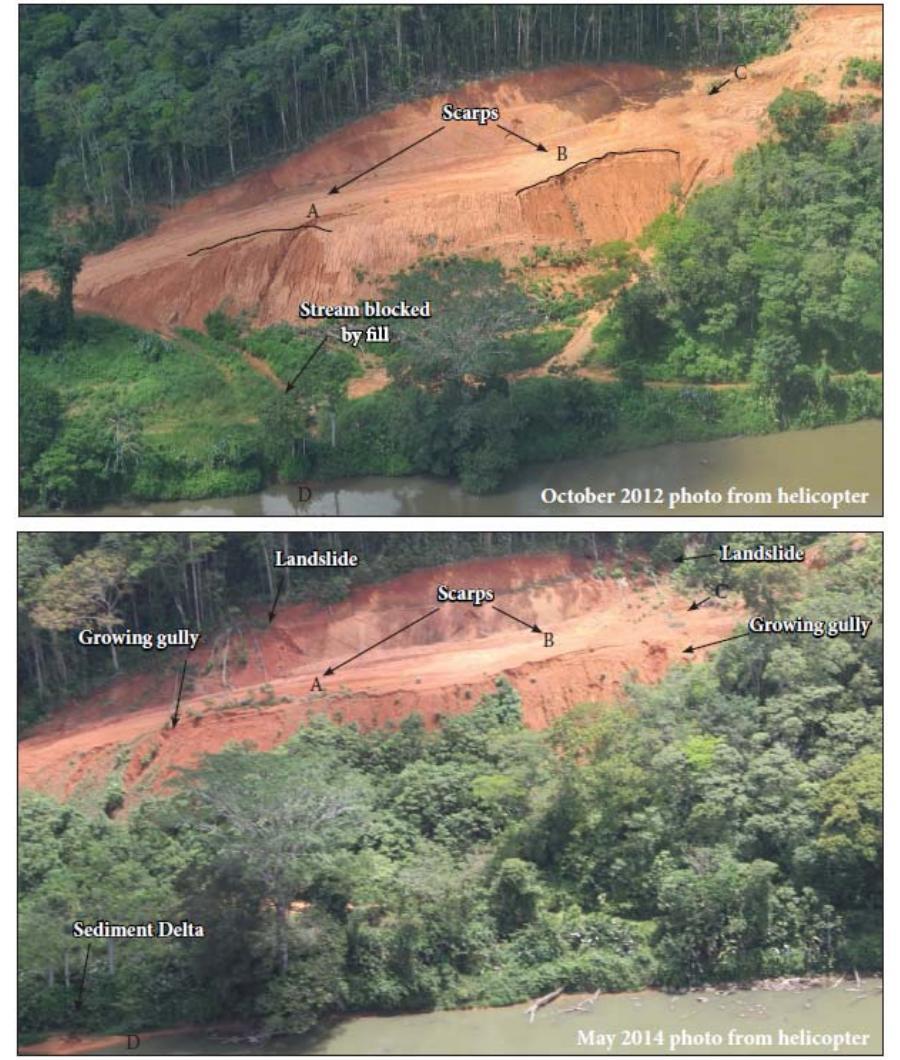
In October 2012, when I first viewed this cut and fill slope complex, the fill slope evidenced multiple shallow failures, rills, and gullies (Figure 19a). Two massive arcuate head cuts are visible in the left side and center of the view. Hagans and Weaver (2014) report that GIS measurements indicate lengths parallel to the river of approximately 50 m for both failures, and surface areas of 1,079 and 1,049 m², respectively. Assuming a 1.75 m average depth, these two prism-shaped failures together involved the loss of approximately 3,724 m³ of sediment, which would fill about 465 dump trucks. Also visible in the 2012 image are sediment deposits at the toe of the failure, sediment left behind in the transfer of this sediment to the San Juan River. As of 2012, some shallow failures had already developed in the cutslope above, but their development was limited.

The oblique helicopter photograph from May 2014 shows the same gullies visible on the December 2013 imagery, but with greater detail (Figure 19b). Also visible is the development of landslides on the cutslope, which have undermined and caused trees to fall. Hagans and Weaver estimate that outside of the two large landslides, the site is experiencing an additional 1,332 m³/yr of rill, gully and landslide erosion, and an additional 601 m³/yr in surface erosion, for a total of approximately 1,933 m³/yr from the bare portions of Site 8.1 that are not covered by the two landslides. However, it is clear from the 2013 and 2014 images that the landslide surfaces are covered with rills, gullies, and possibly shallow landslides. Thus, the site experienced two large landslide failures in the fillslope between construction and October 2012 (which eroded over 3,700 m³), and in each subsequent year surface erosion, rilling, and gullying exceeding another 1,900 m³, for an average of approximately 3,200 m³/yr from Site 8.2.

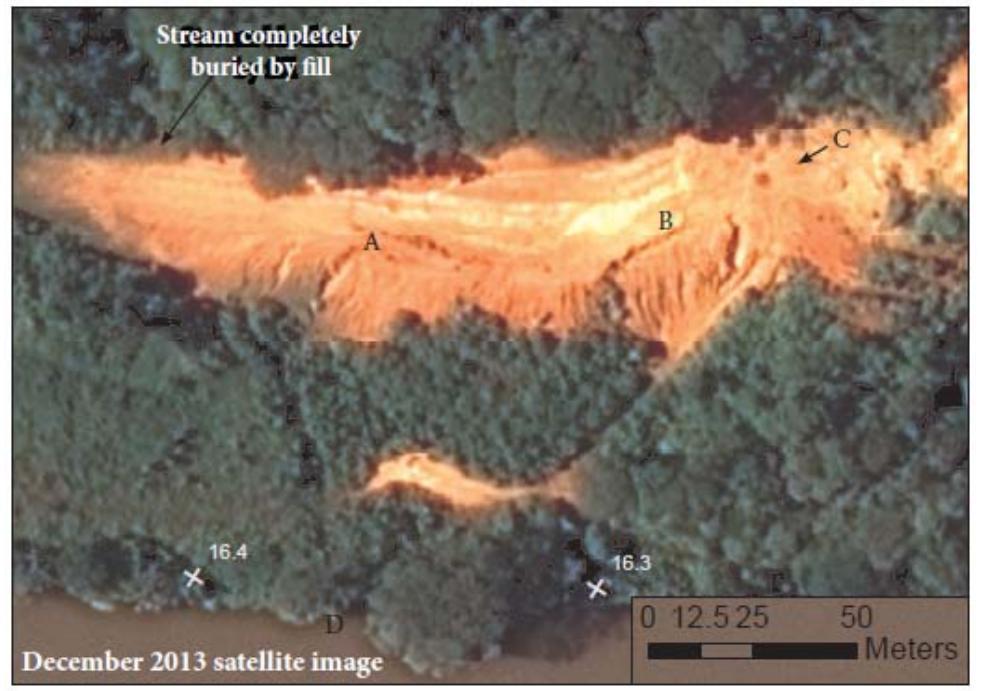
The high-resolution satellite image of December 2013 shows possible continued propagation of the headcuts and unambiguous development of gullies across the entire fillslope (Figure 20).

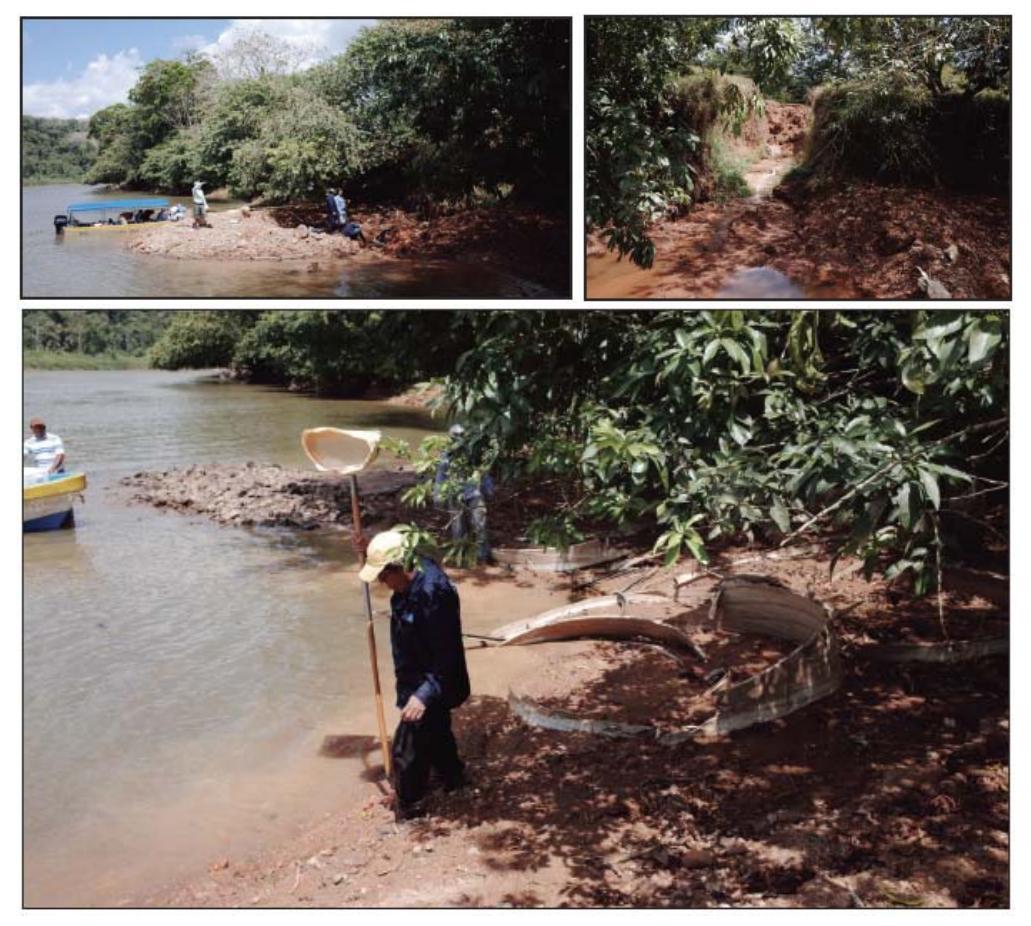
Figure 25. Photographs from a field visit in March 2014 show a delta of sediment with pieces of the failed culvert extending into Río San Juan. New fill material was placed in the channel to partially fill the void created by the failure, but no new culvert was installed.

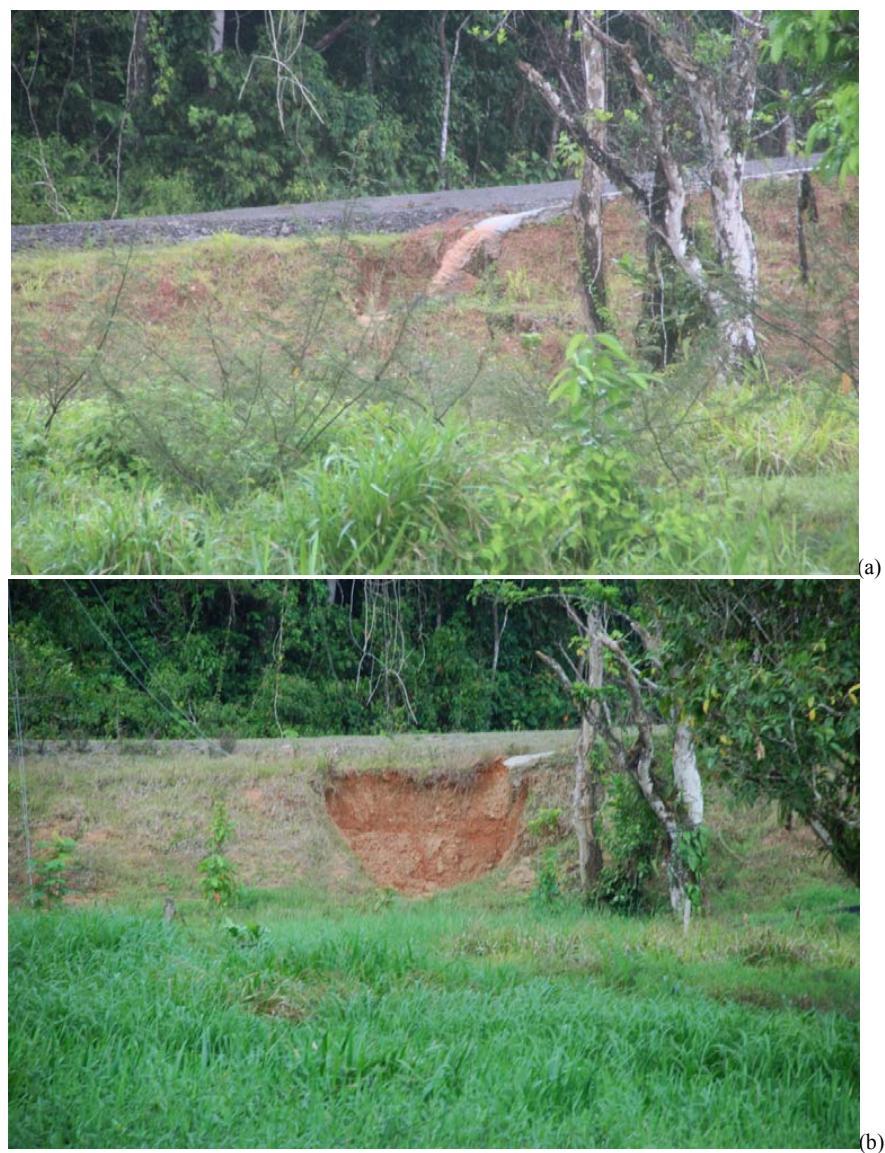
Figure 26. Photo of road runoff directed from drainage structure into fill in May 2013 (a), and resulting erosion in May 2014 (b).

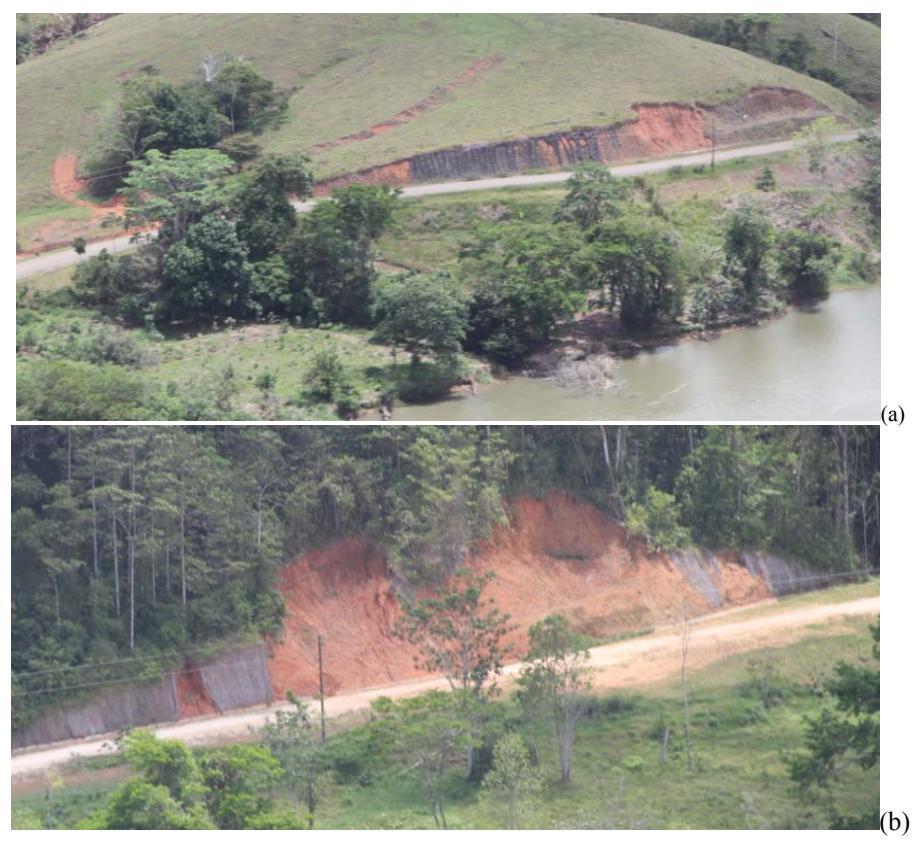
Figure 27. Failing black plastic erosion control fabric approximately (a) 6.8 km and (b)10.0 km downstream from Mojon II, respectively.

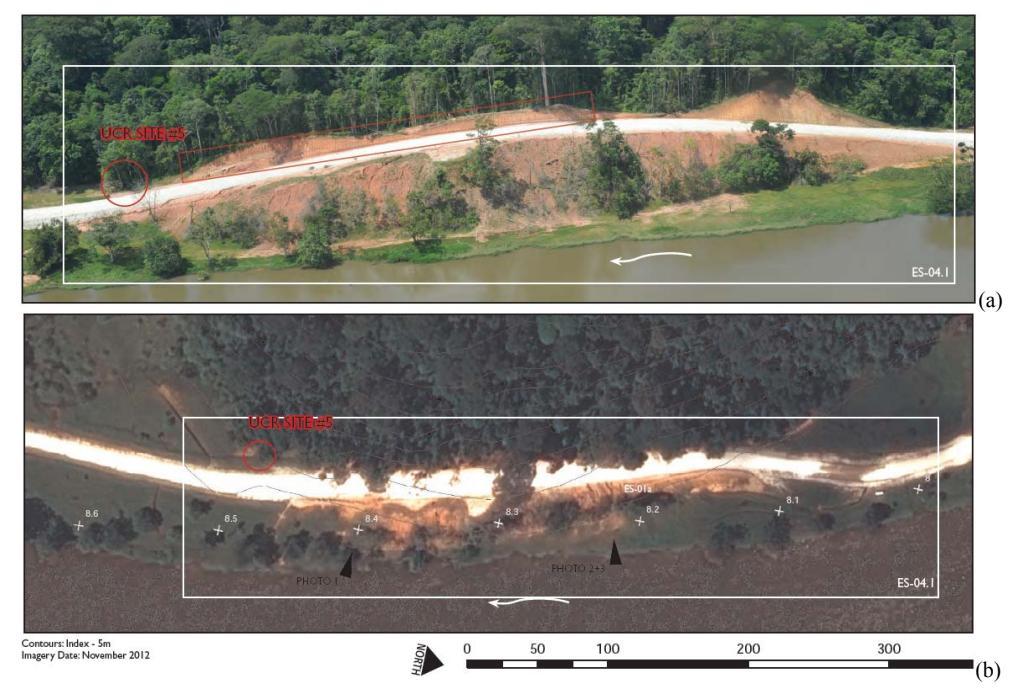
Figure 29. Severely Eroding Site 4, 8-8.7 km downstream of Mojon II. UCR Site 5 was located at the downstream end of this eroding area. a) helicopter photo of October 2012, with UCR study site indicated. B) satellite image of November 2012. Note arcuate headscarps in the road fill beginning within 100 m from the UCR study site.

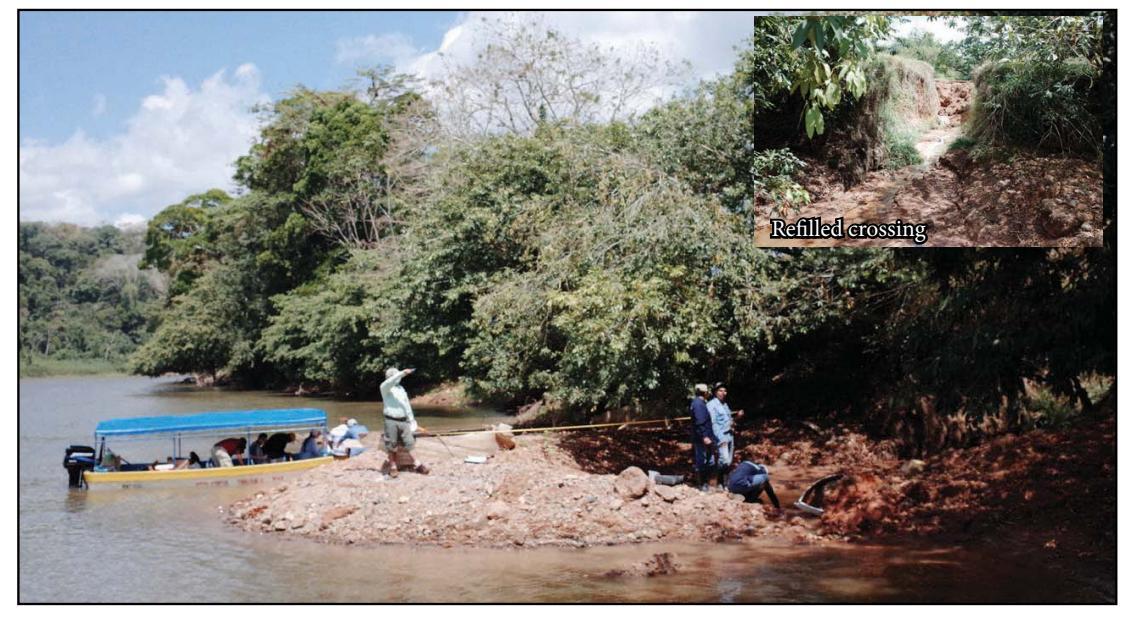
Delta deposit at fill crossing failure 20.3 km downstream of Mojon 2. Ecological Sampling Site 8a. Width (perpindicular to RSJ) = 13m Length (parallel to RSJ) = 15m Height (above RSJ water surface) = 1.5m Photo and measurement date: March 31, 2014

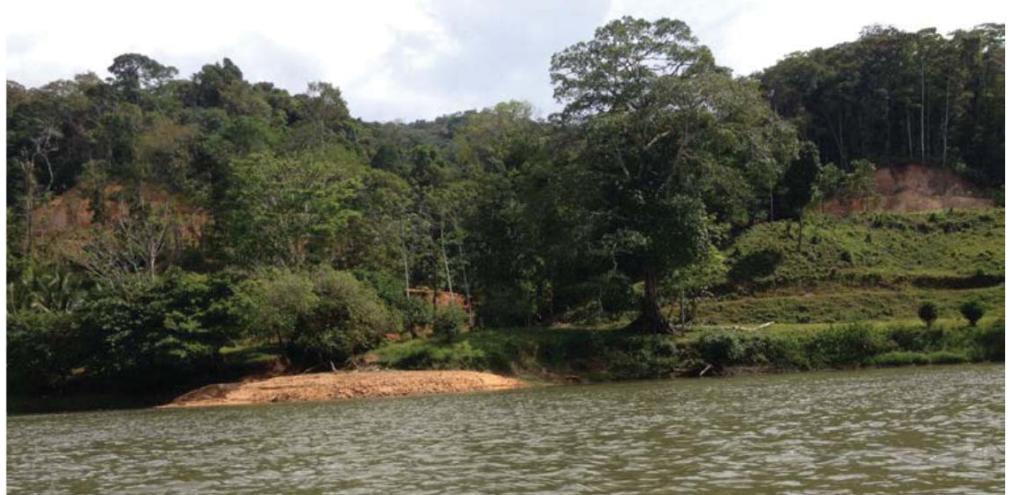
PHOTO 1 - Location: RKM 18 (from boat, May 2014). Formation of sediment delta from erosion and lack of proper water management.

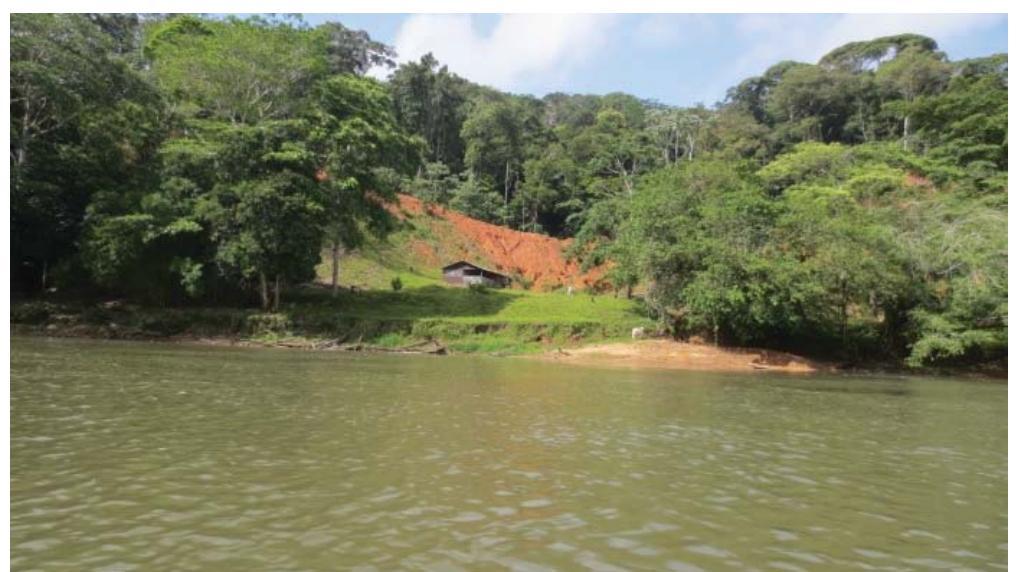
PHOTO 2 - Location: RKM 18.2 to 18.3 (from boat, May 2014). Formation of sediment delta from failed earthen fill stream crossing and other erosion.

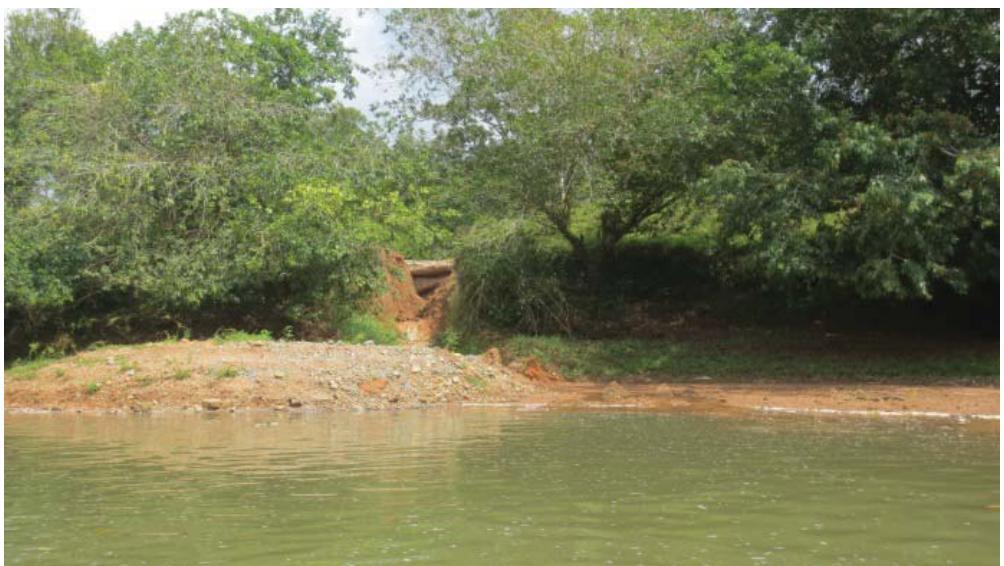
PHOTO 3 - Location: RKM 20.3 (from boat, May 2014). Road section with improper stream crossing consisting of a log bridge that has resulted in constricted of water flow and the creation of sediment delta in the River.

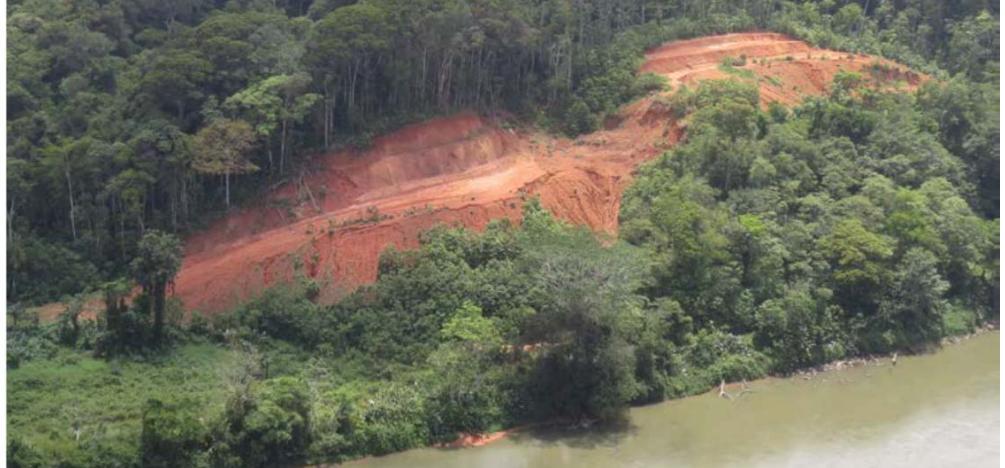
PHOTO 4 - Location: RKM 16.1 to 16.5 (from helicopter, May 2014). Steep cuts and slopes were constructed in these erodible soils at slopes that are not generally considered stable or recommended for these types of soils. Lack of planning, design and mitigation measures have all led to the conditions observed.

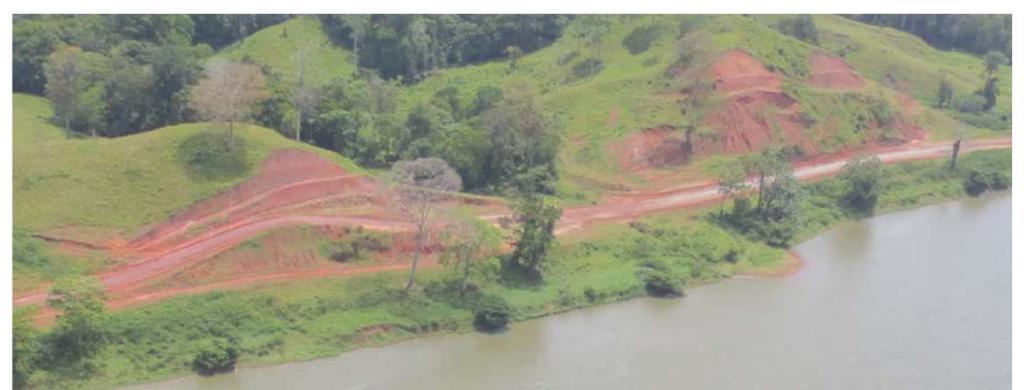
PHOTO 5 – Location: RKM 21.4 to 22.1 (from helicopter, May 2014). Section of the roadway that is too close to the river. The steep cuts that have been made to construct the road and lack of erosion and sediment controls have resulted in sedimentation of the river. The terraces constructed in the slope provide little control of erosive effects of water from storm events as evident from the erosion gulleys of the face of the cuts into the hills.

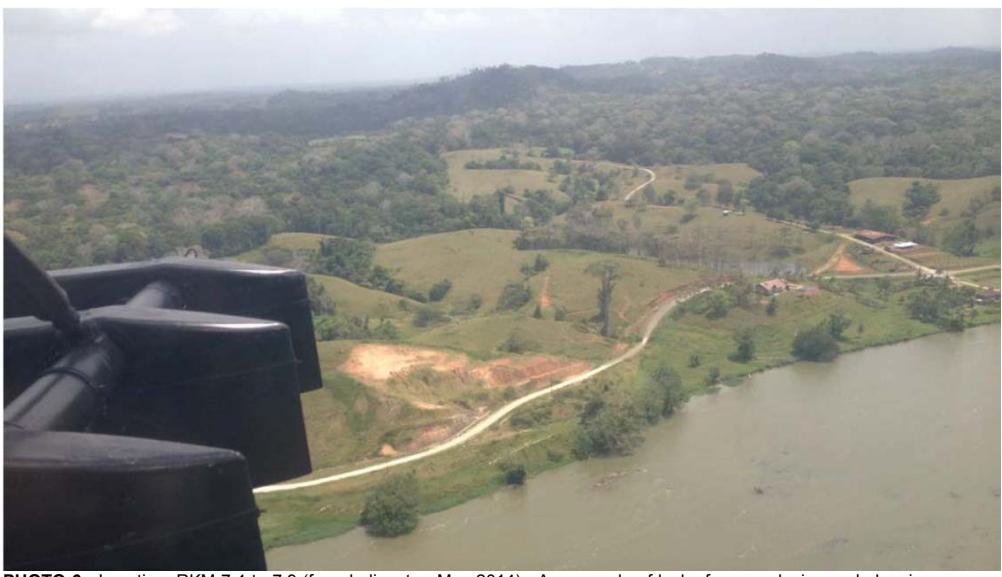
PHOTO 6 - Location: RKM 7.4 to 7.9 (from helicopter, May 2014). An example of lack of proper design and planning process that has located this section of the roadway through undesirable topography. This includes areas that are too steep, too uneven, or too high in comparison to the surrounding environment. The topography in combination with the type of erodible soils combined to create unstable slopes and erodible conditions that have resulted in the sediment loading to the river.

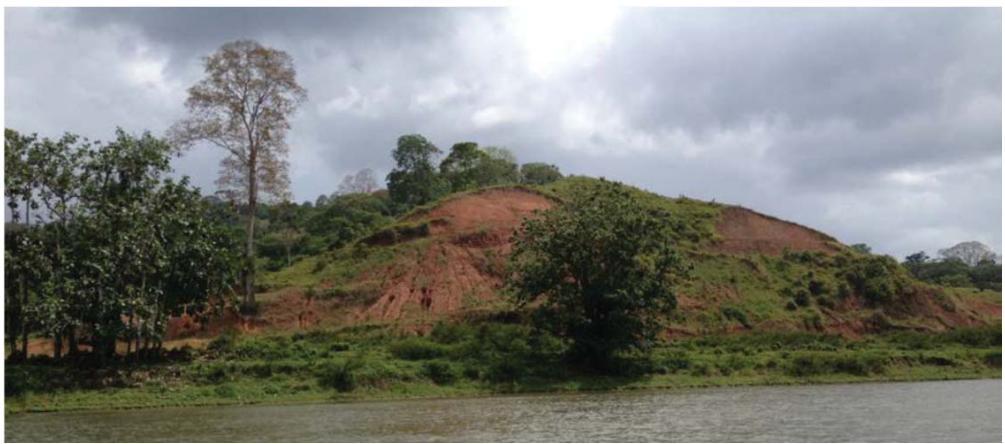
PHOTO 7 - Location: RKM 7.4 to 7.9 (from boat, May 2014). An example of lack of proper design and planning process that has located this section of the roadway through undesirable topography. This includes areas that are too steep, too uneven, or too high in comparison to the surrounding environment. The topography in combination with the type of erodible soils combined to create unstable slopes and erodible conditions that have resulted in the sediment loading to the river.

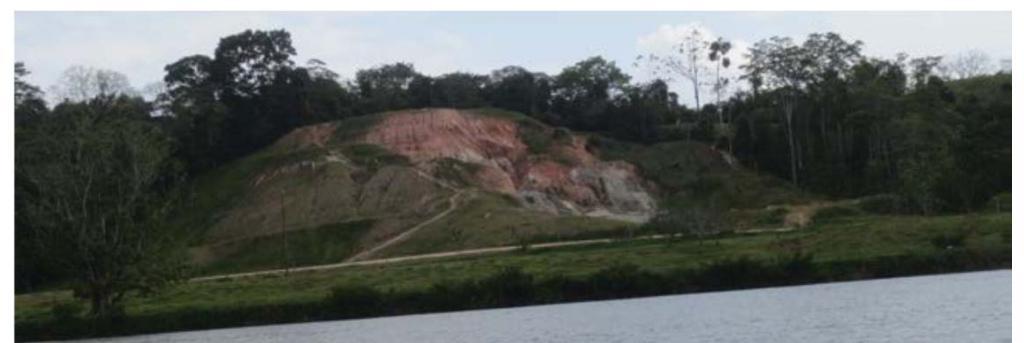
PHOTO 12 - Location: RKM 7.4 to 7.9 (from boat, May 2014). Borrow pit used for extracting soils for the construction of the roadway. The pit constructed in high topography has been left open and subject to erosion from precipitation events without appropriate BMP.
