INTERNATIONAL COURT OF JUSTICE

DISPUTE CONCERNING CERTAIN ACTIVITIES CARRIED  
OUT BY NICARAGUA IN THE BORDER AREA

MEMORIAL OF COSTA RICA

VOLUME IV  
(Annexes from 139 to 165)

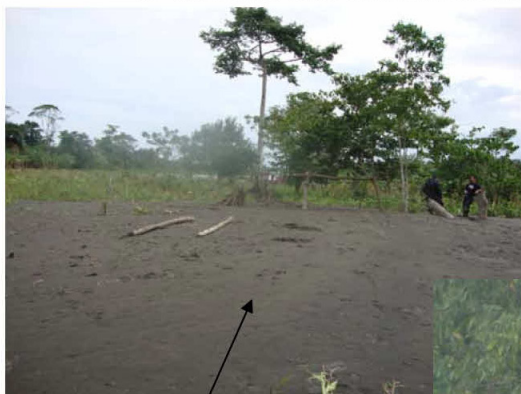
1. There are sand and mud sediment deposits that are not characteristic of the area's wetlands, which are undoubtedly part of the materials drained out of the river as part of the dredging operations, and which have been deposited at this site. This area is 2,625 m<sup>2</sup>.

This sand is a result of sediment deposits from the dredging.

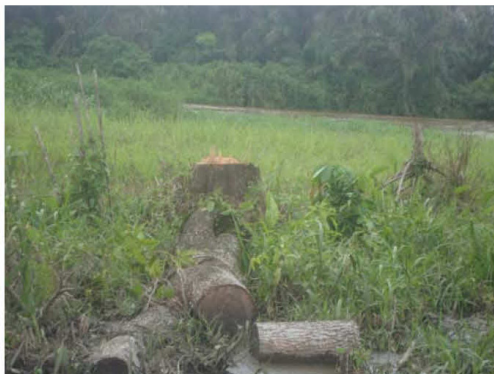
2. Near the sediment deposits area is a *Spondias Mombin* tree measuring 52 cm in diameter and 14 meters in height and 1 189 m<sup>3</sup>, which has been cut down.

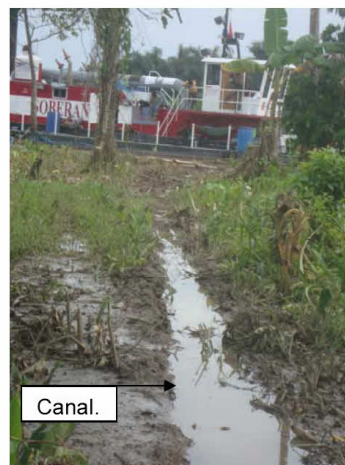
3. There is a canal or track on Costa Rican soil left by the dredger's drainage pipes, which deposited sediments from the river. Due to their muddy nature, sediments made it impossible to walk around the area and made it impossible to safely reach the edge of the river.

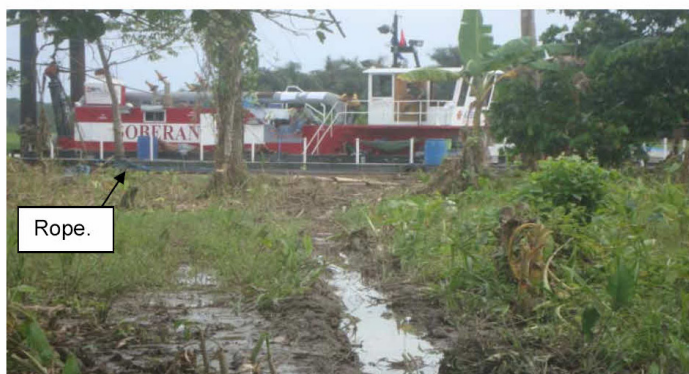
4. There is a barge (named Soberan [sic]) of about 15 meters in length, on which the suction dredger is installed, and where at least 5 armed Nicaraguan soldiers and approximately 6 civilians were observed. It is worth mentioning that this vessel is moored on the Costa Rican side and tied to a tree on Costa Rican soil using a thick blue rope.

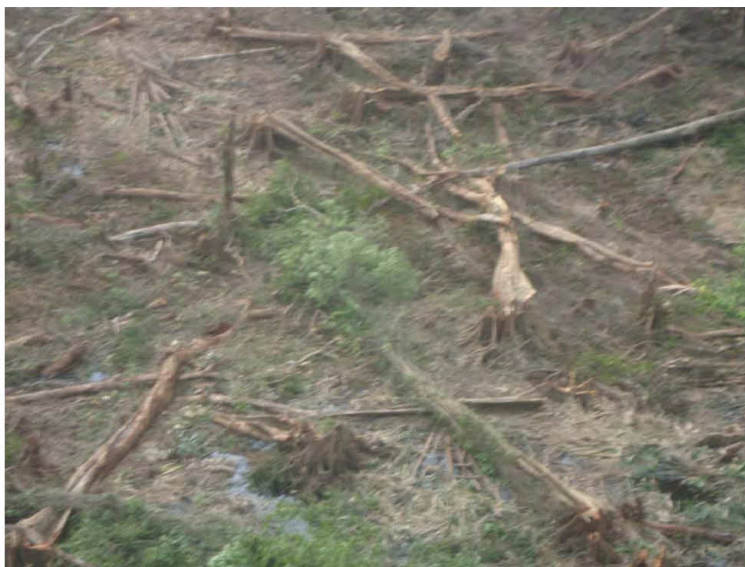
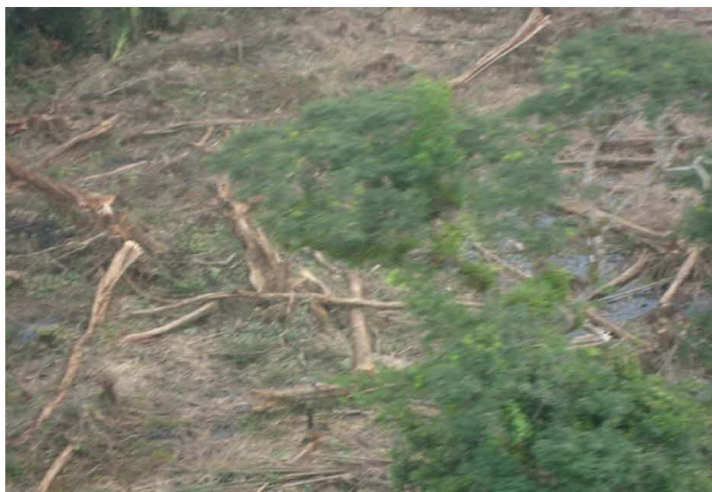
GPS Point N 10.92377° ---W083.68121°

7. Approximately 1000 meters away from the dredger's location towards the Northeast is a large area of approximately 5 hectares that was felled (change of soil use) and where the forest was completely eliminated, with a large number of trees knocked down and a pile of cut wood. It is important to visit this site again in order to take measurements for an appraisal of the environmental damage.

1. Perform another visit to the area of the dispute, going down to the site for the purpose of measuring the felled areas and appraising the environmental impact.
2. Identify and appraise other potential damages caused to the area of the dispute, by means of a flyover, with the assistance of the Law Enforcement's Air Unit.

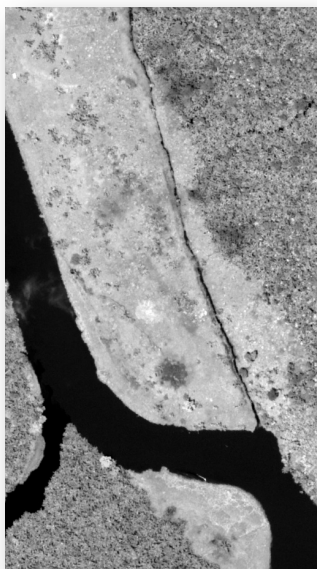
Figure 2 - Reduced water flow through the channel as on 7 June 2011

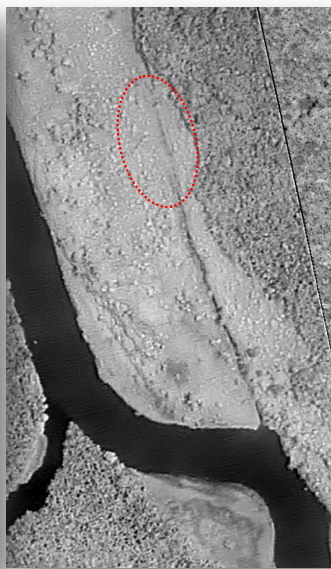
Figure 3 - Continued reduction in observed channel water flow as on 28 August 2011

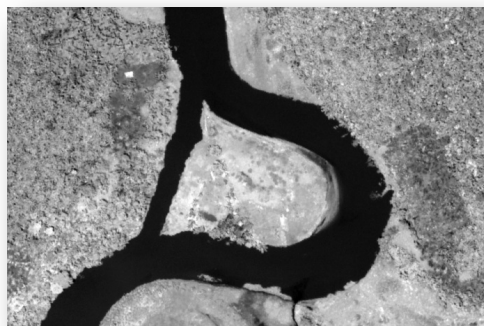
Figure 5 - Meander Cut Site 1 on 7 June 2011

The major cut site in the meander bend along in the San Juan River immediately upstream from the new channel area<sup>6</sup> as identified and described in detail in the earlier UNITAR/UNOSAT reports has remained relatively unchanged between 7 June and 25 October 2011, showing no indications of significant erosion along the river banks or changes in water flow due to deposition or further dredging. There is, however, a possible light to moderate accumulation of sediment deposits along the inner edge of the original river bend, however this may be only due to normal fluctuations in the river levels. See Figures 5 and 6 below and see also focus Map 5 on page 9. Further, there are no indications within the immediate vicinity of meander cut site 1 of deforestation or other measurable changes in vegetation cover over the same period. There has been recent building activity within the area, specifically the construction of two small structures approximately 5x5m in size on the Nicaraguan side of the San Juan immediately adjacent to the meander bend cut.

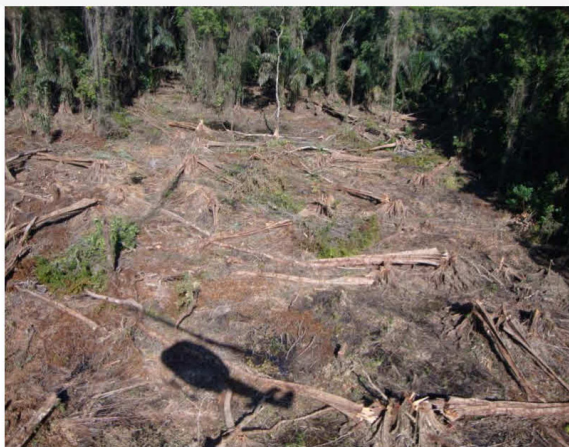
**Photo DSC\_1076.** Panoramic view of the northeast corner of the cut area shown in Figure 1. Photo taken on 25 October 2010.

In photo DSC\_1076 it is shown that in that section of cleared forest, it was not observed evidence of the existence of a natural channel during the inspection carried out on October 2010.

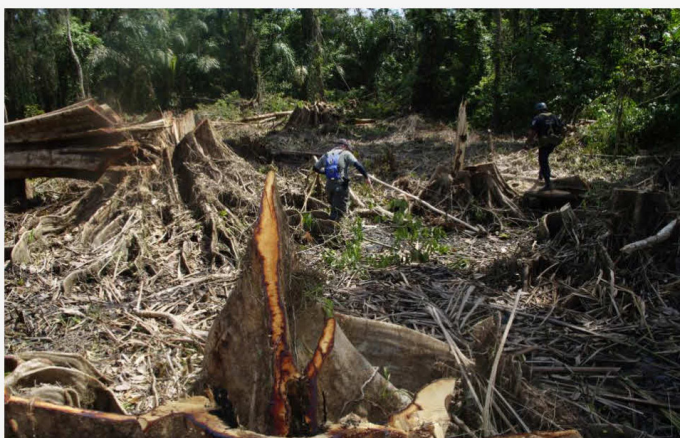
**Photo IGP\_3909.** Partial view of the affected area located in the northeast corner of the cut area shown in Figure 1. Photo taken on 25 October 2010.

In photograph IGP\_3909, considering that the height of the officer in the center is just over 1.80 mts, it can be inferred that the base of the tree located in the upper left corner of the picture measures approximately 6 meters and its diameter exceeds 80 cms approximately

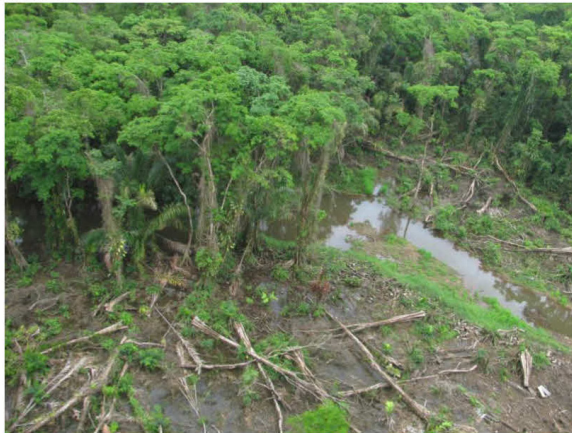
**Photo IMG\_0821.** Partial panoramic view of northeast corner of cut area shown in Figure1.  
Photo taken on 5 April 2011.

In photo IMG\_0821 it can be seen the appearance of the artificial channel in an area that as of October 2010 did not show signs of its existence. At the same time, it is observed that in the causeway of the said channel, in the section shown in the lower right corner there is a tree stump.

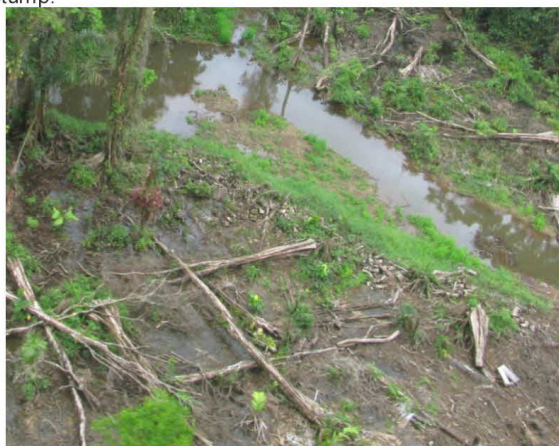
**Photo IMG\_0821-1.** Corresponds to a partial enlargement of the lower right corner of the previous photo, where it is evidenced more clearly the existence of the stump mentioned for photo IMG\_0821.

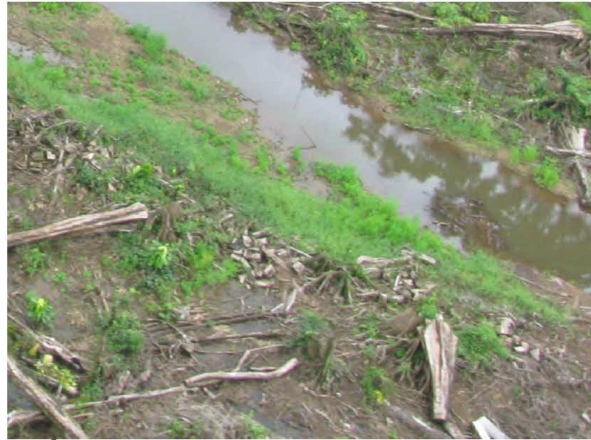
**Photo IMG\_0821-2.** Corresponds to a partial enlargement of the lower right corner of photo IMG\_0821-1.

If in Figure 1 was established that the width of the artificial channel in the area of study was about 6-7 meters, it can be inferred that the base of the tree located in the artificial channel measures at least 5 meters at its widest section.

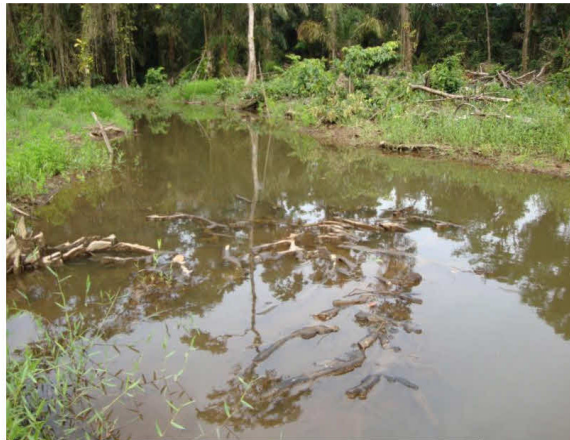
**Photo DSC\_731.** Partial view of stump shown in the previous photos. It can be observed that the stump covers over 60% of the artificial channel's width in that section. Photo taken on 5 April 2011.

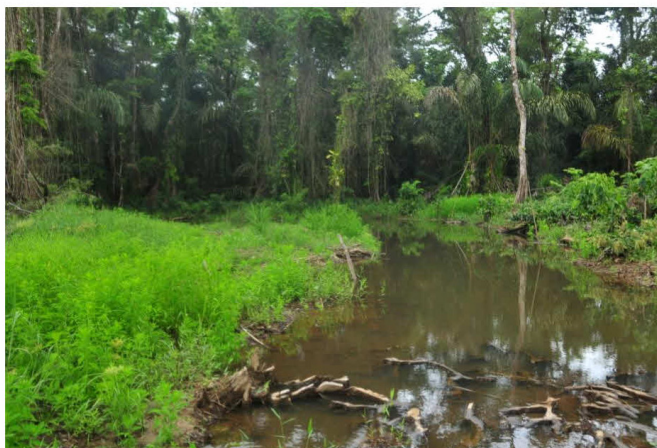
**Photo DSC\_5440.** Partial view of stump shown in previous photos. It can be observed that the stump covers over 60% of the artificial channel's width in that section. Photo taken on 5 April 2011.

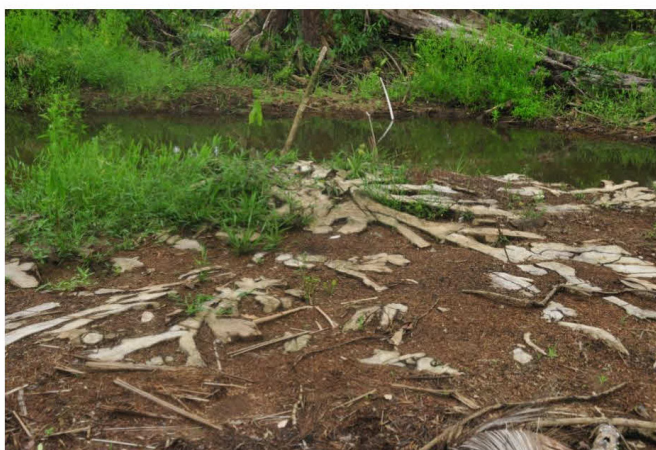
**Photo DSC\_5434.** Partial view of a stump of *Pterocarpus officinalis* located next to the artificial channel built in the forest area located in Calero Island between Los Portillos Lagoon and the San Juan River. Photo taken on 5 April 2011.

Based on the attached map in Figure 1 of this document, it is possible that in the causeway of the artificial channel remains may be found of at least 20 trees of different species and dimensions whose ages could reach up to 268.4 years. In addition, for the felled areas adjacent to the causeway of the artificial channel, individuals were identified with diameters of up to 130 cms of the species *Pterocarpus officinalis*, which could reach up to over 353 years of age.

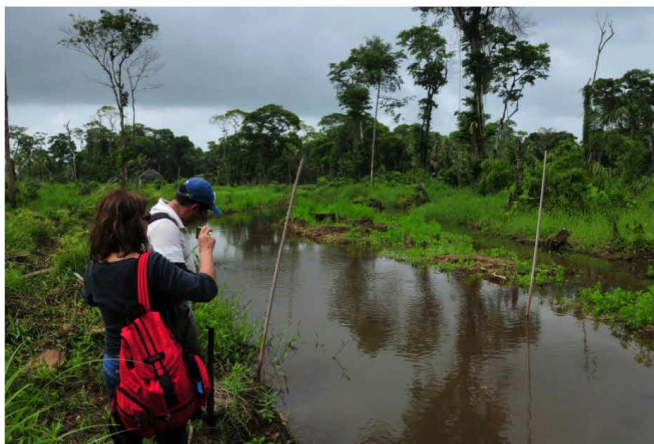
**Photo DSC\_5349.** Partial view of a channel section located south of the felled area shown in Figure 1. One can see that at the center of the artificial channel there is presence of strains of *Raphia taedigera* (yolillo).

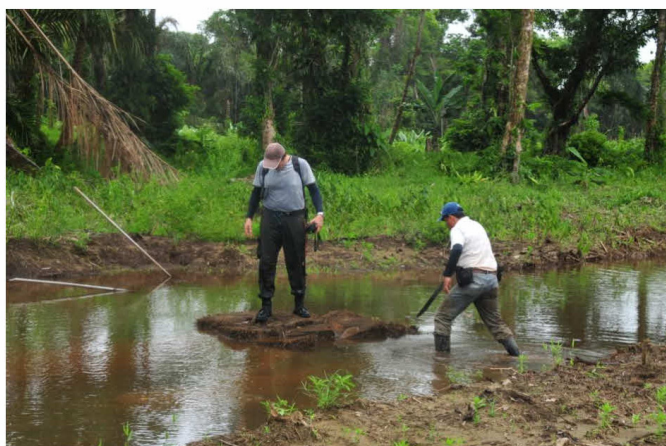
**Photo DSC\_5465.** Partial view of channel section located adjacent to the area of cut forest shown in Figure 1. One can see that at the center of the artificial channel there is presence of strains of *Raphia taedigera* (yolillo)

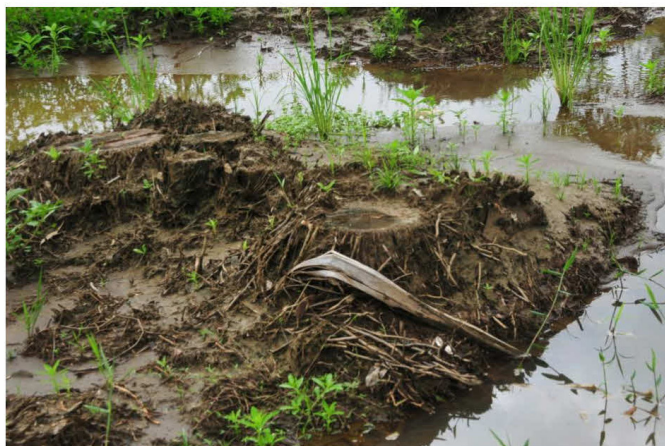
**Photo DSC\_5316.** Partial view of channel section located outside of the forest, towards the south of the felled area shown in Figure 1. One can see that at the center of the artificial channel there is presence of strains of *Raphia taedigera* (yolillo). It also shows the shallowness of the channel caused by a natural elevation of the ground.

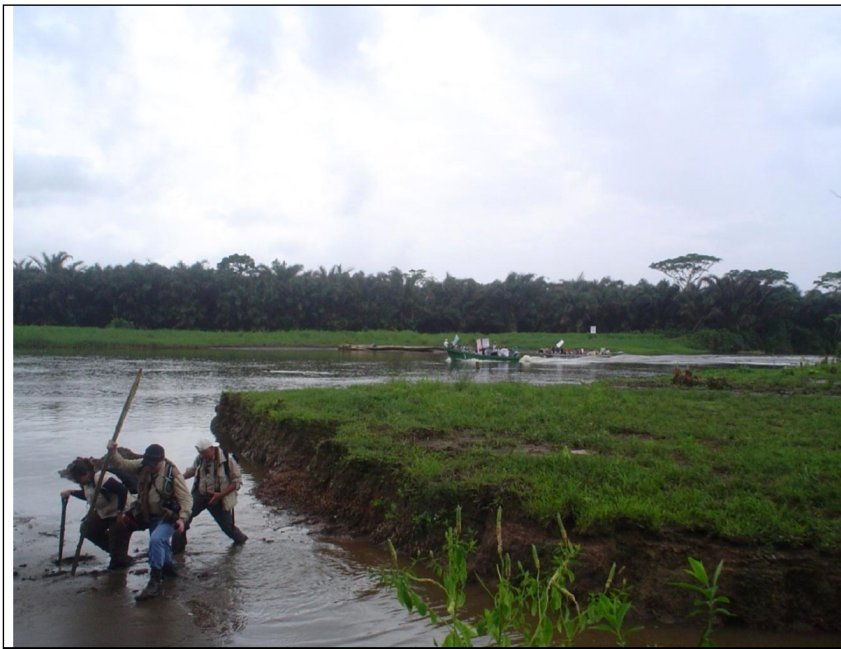
**Figure 5. Site 1:** Beginning of the artificial canal on the right bank of the San Juan river. In the background a boat with some of the Nicaraguans who harassed mission members.

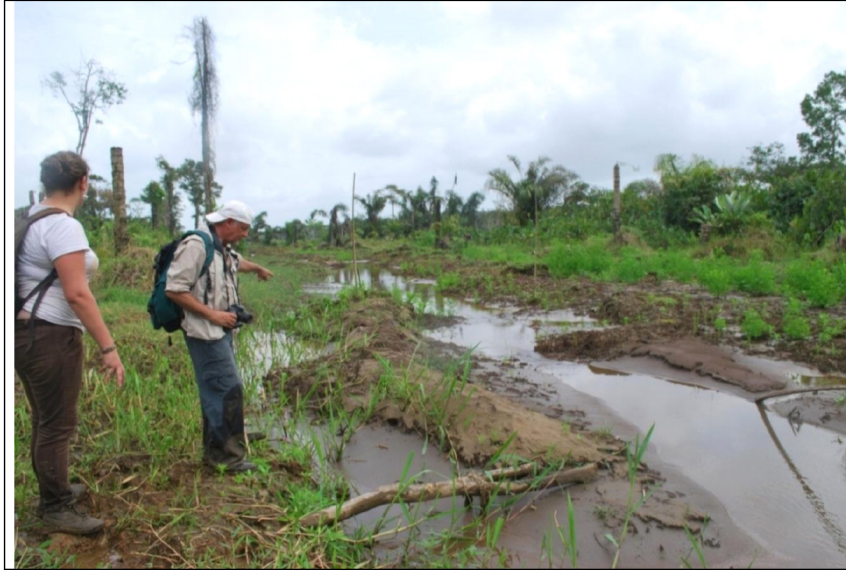
In site 2, located at coordinates N 1207267 and W 535041, approximately 300 metres to the north of site 1, on the artificial canal and in the direction of the Los Portillos lagoon (see Figure 6), a second measurement was taken of the dimensions of the cross section of the artificial canal.

This cross section of the canal provides clear evidence of sedimentation. The surface width, between banks, is 4.2 metres, the depth of the canal is 0.6 metres and the water level only amounts to 0.2 metres. The walls of the canal are of silt and fine sand and the sediment within the canal is composed of silt. In this sector the canal water, as in site 1, flows in the direction of the San Juan river.

**Figure 6.** Artificial canal measurement site 2, located 300 metres from site 1.

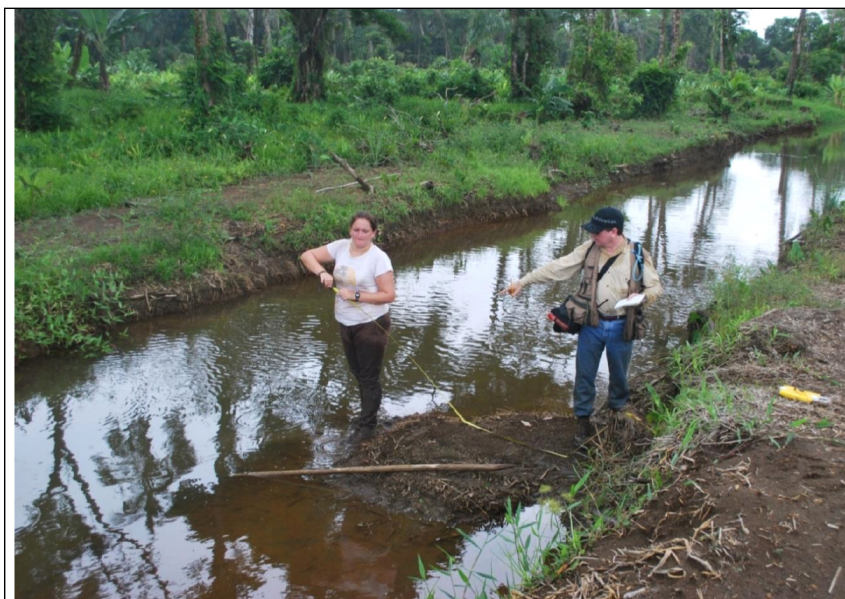
**Figure 7.** Artificial canal measurement site 3, located 800 metres from site 1. Sediments dumped on both sides of the canal were observed.

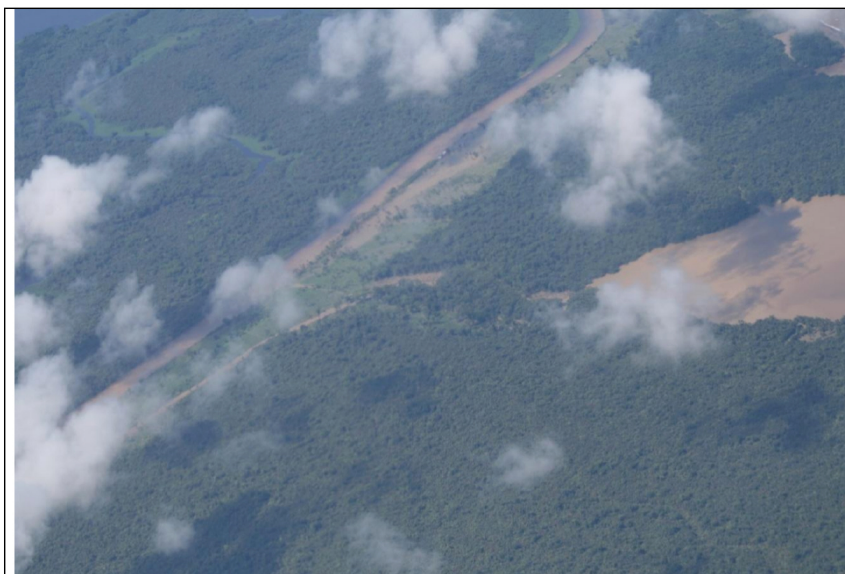
**Figure 9.b.** Aerial photograph of 5 December 2010 during a flood period of the San Juan river, which shows it transporting a substantial amount of sediments, and how the artificial canal opened up by the Nicaraguans allows a direct hydraulic connection between the river and the Los Portillos lagoon, which is how the sediments of the river pass via the canal towards the lagoon, altering its environmental quality.

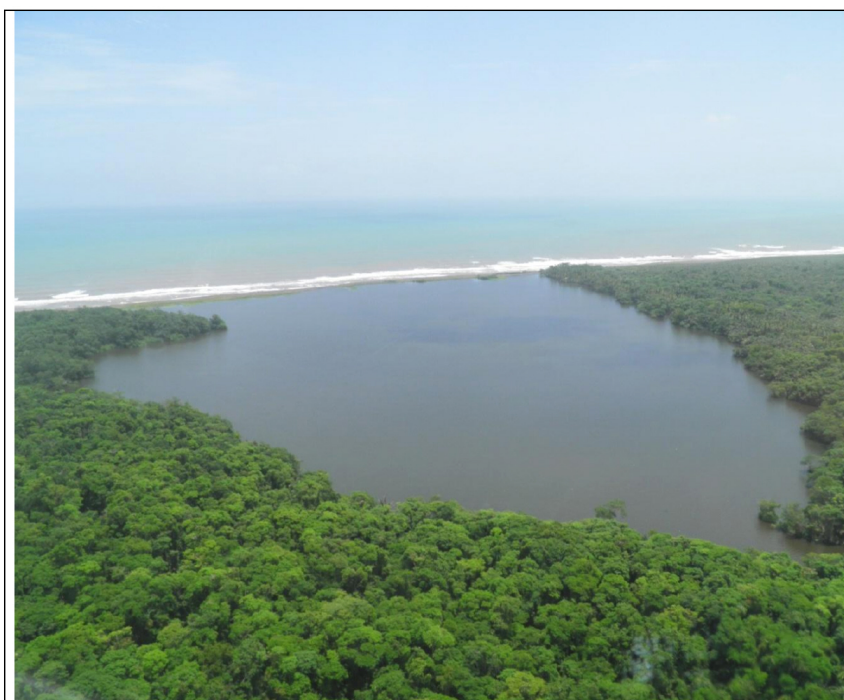
By contrast, **Figure 12** shows an aerial photograph taken in the Los Portillos lagoon on 5 April 2011, a period of low water levels, when clearly no plume of sediment is apparent whatsoever and, moreover, the coastal sandbank, in Punta Castilla, remains unaltered, with no direct connection between the Los Portillos lagoon and the Caribbean Sea.

**Figure 12.** Aerial photograph of the Los Portillos lagoon taken on 5 April 2011.

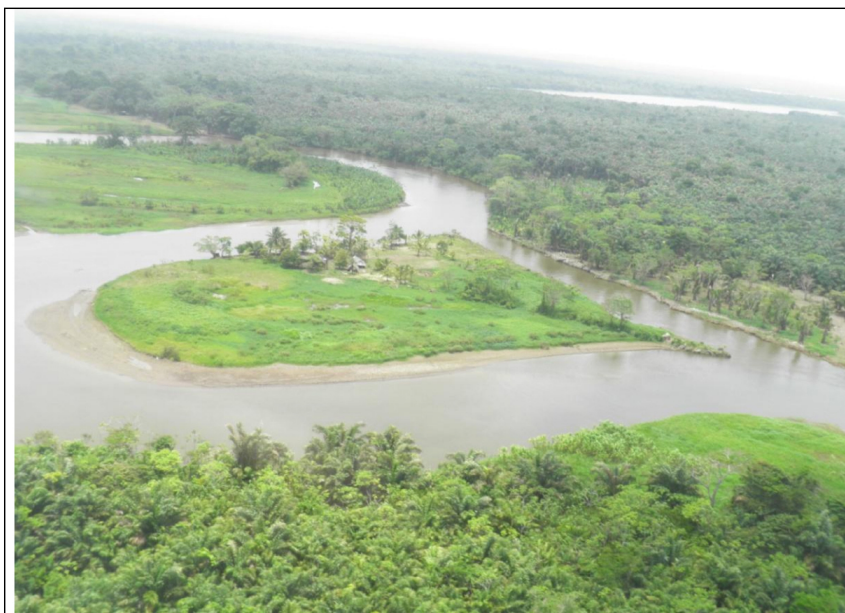
**Figure 13a.** Photograph of 6 April showing the cutoff of a meander to channel the flow of water from the San Juan river to the artificial canal.

Based on information available before the visit to the area in April, it had been noted that since November 2010 Nicaragua had been cutting off meanders in its own territory to alter the water flow pattern of the river so that it flowed more easily and faster towards the artificial canal (see Figures 13a, 13b and 13c), thereby transporting more sediments towards the wetland.

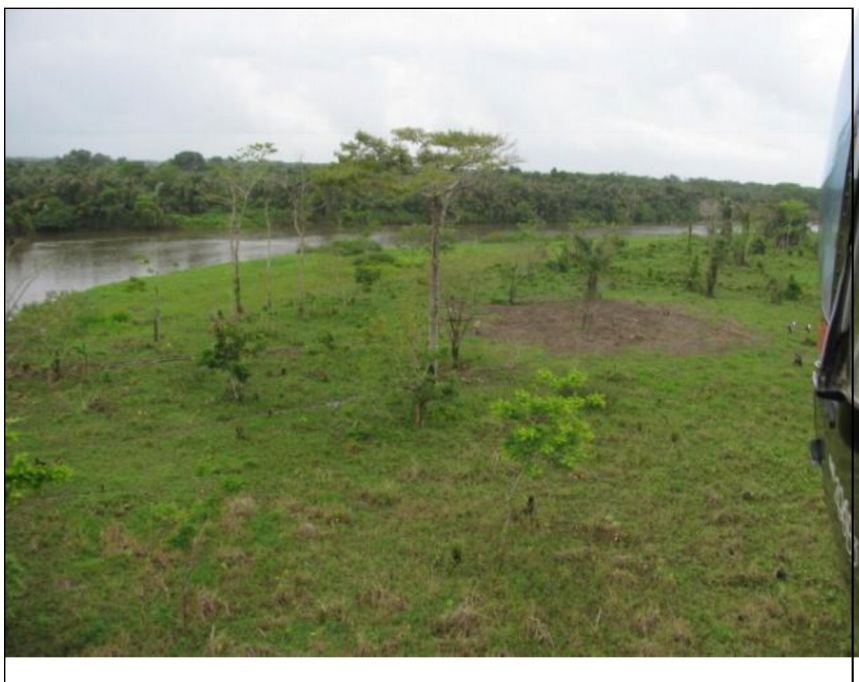
**Figure 15.** Area where sediments from the San Juan river extracted by the Nicaraguans and moved to land on the right bank were deposited and where in addition a work camp was set up during the artificial canal construction works.

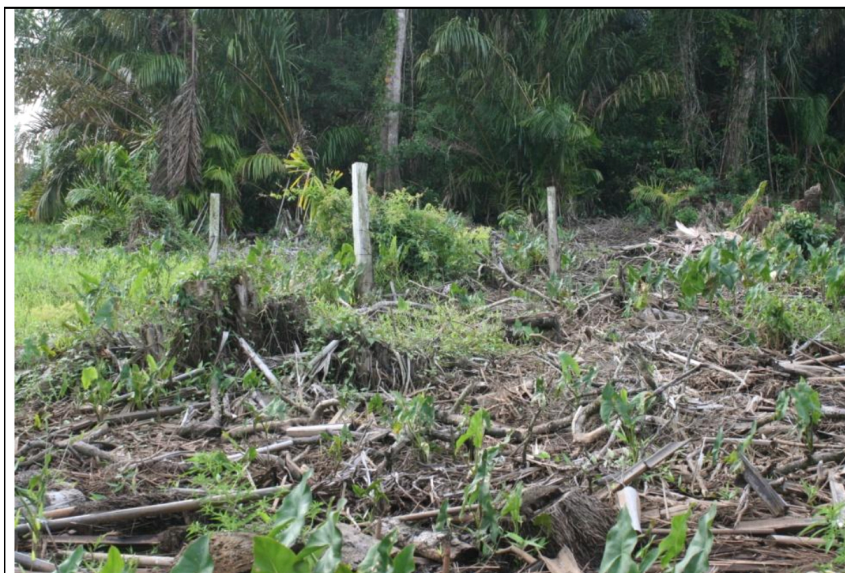
jobo (*Spondias mombin*), golden fruit (*Virola koschnyi*), *Montrichardia arborescens*, et al (see **Figure 16**).

**Figure 16.** Deforestation process (tree felling) with change in land use. (Photo: J. Bravo, 5 April 2011).

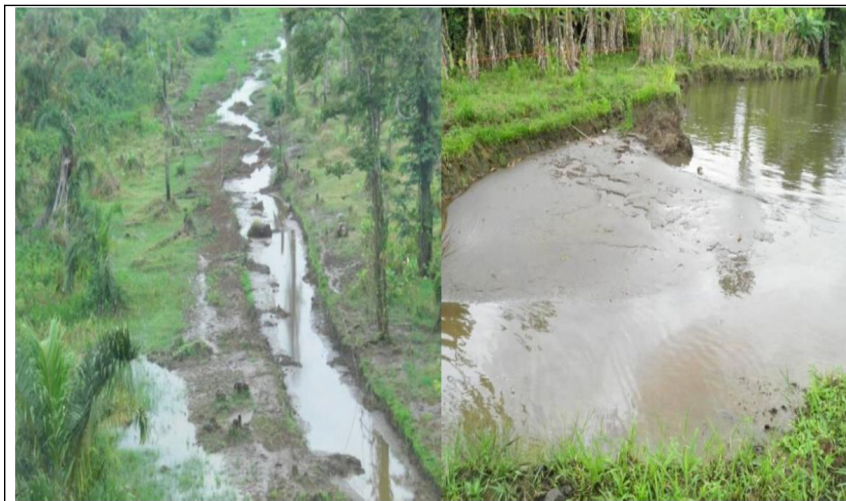
**Figure 17.** Erosion of the banks of the artificial canal and deposit of sediments in the confluence with the San Juan river. (Photo: A. Monge, April 2011).

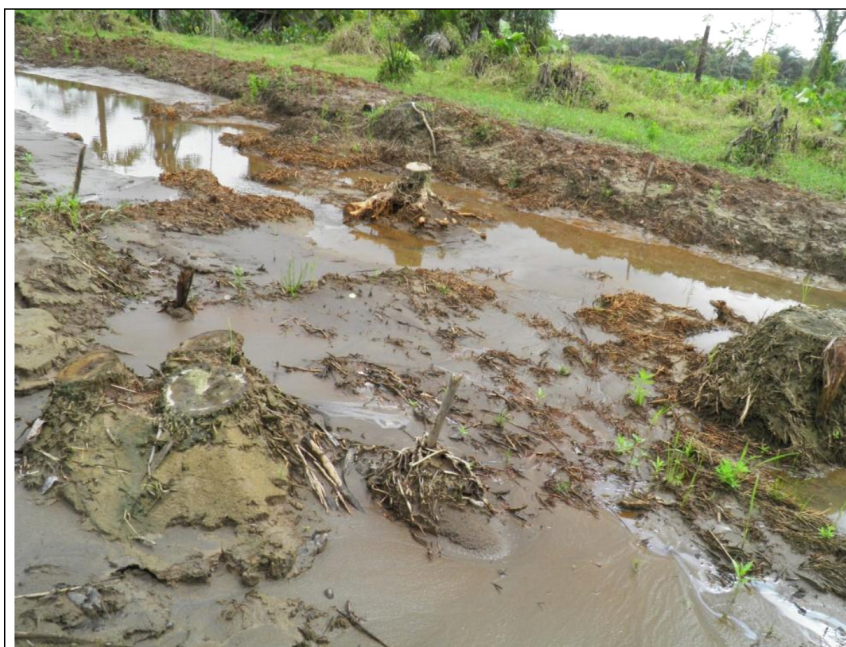
Along the artificial canal there is a shallow body of water with deposits of clay-like materials on the banks, probably extracted from the canal. These sediments are dragged to the canal basin by surface rain water runoff (see **Figure 18**).

**Figure 18.** Unconsolidated sediments on the banks of the canal, colonization of herbaceous vegetation and some tree remains (Photo: A. Monge, April 2011).

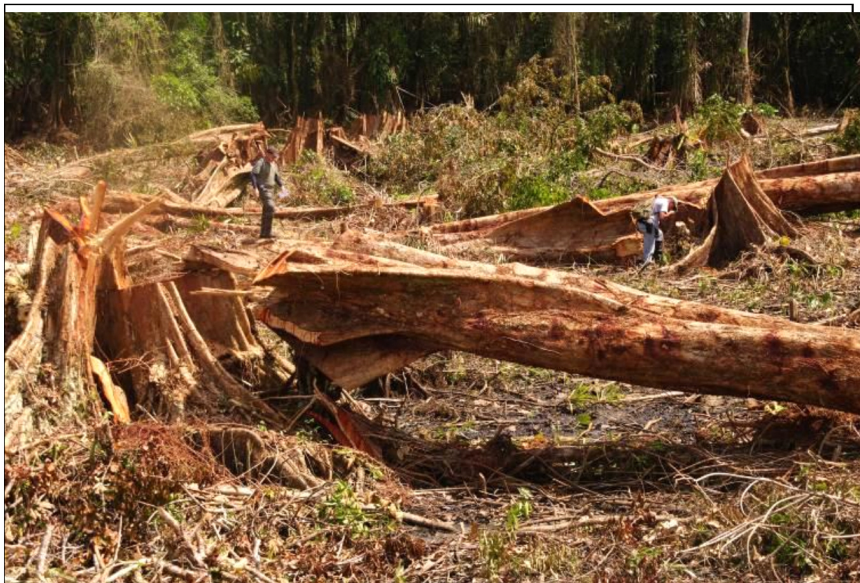
**Figure 19.** Partial view of areas of recent deforestation, as observed in the inspection of 25 October 2010. Large pieces of trunk and stumps of over two metres high left after felling activities can be seen.

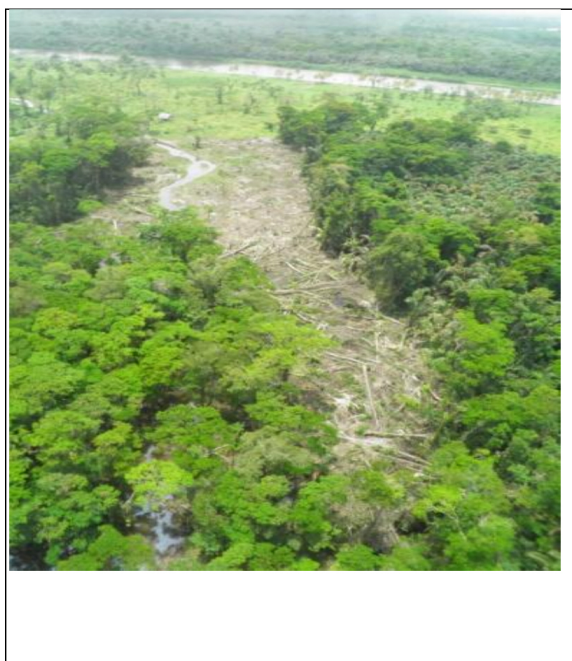
**Figure 20.** Partial panoramic view of the deforested area in the Punta Castilla sector, Isla Calero, taken on 5 April 2011. The deforested area in the bottom right corresponds to part of the area deforested after 25 October of approximately 0.33 ha (Deforestation site 2). The deforestation front located next to the Los Portillos lagoon is out of shot. The San Juan river can be seen in the background. (Photo by Ana María Monge)

However, these 2.48 ha of primary forest do not make up a single block, but consist of two deforestation fronts; one of approximately 0.48 ha located next to the Los Portillos lagoon (Deforestation site 3 in **Figure 2**, see also **Figure 26**), while the remaining two hectares are located more towards the south-west, approximately 300 metres from the San Juan river (Deforestation sites 1 and 2 in **Figure 2**, see also **Figure 20**).

Of the two deforested hectares located closer to the San Juan river, 1.67 ha corresponds to the tree felling observed in the first inspection (Deforestation site 1), whereas the remaining 0.33 ha were felled after 25 October 2010 (Deforestation site 2).

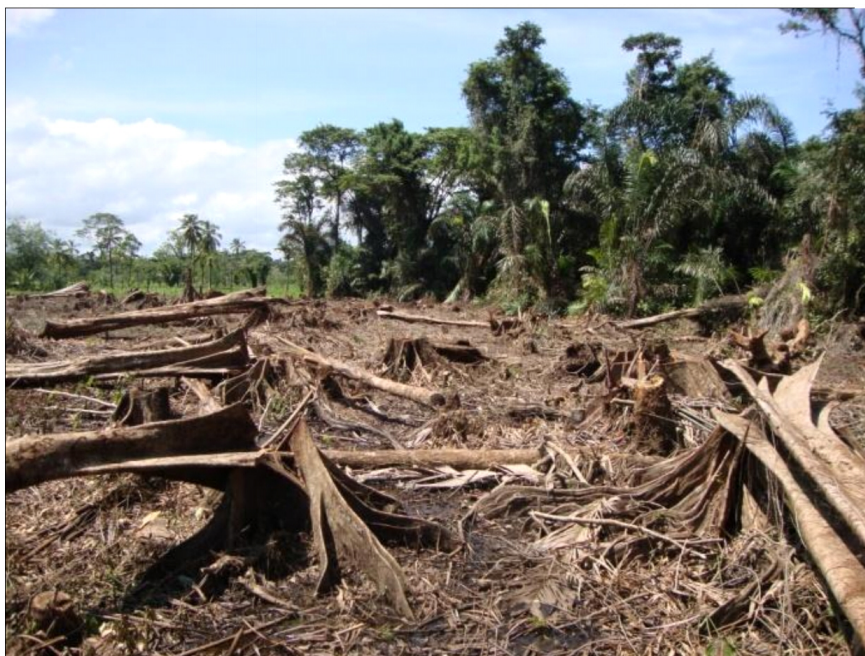
**Figure 21.** Partial view of the area deforested as at 25 October 2010. The clearing of trunks, height of stumps and absence of branches due to their removal can be observed. (Photo by Miguel Araya).

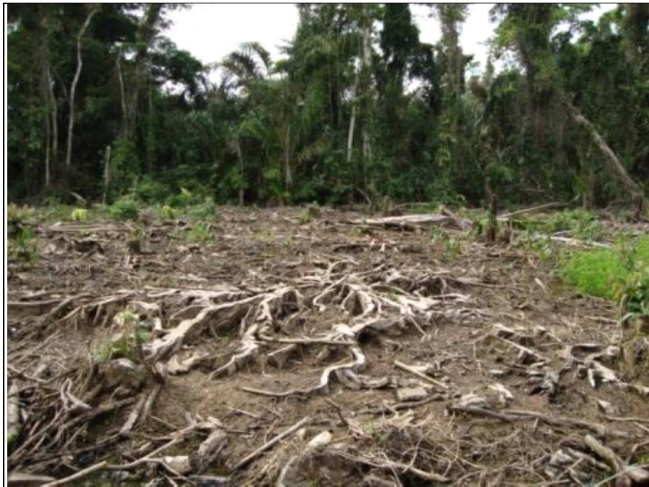
**Figure 22.** Partial view of deforested areas as at 25 October 2010, which had been subject to forestry exploitation by 5 April 2011. The absence of trunks can be seen due to sawmilling and the cutting down of stumps to ground level. (Photo by Miguel Araya).

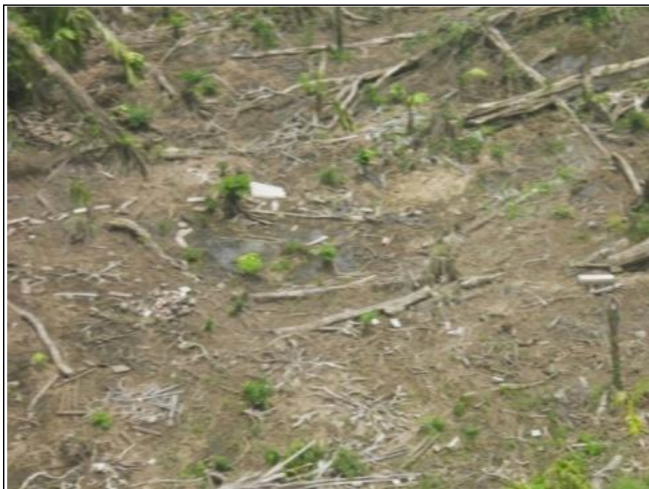
**Figure 23.** Partial view of deforested areas as at 25 October 2010, which show that they had been harvested by 5 April 2011. On the left and right-hand sides can be seen the remains of sawmilling.

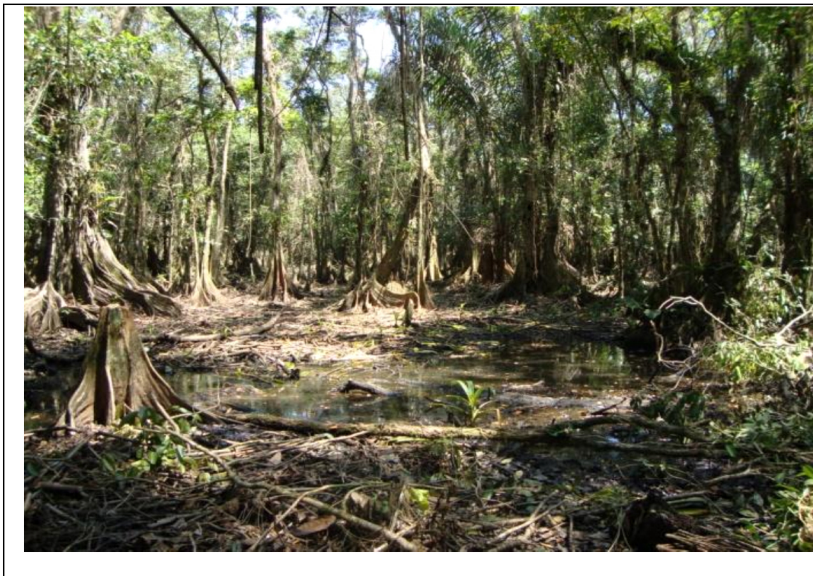
**Figure 25.** Partial view of the area with removal of undergrowth, as at 25 October 2010. The removal of small trees and palms as part of the tree felling process can be observed. The prevalent body of water can also be seen. (Photo by Miguel Araya).

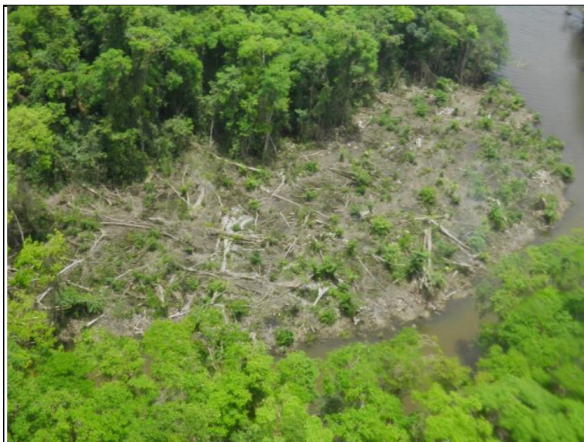
**Figure 26.** Panoramic view of the deforestation front located next to the Los Portillos lagoon (Deforestation site 3). The body of water in the deforested areas can be seen, as well as the presence of regrowth. No sawmilling work was observed in this sector. (Photo by Ana María Monge).

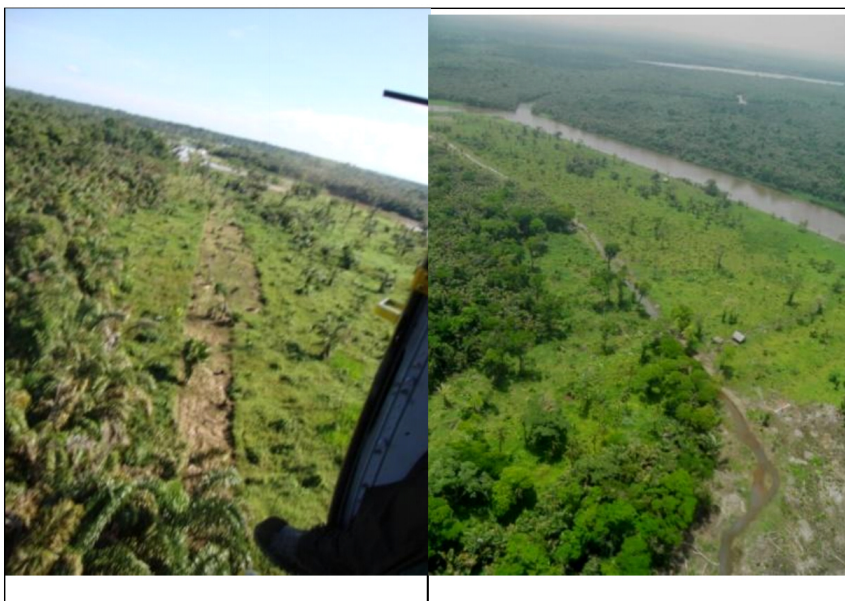
**Figures 27a. and 27.b.** On the left, partial view on 25 October 2010 of the pathway cleared to construct the artificial canal, as seen on 5 April 2011, which is shown in the image on the right (left photo Miguel Araya, right photo Ana María Monge).

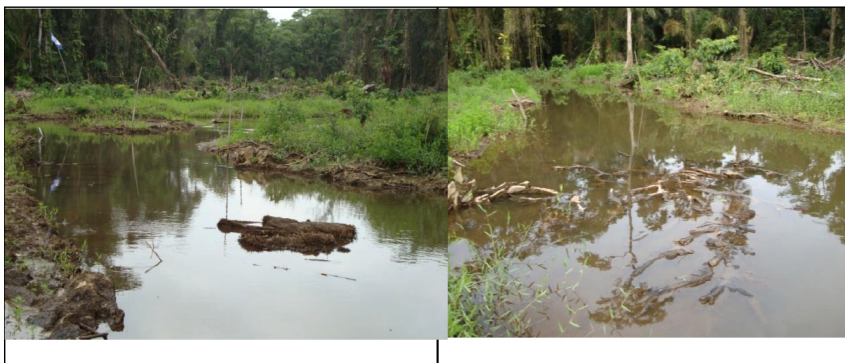
**Figures 28.a and 28.b.** On the left can be observed the stumps of the *Raphia taedigera* species in the middle of the constructed canal. On the right can be seen the stump of a *Pterocarpus officinalis* in the canal channel.

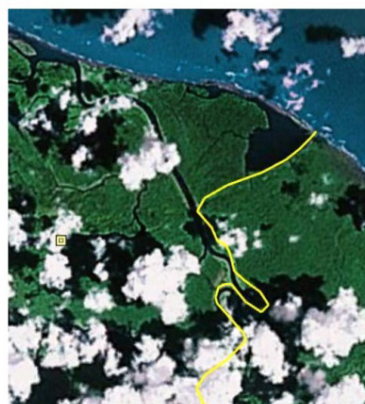
Figure 3- Google Image indicating the border between Nicaragua and Costa Rica in yellow. The caption at the critical ogle web site reads: "Current incorrect border in Google Earth, showing the S-shaped river course". Source: <http://ogleearth.com/2010/11/about-costa-rica-nicaragua-their-border-and-google/>

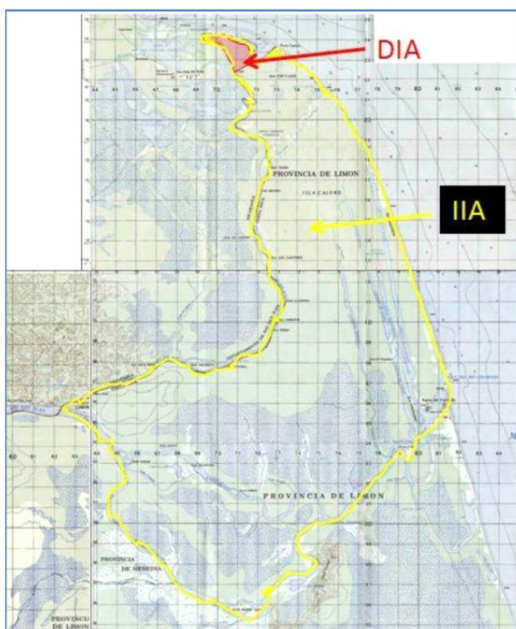
Figure 6- Approximate location of the DIA and IIA according to the description of the RAMSAR Report. The line of the diagram on the San Juan River should be interpreted strictly on the Costa Rican Edge. Source: Authors Based on Official CR-IGN Maps 1:50:000

The report also recognizes an Indirect Influence Area (IIA) to be the coastal area from the mouth of the San Juan River to the mouth of the Colorado River as well as the delta of the San Juan River and the rest of the wetlands located in Isla Portillos (According to this description about 21,500 ha.). It also recognizes that adjacent to the IIA is Portillos Lagoon which is part of the RAMSAR SJWR (RAMSAR Advising Mission 69, 2010) (Figure 6). The report says that according to the evidence shown by Costa Rica the following events are indicated as causing the changes:

- Dredging of the San Juan River west of Portillos lagoon,
- Sediment deposition in the CNW coming from the San Juan River in the area of Portillos Island. The estimated sediment deposit at that time (November, 2010) was 1688 m<sup>3</sup> (0,24 ha),
- Cutting of the vegetation of the CNW (forest and understory vegetation), the forest cover was at that time 5.75 ha (1.67 ha of trees and 4.8 ha of understory vegetation),

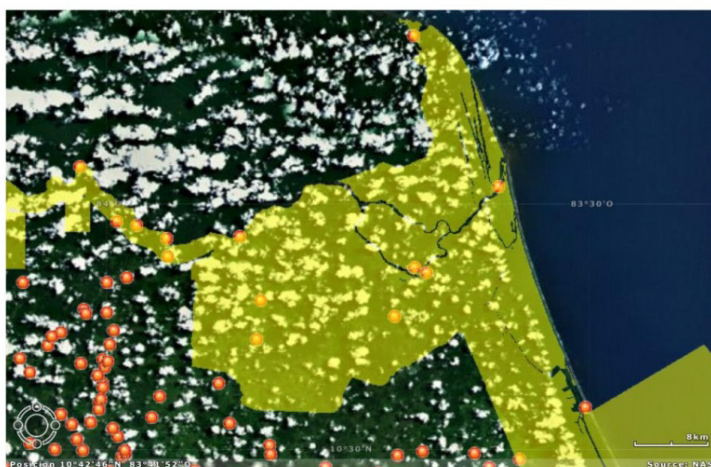
Figure 10- Main Communities (marked in orange) Located Close to and Within the Protected Areas (Barra del Colorado Wildlife Refuge) that are Part of the CNW. Source: Adapted from Maps from Costa Rica's Digital Atlas by the ITCR.

The area of the Barra del Colorado Wildlife Refuge (northern part of the CNW) is inhabited by close to 15 communities (the main of which appear on Figure 10). The socioeconomic characteristics of these populations point to a low quality of life due to non-satisfaction of basic needs such as employment, education, health, potable water, access infrastructure and communications to which drug trafficking related illegal activities have been added lately. Its main economic activities are very natural resource dependent: agriculture and animal husbandry, commercial fisheries and hunting. These activities have not been fully controlled leading to some

As can be seen also in Figure 10, the colonization front is very close to the southwestern border of this area. These communities are also very dependent on the ecosystem services provided by the protected area.
