# CONCERNING THE GABCIKOVO-NAGYMAROS PROJECT (HUNGARY/SLOVAKIA)

# MEMORIAL OF THE REPUBLIC OF HUNGARY

MAPS & PHOTOGRAPHS

VOLUME 2

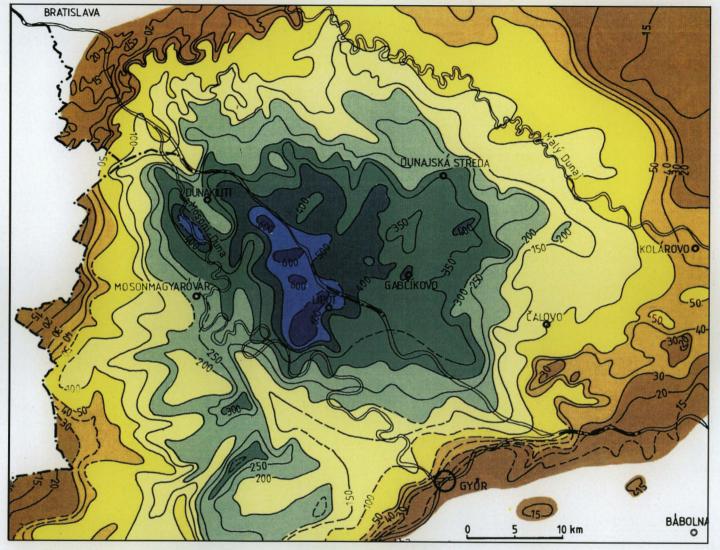
### Map. No. 12

Map compiled in the DANREG project, using the interpretation of the vertical electric soundings, measured by Slovak and Hungarian field geophysical parties.

Thickness map of the main aquifer

showing the extent and the thickness of the Quarternary gravel/sand complex, containing the biggest underground fresh-water source of Central Europe

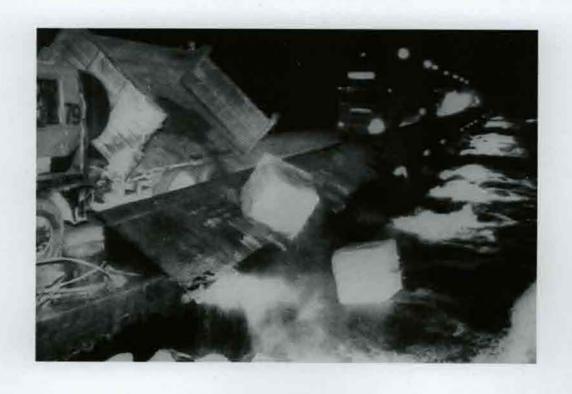
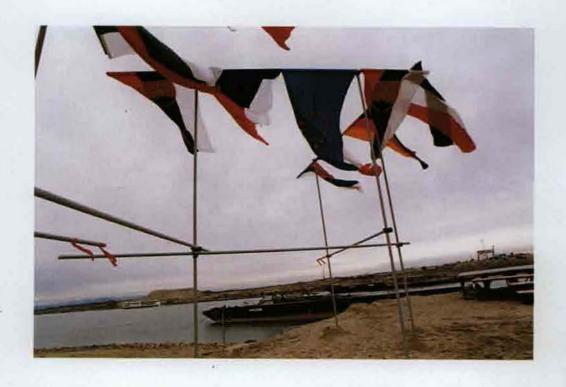
Photo 9 - A Consequence of the November 1992 flood - the sinking of a barge.

Photo 10 - A Consequence of the November 1992 flood - the washing away of a twenty ton flood weir gate.

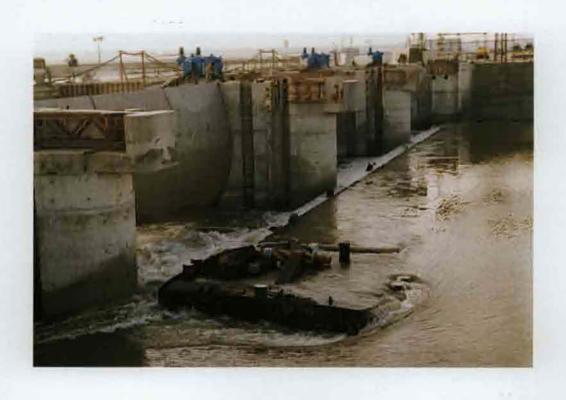
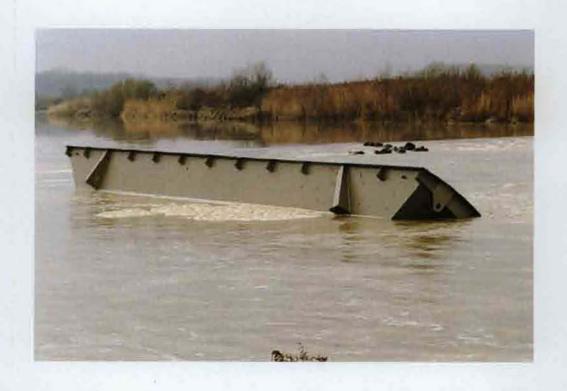
Photo 11 - An area after the diversion of the Danube. Photo 12 - An area after the diversion of the Danube.

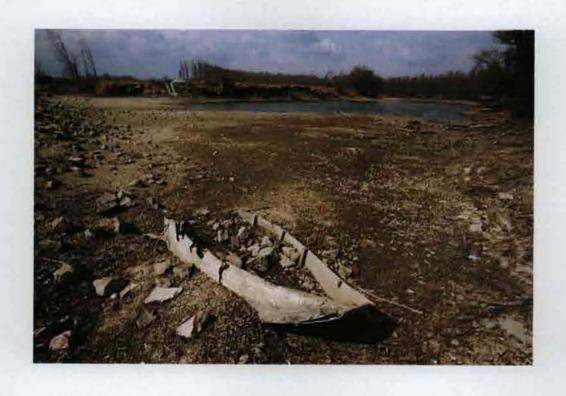
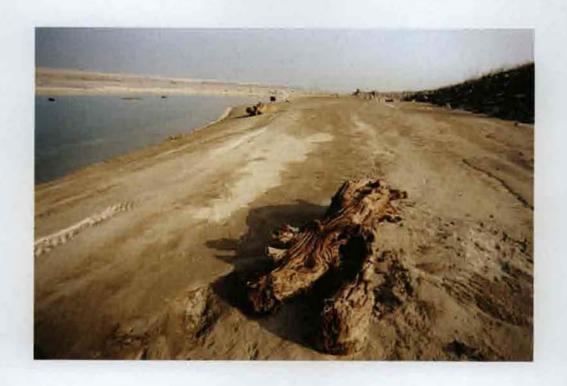
Photo 13 A - An area between Dunakiliti and Tejfalusziget: July 1990. Photo 13 B - An area between Dunakiliti and Tejfalusziget: May 1993.

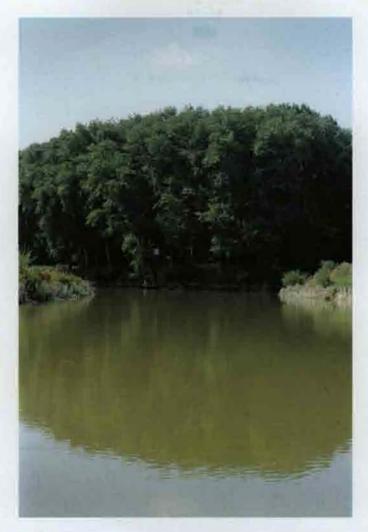
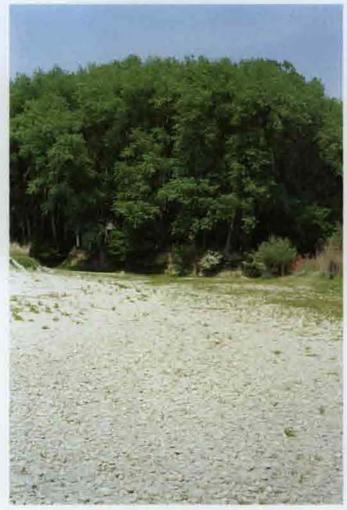
Photo 14 A - An area between Dunakiliti and Tejfalusziget: June 1992. Photo 14 B - An area between Dunakiliti and Tejfalusziget: May 1993.
