INTERNATIONAL COURT OF JUSTICE

CONSTRUCTION OF A ROAD IN COSTA RICA ALONG THE SAN JUAN RIVER (NICARAGUA V. COSTA RICA)

REPLY

ANNEX 1

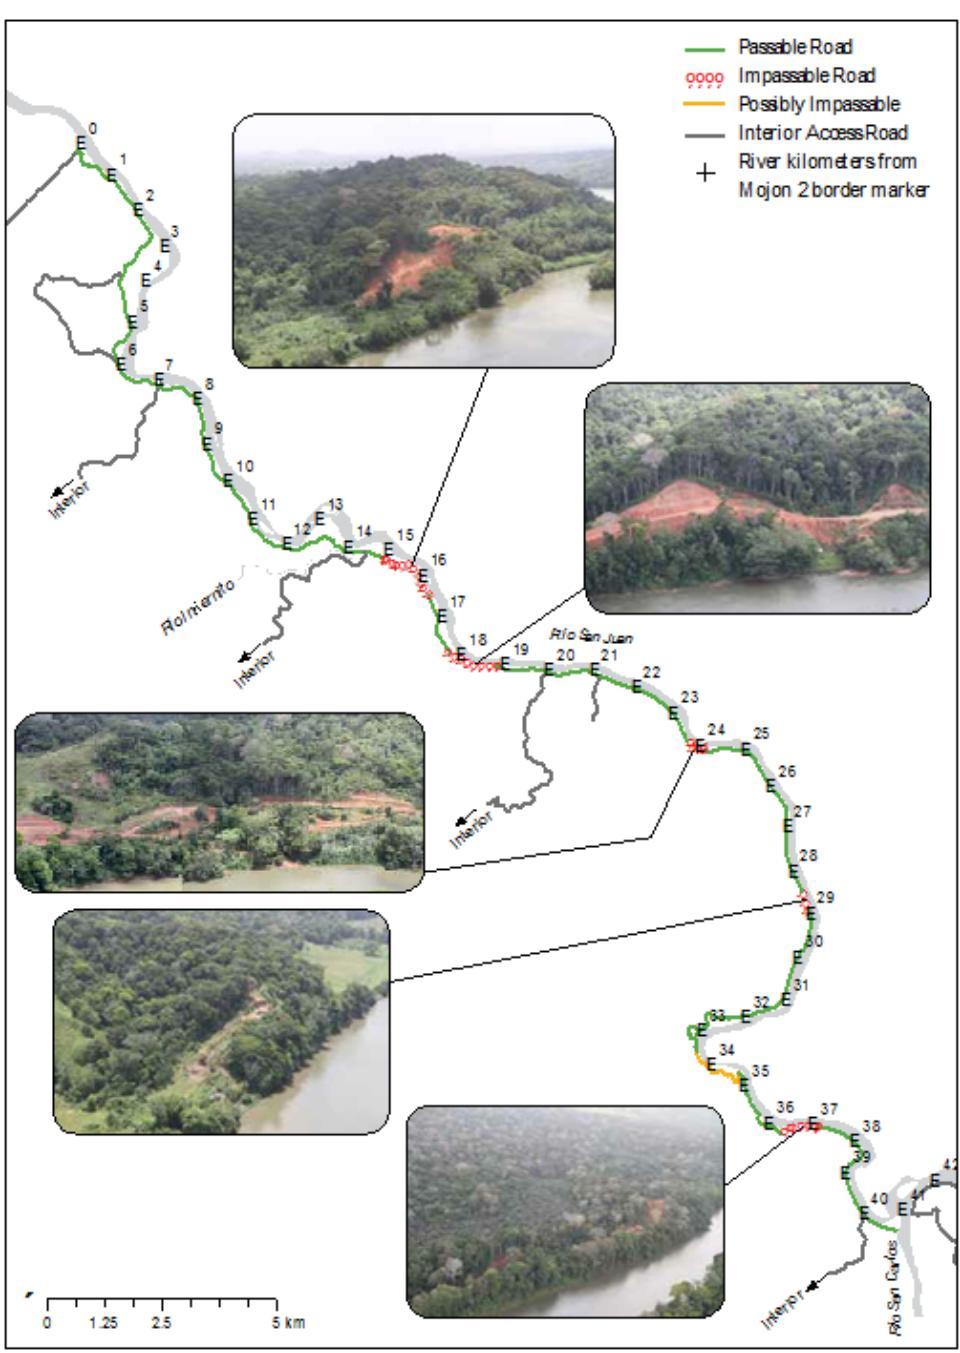
There are at least five significant gaps in Rte 1856 between Mojon II and Boca San Carlos (Figure 1), where the road is impassable because of failures, or construction attempts were abandoned due to failures on adjacent sections. In addition, a section around Rkm² 34-35 is likely impassable, but would need closer inspection to determine with confidence.

Figure 1. Map of passable and impassable portions of Rte 1856 along the Río San Juan from Mojon 2 to Boca San Carlos.

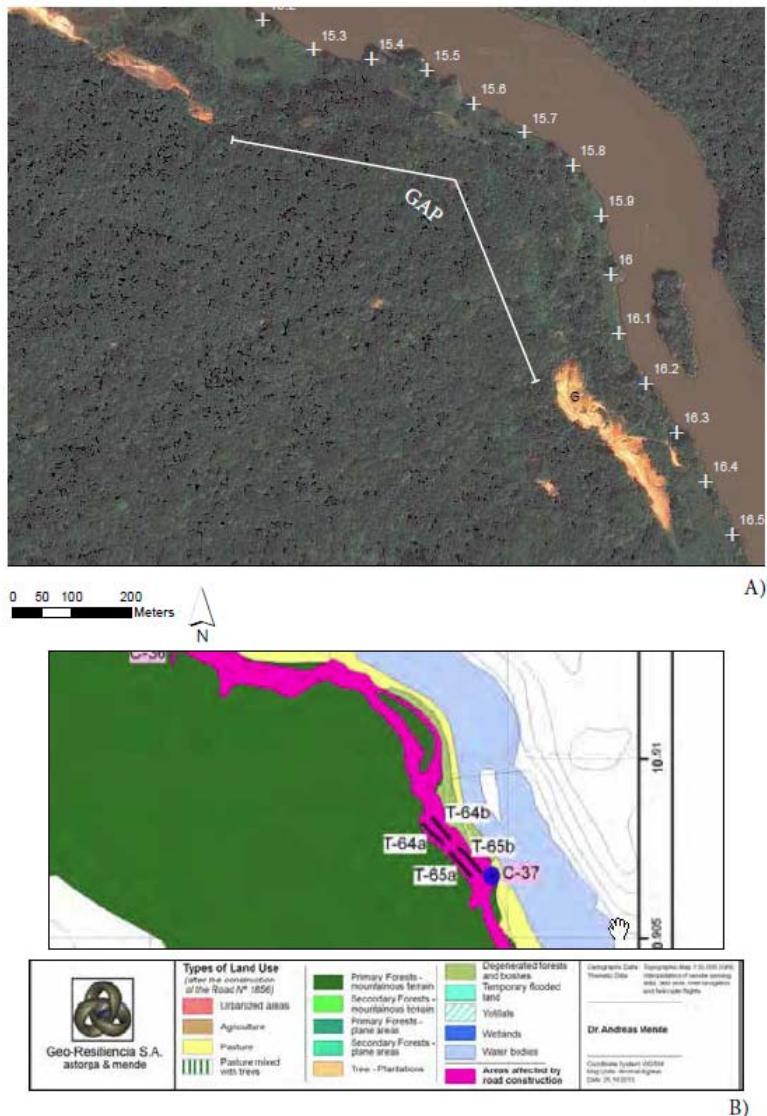
Attempts to build the road were completely abandoned from Rkm 15.3-16.1 (i.e., 15.3-16.1 km downstream of Mojon II), as visible on the high-resolution 2013 imagery in Figure 2. It appears that trees were cut, but the land was not altered with bulldozers before the attempt to build the road was abandoned. Vegetation has resprouted from the area cut. The maps of Mende and Astorga's (2013) "slope inventory" do not show a gap in the red footprint of the road "affected" area here (between "slopes" T-61 and T-64b), but show the red footprint of disturbance continuing through the gap. Their mapping of this as disturbed may reflect the initial clearing before the construction attempt was abandoned, but clearly this is a gap in the attempted road construction (Figure 2).

Figure 2, The gap in Rte 1856 from Rkm 15.3 - 16.1. A) Detail from Dec 2013 high-resolution satellite image showing the gap. B) Detail from the "slope inventory" map of Mende and Astorga (2013), Annex 6, covering the same area.

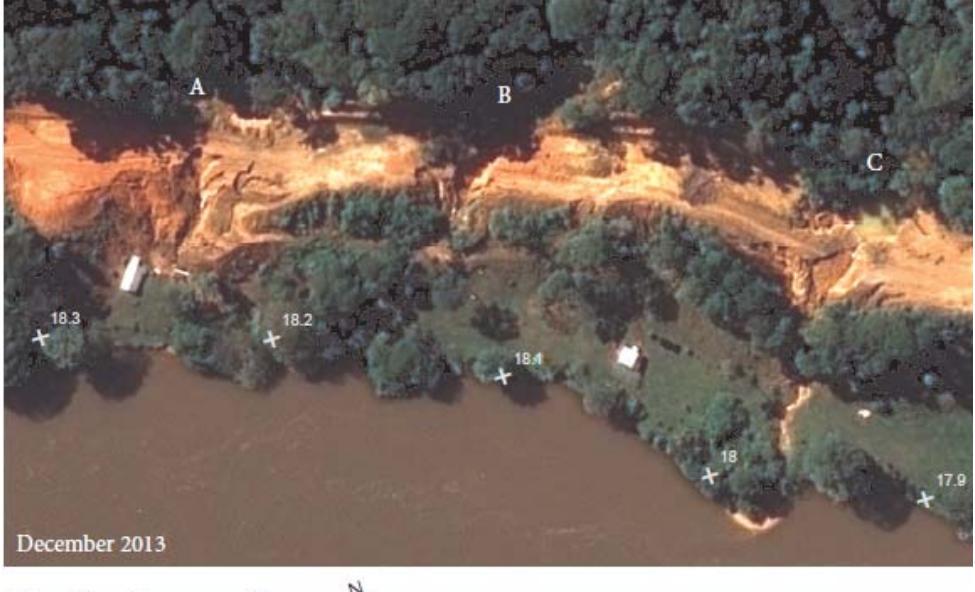
The section from Rkm 17.8 to 18.3 is a spectacularly eroding section of Rte 1856, with multiple failed cutslopes, fillslopes, and stream crossings. There are three massive stream crossings flanked by four large cuts in steep hillslopes and attendant fillslopes, all undergoing active erosion. This 1.5-km section is a gap in Rte 1856, as stream crossings have failed, been poorly repaired (as shown in Section 3), and will inevitably fail again. The road here may be navigable by dirt bike, donkey, or on foot, but not by normal road vehicles. The failed stream crossings in this section are designated as Sites 9.4, 9.5, and 9.6 in the Inventory of Severely Eroding Sites (Appendix A), described in more detail below in Section 3, and they constitute an impassable section of road, as is clear from December 2013 satellite imagery (Figure 3).

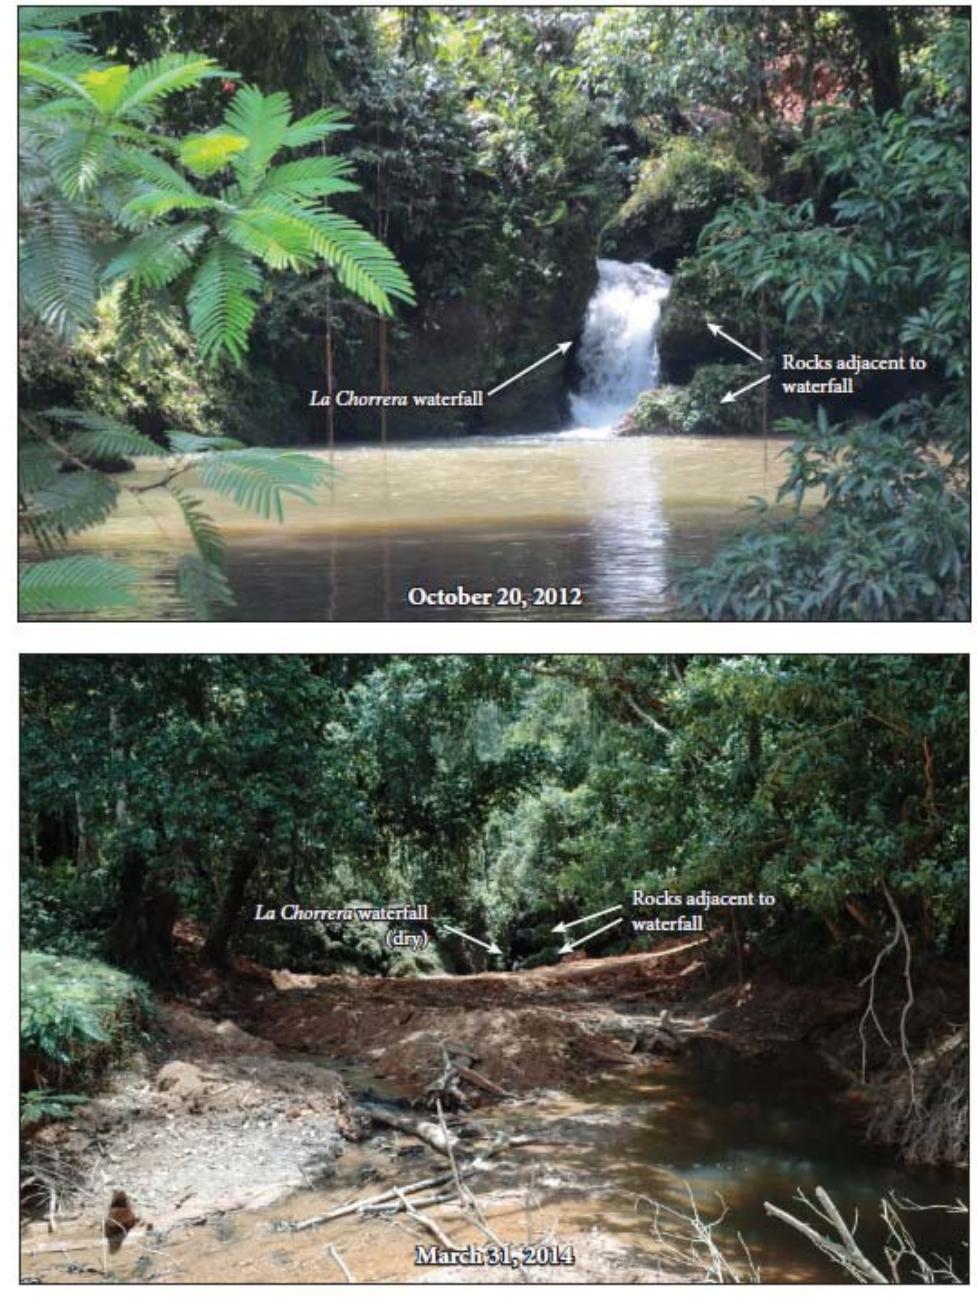
In the section from Rkm 23.6 to 24.4 (known locally as "La Chorrera"), contractors made multiple failed attempts to cross Caño La Chorrera: four different attempted routes appear as eroding scars on the hillslope (Figure 4). The most recently used crossing was constructed by filling across what used to be an embayment off the main river, a pool under a canopy of trees, which formerly provided off-channel habitat for fish but is now filled by an earthen stream crossing (Figure 5).

Figure 5. Views from Río San Juan of Caño La Chorrera, 23.9 km downstream of Mojon II. Photo dates (a) October 20, 2012 and (b) March 31, 2014.

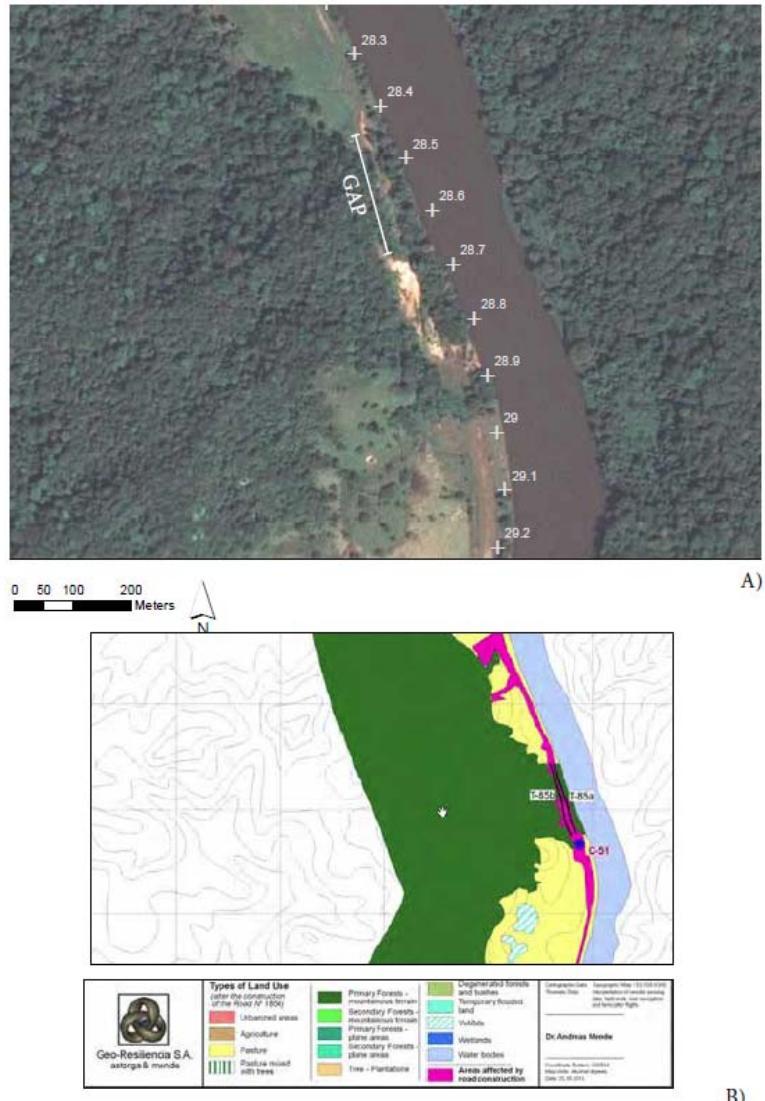
Another gap appears from Rkm 28.4 to 28.9 (Figure 6) (approximately 3 km downstream of Las Cruces), visible in the aerial imagery of 2013. It appears that some initial clearing was done, but the construction attempt was abandoned before major earthwork was attempted. The section from Rkm 28.5 - 28.65 appears as a gap on the Mende and Astorga (2013) maps on p.386. It is not identified as a gap in the road, but can be seen as such in the red footprint of the road disturbance appearing within the straight lines for "slopes" T-85a and T-85b (Figure 6). The lines were drawn continuously through this gap (with red color within the lines), as if to suggest the road was continuous through here, but in fact there is a gap, as clearly visible on aerial imagery.

Figure 6. The gap in Rte 1856 from Rkm 28.4-28.9. A) Detail from Feb 2014 high-resolution satellite image showing the gap. B) Detail from the "slope inventory" map of Mende and Astorga (2013), Annex 6, covering the same area.

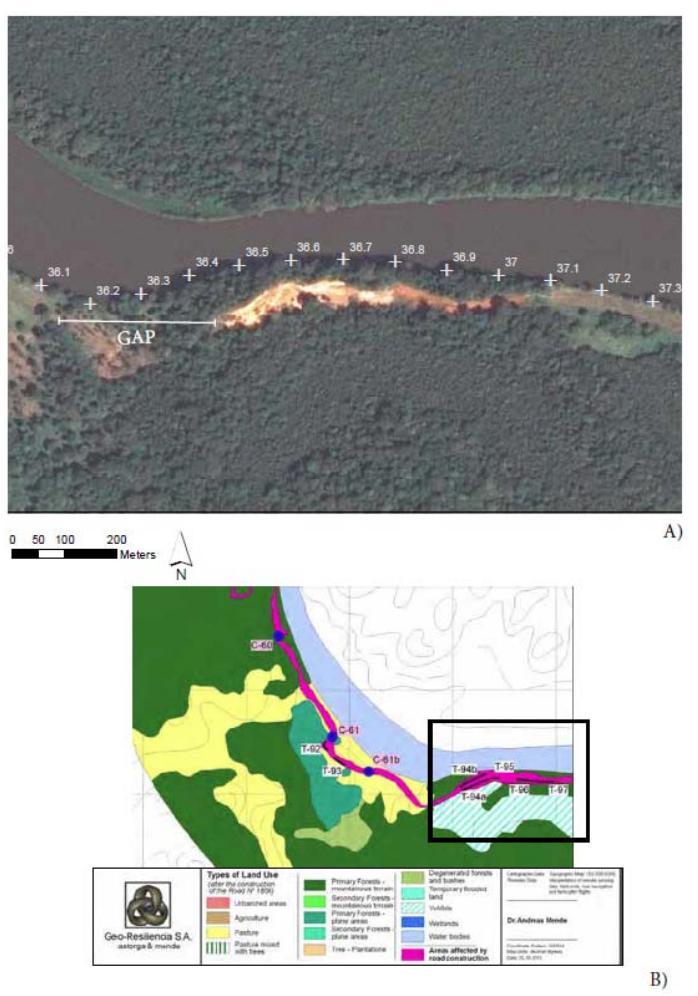
Another gap in the road exists approximately 1 km downstream of El Jardin, at Rkm 36.2 - 37.1, where construction attempts were abandoned prior to initiating major earthwork (Figure 7). From Rkm 36.2 - 36.4, some clearing of vegetation was evidently done, but no major earthwork was attempted. The road construction attempt was presumably abandoned because of the disastrous results of attempts to build the road from Rkm 37.1 to 36.4, which resulted in multiple landslides and instability across the entire attempted road segment (Figure 8). The map of Mende and Astorga in Annex 6 (p.387 of Vol. II of the Counter-Memorial) shows multiple parallel red lines and wide red areas in this section of multiple landslides (Figure 7). The parallel red lines presumably indicate multiple failed attempts to construct the road up this slope. Curiously, they also show a thin line of red 'affected' area from Rkm 36.2 - 36.4, implying that the road is continuous through this section but with more restricted impacts. However, it is clear from inspection of the aerial imagery that no earthwork was attempted in this section, and thus it should be recognized as a gap.

Figure 7. The gap in Rte 1856 from Rkm 36.2-37.1. A) Detail from Feb 2014 high-resolution satellite image showing the gap. B) Detail from the "slope inventory" map of Mende and Astorga (2013), Annex 6, showing the same area.

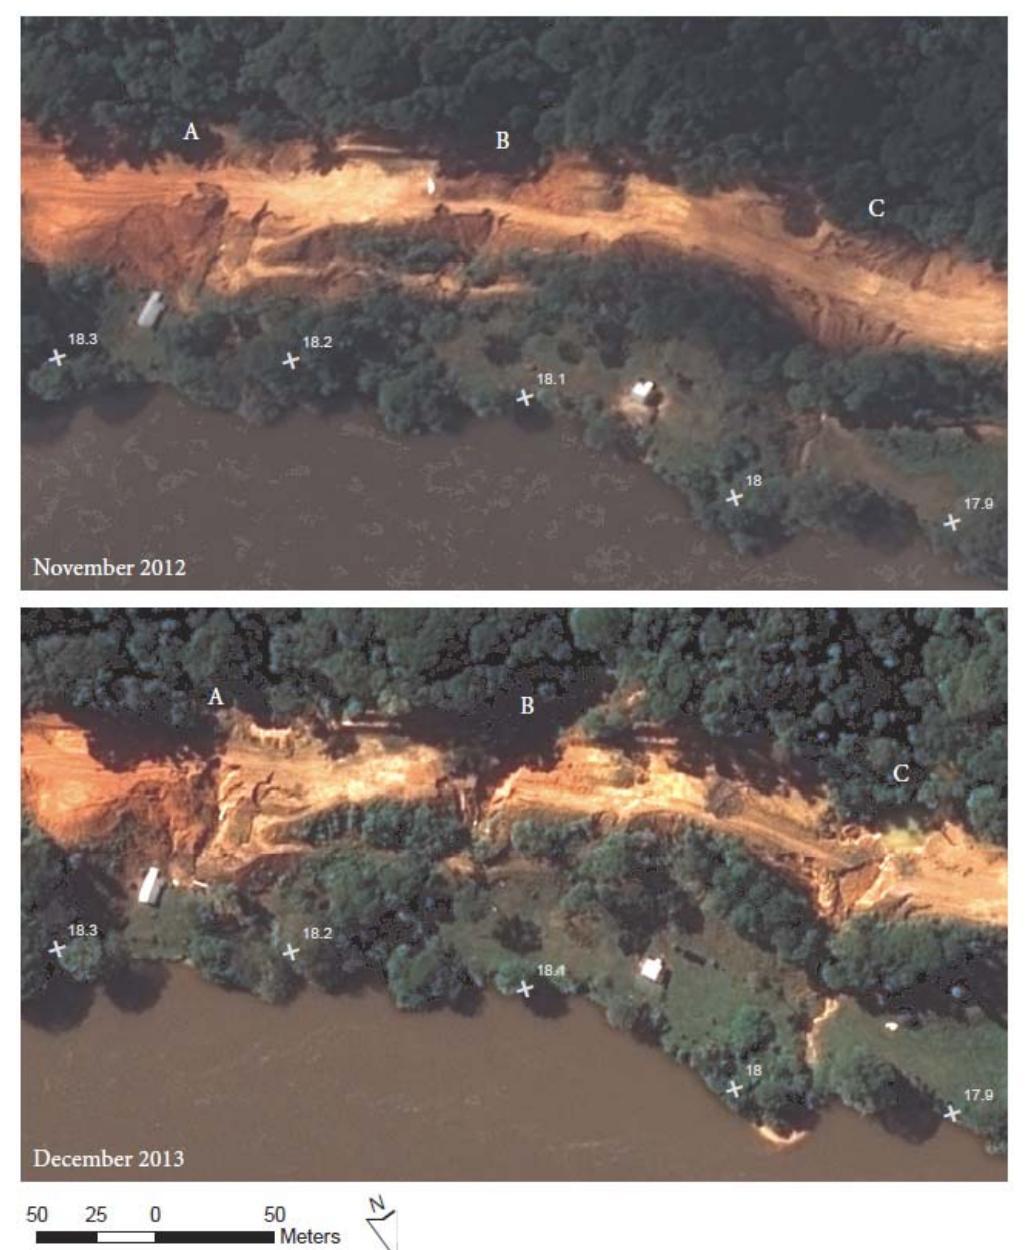
The Inventory of Severely Eroding Sites included as Appendix A to this report, and the analysis on continuing erosion presented below, show massive, continuing erosion, lack of any serious efforts to stabilize slopes and control erosion, and continued delivery of sediment to the Río San Juan. These problems are sufficiently significant to be visible from space. For instance, sequential satellite images show the progression of erosion of exposed road from approximately 17.9 to 18.3 km downstream of Mojon II (in the area known as Las Crucitas) from November 2012 to December 2013 (Figure 9).

Figure 9. Progression of erosion at Las Crucitas, 17.9 to 18.3 km downstream of Mojon II. (a) Satellite image of November 2012 shows erosion has already begun on fillslopes and stream crossing fill prisms since construction. (b) Satellite image of December 2013 shows significant progression of erosion, with expansion of a gully complex at the stream crossing fill prism "A", and washouts of stream crossings "B" and "C".

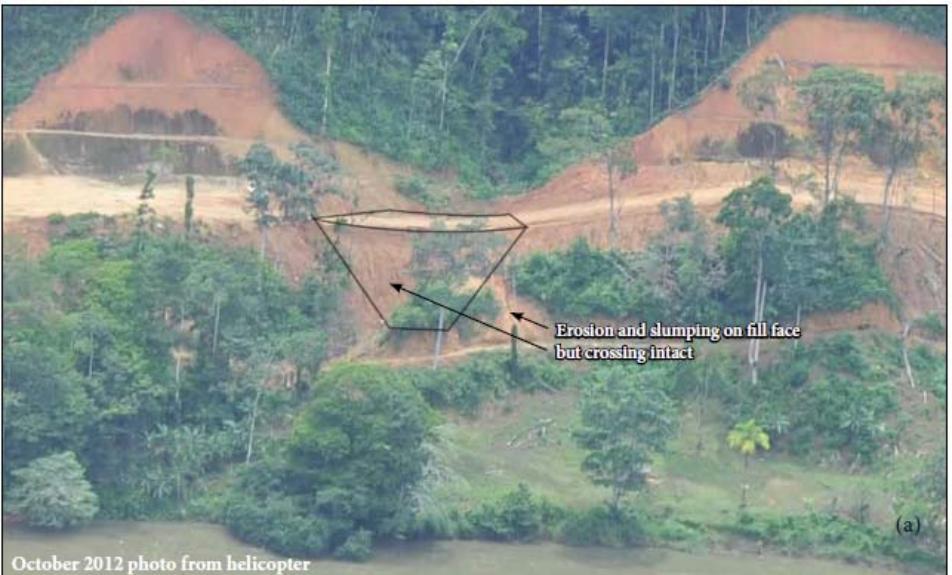
The fill prism for this stream crossing, as I first viewed it from a helicopter in October 2012, was at least 18 m high and 45 m of road length across at the top, totaling at least 12,000 m³ in volume (Figure 13a). As in the prior example, no culvert for this fill is visible in the 2012 photograph. However, if it existed, it was apparently undersized and/or poorly located. The fill material appears to have been simply dumped and pushed in place by trucks and bulldozers, and not compacted or otherwise engineered and its slopes stabilized, as would be required by international standards (FAO 1998).

Figure 13. Eroding Site 9.5, 18.1 km downstream of Mojon II. Oblique aerial views from October 2012 (a) and May 2014 (b).

By May 2014, when I took the photograph in Figure 13b, the fill failure had been filled in and a new culvert placed in the fill. The refilled crossing as reconstructed is not as wide as the original crossing, or it may have been rebuilt to the same width and partially failed by May 2014. A small culvert is visible within the prism of the rebuilt crossing. This culvert appears to be grossly undersized and is improperly located such that it is perched far up in the fill prism, likely because landslides on the slopes upstream of the crossing have filled the former stream valley with sediment and blocked the original culvert (if one existed), which was presumably at a lower elevation. The crossing perched high in the fill is an inherently unstable location because of the likelihood that water will seep around the pipe and cause it to fail again. This poses a severe risk for any vehicles attempting to drive over the fill, let alone transport hazardous materials here, as discussed in Section 5, below.

Also visible in the May 2014 photo is the sediment delta deposited along the south bank of the Río San Juan (Figure 13b). This delta consists primarily or entirely of sediment eroded from the road, as is evident from the fact that the sediments on this delta consist dominantly of angular, friable fragments of deeply weathered rock. These weak fragments are clearly from the nearby road construction because they would break down into sand, silt, and clay if they were transported any significant distance.

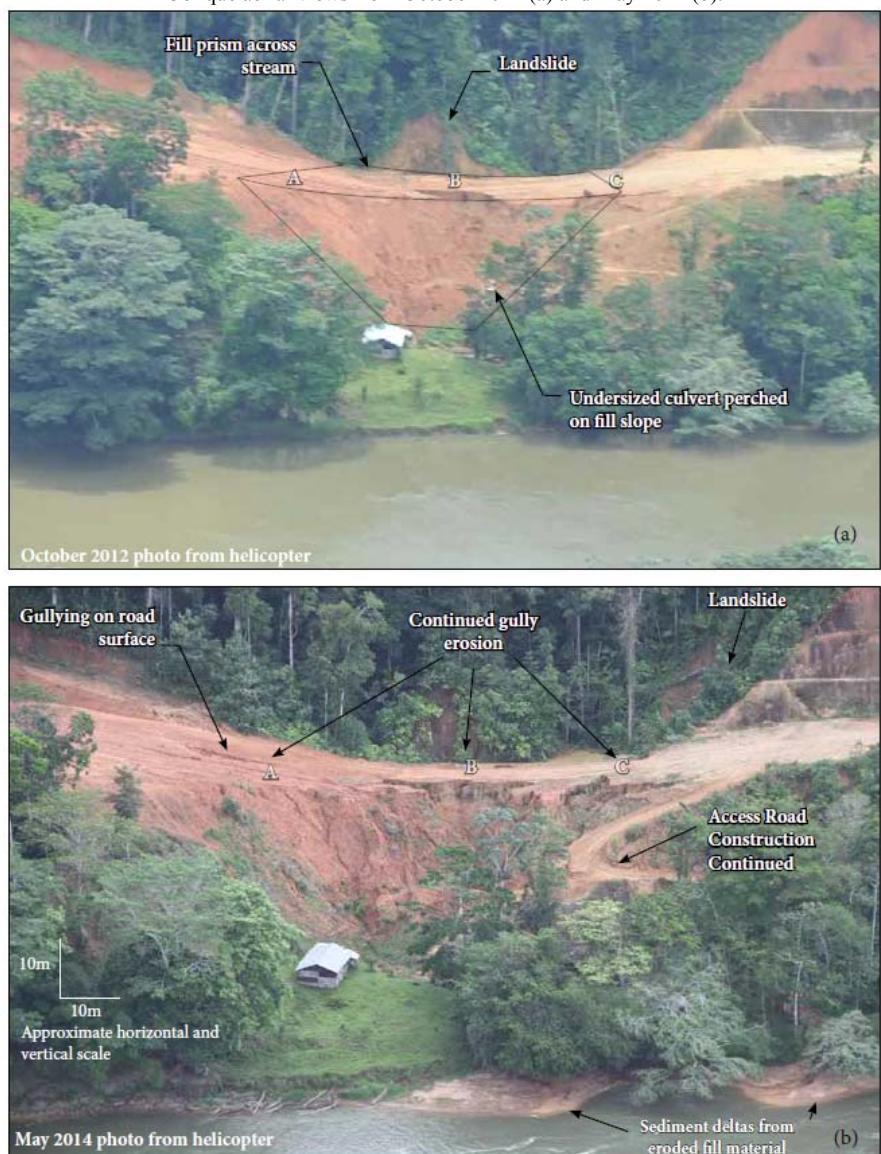
This stream crossing is 100 m downstream of Site 9.5, described above. The fill prism for this stream crossing when I first viewed it from a helicopter in October 2012 was approximately 20 m high and 65 m of road length across at the top of the prism, for a total volume of approximately 44,000 m³ (Figure 15a). Visible in the October 2012 photograph is an undersized culvert, perched approximately one-third of the way up within the fill prism. Normally a culvert would be larger for such a crossing and located at the base of the fill, along the grade of the original streambed. Already in the October 2012 photograph active erosion and slumping of the fill face are visible, but the crossing itself is mostly intact.

Figure 15. Eroding Site 9.6, 18.2 km downstream of Mojon II. Oblique aerial views from October 2012 (a) and May 2014 (b).

The photograph I took in May 2014 (Figure 15b) shows a fresh landslide on the cutslope hillside in the upper right of the view (with no apparent efforts to stabilize it), continued construction of an access road descending from the road in the middle right of the view, and two deltas built up from sediment eroded from the road. The delta on the right is the same delta as appeared in Figure 13b, and consists of sediments eroded from the stream crossing at Eroding Site 9.5, 100 m upstream. The delta on the left consists of sediments eroded from the crossing at Eroding Site 9.6, mostly from the three large gullies. Continued gully erosion is evident on the surface of the road and the side slopes. This stream crossing is clearly not fit for use by vehicles.

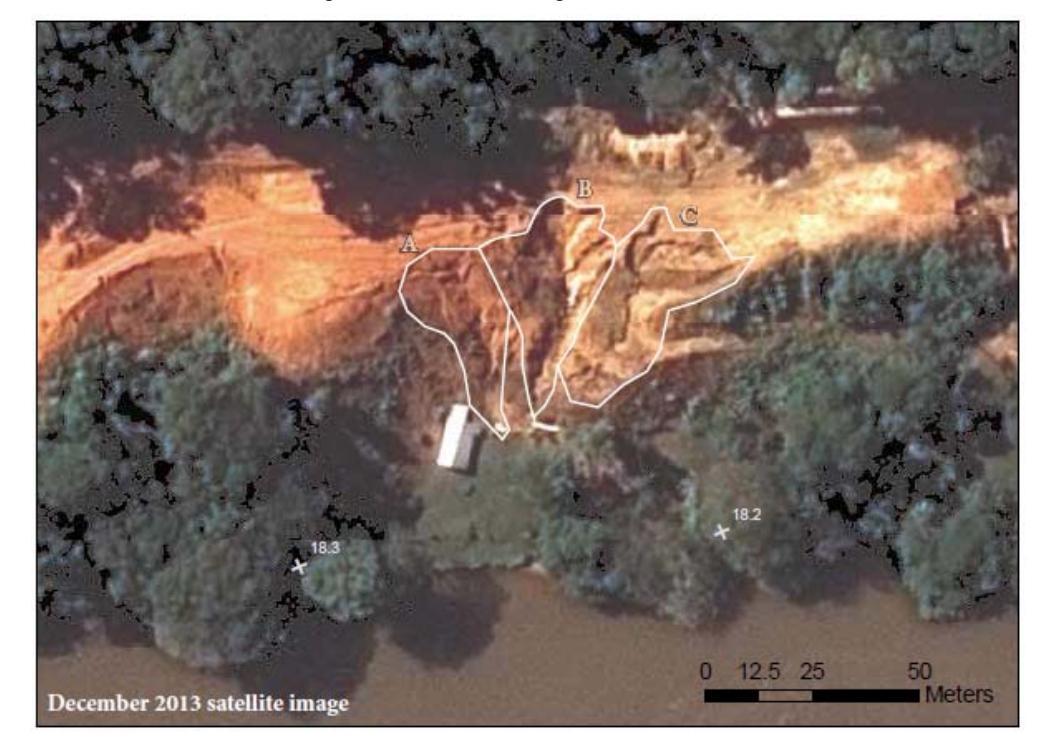
The vertical aerial (high-resolution satellite) image of December 2013 shows the development of three adjacent gullies (Figure 16). Taken together, the gullies measure 80 m across (in the direction parallel to the river bank), and 50 m horizontally from the headcuts down to the foot of the fill slope. The volume represented by these three gullies – the volume of sediment already eroded from the stream crossing fill prism – totals about 6,600 m³, or about 15% of the original total fill volume. This is a truly massive quantity of sediment, the equivalent of about 825 dump truck loads. Once again, the total volume of erosion from the site would include additional erosion outside the gullies themselves. Hagans and Weaver (2014) estimate that the site is experiencing an additional 1,081 m³/yr of additional rill, gully and landslide erosion, and an additional 488 m³/yr in surface erosion, for a total of 8,169 m³ – or a total of over 1,000 dump truck loads – per year from the entirety of Severely Eroding Site 9.6.

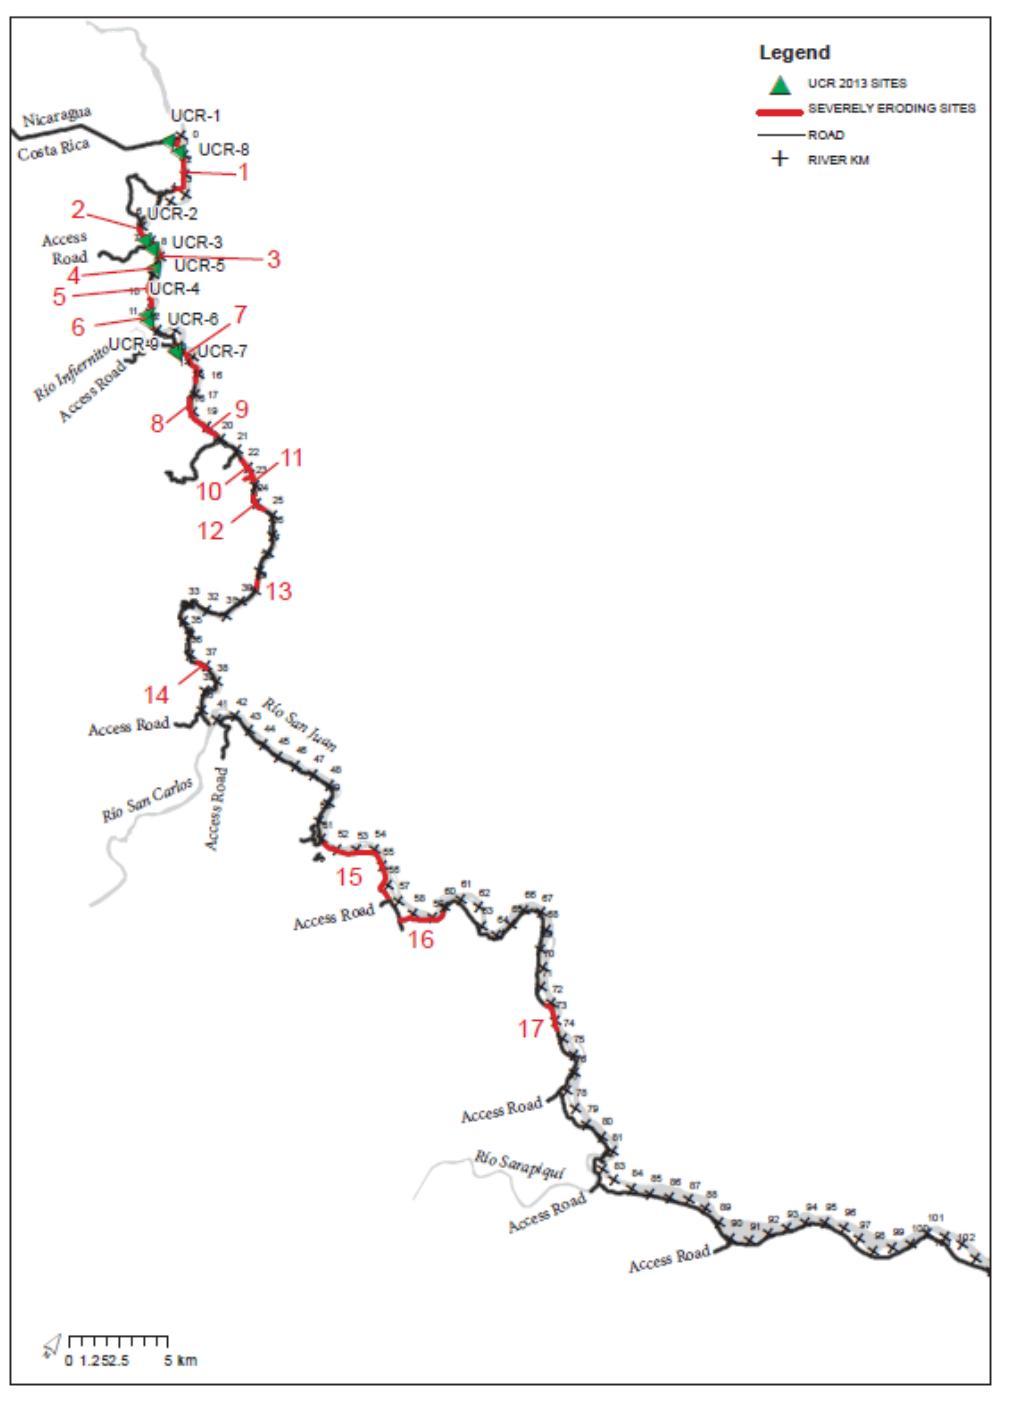
These are only a few examples of the widespread erosion and failure of the unprotected cut and fill slopes, and the deterioration of fill-based stream crossings, that are visible along Rte 1856, even from helicopter and satellite imagery. Additional examples, covering a total area of approximately 788,038 m^2 , are included in the Inventory of Severely Eroding Sites, appended to this report as Appendix A. Figure 21, below, plots those sites in red on a map of the portion of Rte 1856 that is adjacent to the San Juan River.

Figure 21. Map of Severely Eroding Sites along Rte 1856 from 2014 Inventory (Appendix A), and locations of the UCR (2013) erosion sites.

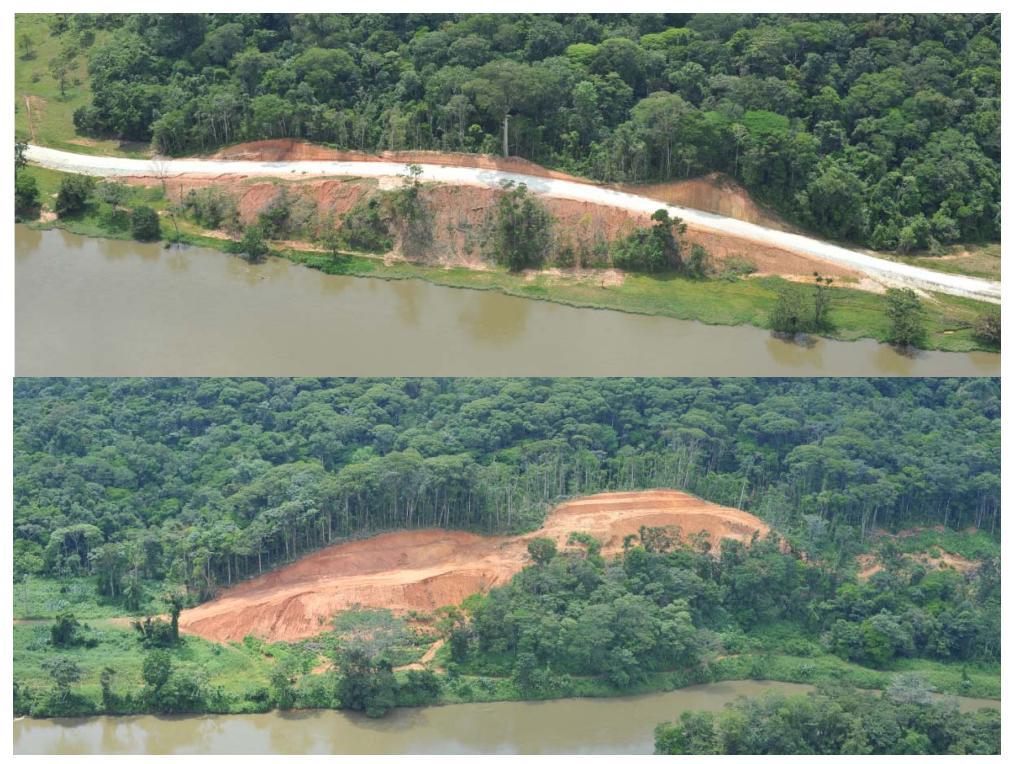
Construction of Rte 1856 involved multiple cut and fill roads across steep hillslopes, many underlain by weak rock types or with unfavorable orientation of geologic structure, resulting in inherently weak cutslopes. The material removed from the cut was simply 'sidecast', i.e., pushed down the slope by the blade, without first removing vegetation from the slope and with neither engineering the fill by compaction nor use of geotextiles. As a result, the fillslopes are inherently unstable, no more than loose piles of earth, easily eroded into rills and gullies by surface runoff, and prone to landsliding. For instance, from Rkm 8.2-8.7 (Severely Eroding Site 4), the bulldozers cut into hills well within 100 m of the river bank. As visible in Figure 22a, the bulldozers simply took the material cut from the hillslope and dumped it down the slope below, creating an unstable slope of loose fill, with multiple shallow landslides (which can be seen to be eroding the edge of the road) and gullying/rilling over the entire fillslope. Likewise, from Rkm 16.1-16.4 (Severely Eroding Site 8), it is clear that the fill material was simply sidecast off the road in loose piles, which by October 2012 had developed three large landslides in the fill (described in detail in Section 3 above) (Figure 22b).

Figure 22. Examples of sidecasting fill material. a) Severely Eroding Site 4 (Rkm 8.2-8.7) (photo from helicopter over north bank of Río San Juan, October 2012). b) Severely Eroding Site 8 (Rkm 16.1-16.4) (photo from helicopter over north bank of Río San Juan, October 2012). It is clear from the loose, failing nature of the fill slopes that the bulldozers simply dumped the material down the slope below, creating an unstable slope of loose fill vulnerable to landsliding, gullying, and rilling.

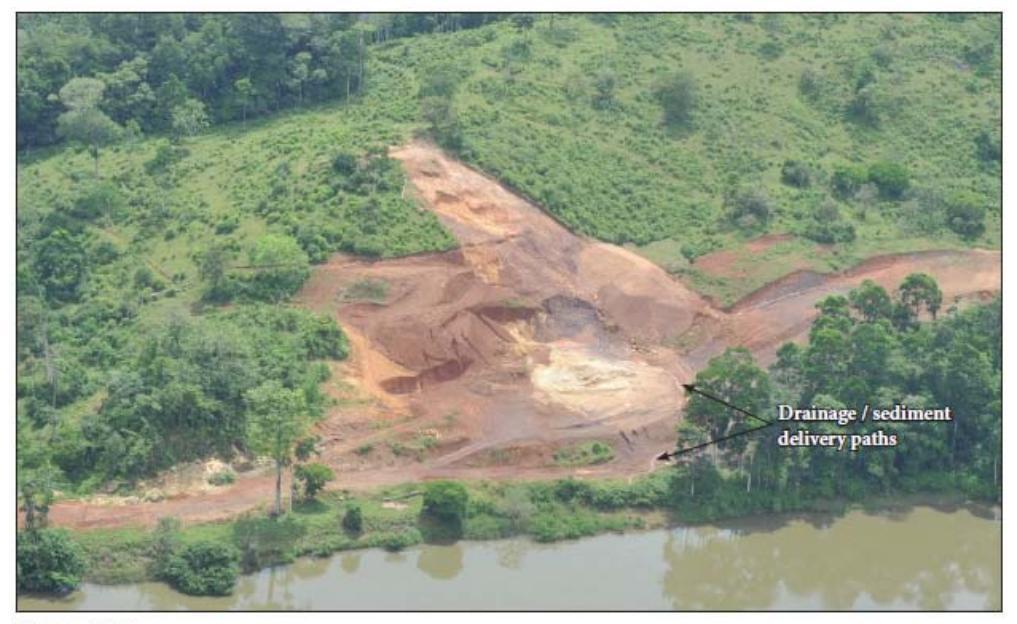
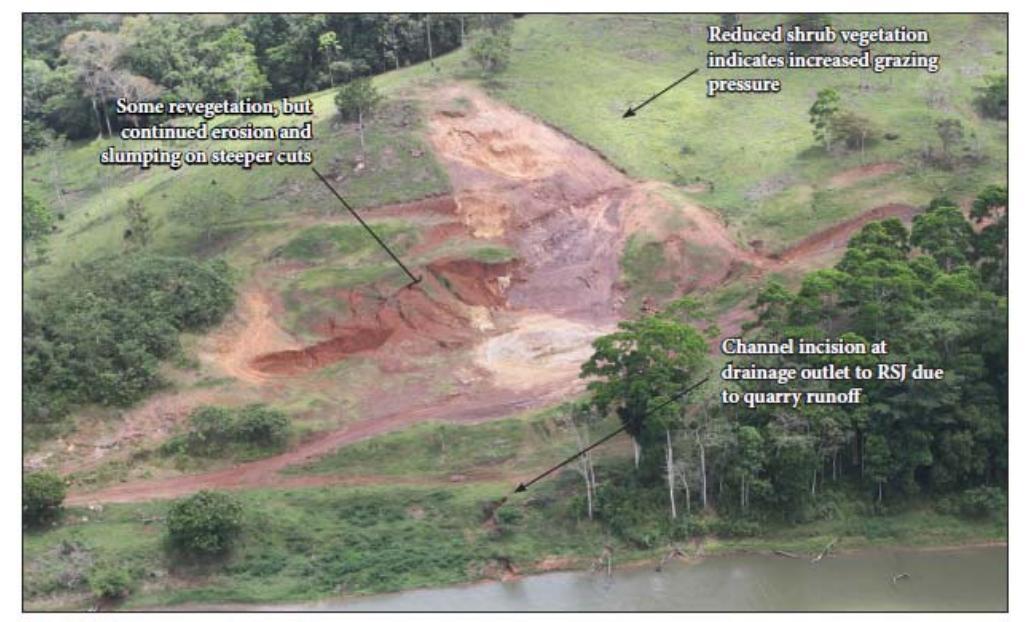
As explained in my 2012 report, construction of a cut-and-fill road such as Rte 1856 disturbs the natural infiltration of rain that occurred in the natural, vegetated hillslope and disrupts the natural drainage patterns, leading to more rainwater running off the surface and concentration of this runoff. The concentrated runoff, in turn, is very effective in eroding the exposed soils. Even with good drainage, a road such as Rte 1856 will result in increased erosion rates. When good drainage is lacking, as is the case along the vast majority of Rte 1856, the problems are compounded as runoff accumulates and often creates new channels draining towards the river, which carry substantial loads of sediment. For example, the quarry located at Rkm 25.3 km has had no erosion control or slope stabilization measures, nor any drainage features constructed. Sediment-laden runoff from the exposed quarry surfaces drained towards the Rio San Juan, and by May 2014 had eroded a small channel to carry this runoff (Figure 23).

Figure 23. Surface erosion of a quarry for road construction materials located at Rkm 25.3 km (downstream of Mojon II). No erosion control, slope stabilization, or drainage measures were visible as of May 2014. Sediment-laden runoff from the exposed quarry surfaces drained towards the Río San Juan, and by May 2014 had eroded a small channel to carry this runoff and sediment into the Río San Juan. (Photographs taken from helicopter over the north bank of the Río San Juan.)

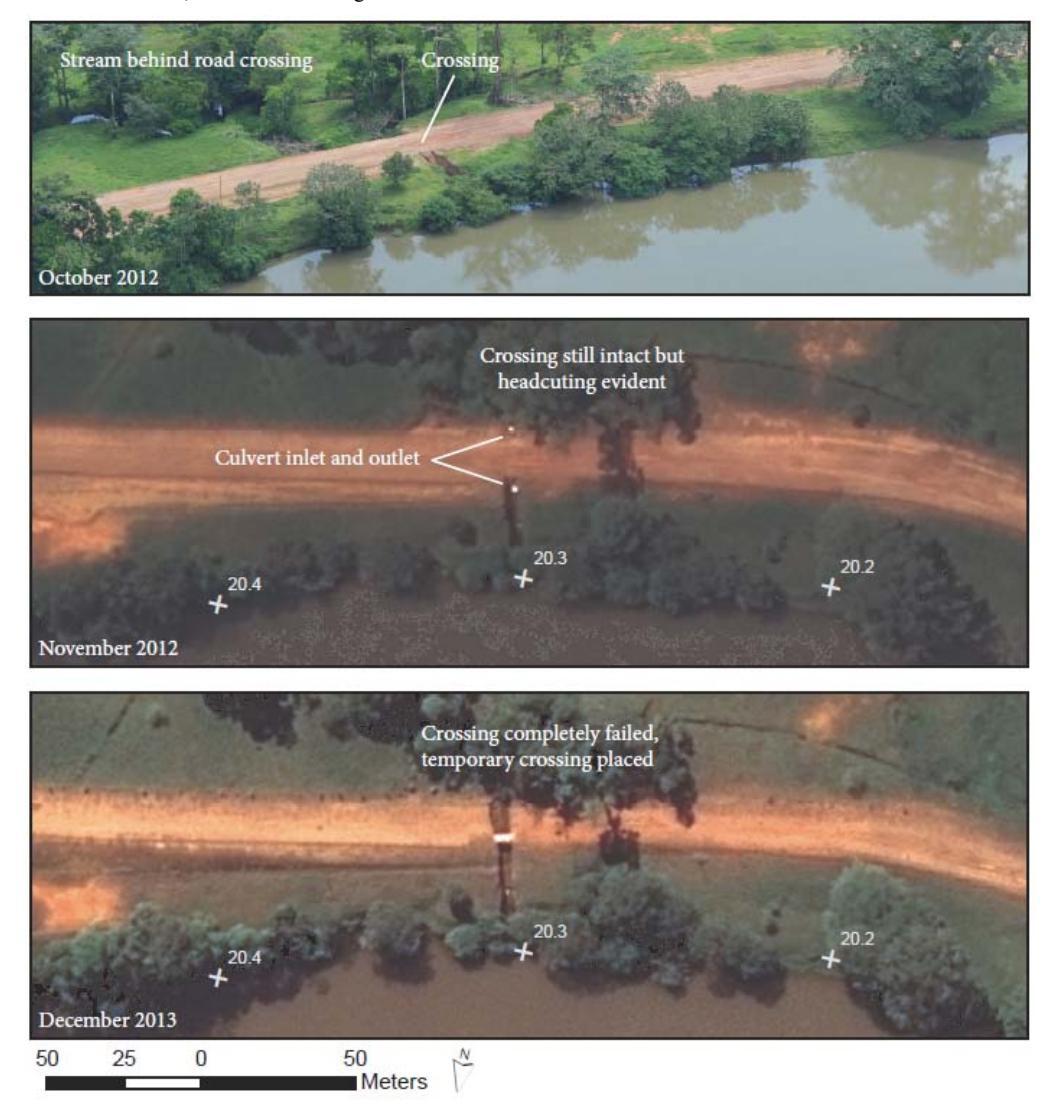
While many failed stream crossings were constructed in steep terrain, the poorly built crossings of Rte 1856 are vulnerable to failure even on flat ground. The tributary crossing at Rkm 20.3 (i.e,. 20.3 km downstream of Mojon II) is illustrative. Located on flat floodplain, this was a minor bridge spanning a small stream (Figure 24a). Its construction presumably involved earthen fill to narrow the stream width to be spanned by the bridge (as was the case for all crossings but one, according to Table 3 in Mende and Astorga in Annex 6, p.27). As visible in Figure 24, the oblique helicopter image of October 2012 and the satellite image of November 2012 show the crossing intact but being eroded from the north (downstream) side. By December 2013, the crossing had completely failed, the crossing had been partially refilled with unengineered fill, and a small footbridge had been installed to allow crossing by pedestrians, dirt bikes, or donkeys, but not vehicles. The fill material washed out from the crossing was transported down to the Río San Juan, where it created a new delta, as visible in Figure 25. This delta incorporated white plastic pieces of the failed culvert, as visible in Figure 25. Based on measurements in GIS of the area of the crossing washout and a height estimated from the field observations (from the river), the failure produced a sediment pulse of approximately 480 m³ of fill material, which was enough to build a new delta in the Río San Juan. This crossing failure illustrates that the stream crossings for Rte 1856 are vulnerable to failure not only because of steeply sloping lands, but even in flat lands because of the substandard construction practices (see CFIA 2012 and LANNAME 2012 for further description of unacceptable and dangerous construction methods). The poor construction practices implemented on Rte 1856 all but guarantee further failures and further delivery of sediment to the Río San Juan. It is worth bearing in mind that these failures and sediment delivery to the river have occurred during years with relatively modest rainfall, and that much greater erosion is inevitable during the intense rains that will accompany a hurricane or tropical storm in the region.

Figure 24. Helicopter and satellite imagery of failed fill crossing 20.3 km downstream of Mojon 2 border marker. a) The oblique helicopter photo of October 2012 shows evidence of headcutting. b) The November satellite 2012 imagery shows the same situation: headcutting but the fill still mostly intact. c) By December 2013, satellite imagery shows the crossing had failed completely. A temporary single-track crossing had been placed over the channel, and fill material had been placed in the channel to re-narrow the crossing, but the culvert had not been replaced and water was flowing freely over the loosely compacted material. The plastic pipe culvert washed out and was transported down to the Río San Juan along with the eroded sediment, as illustrated in Figure 25.

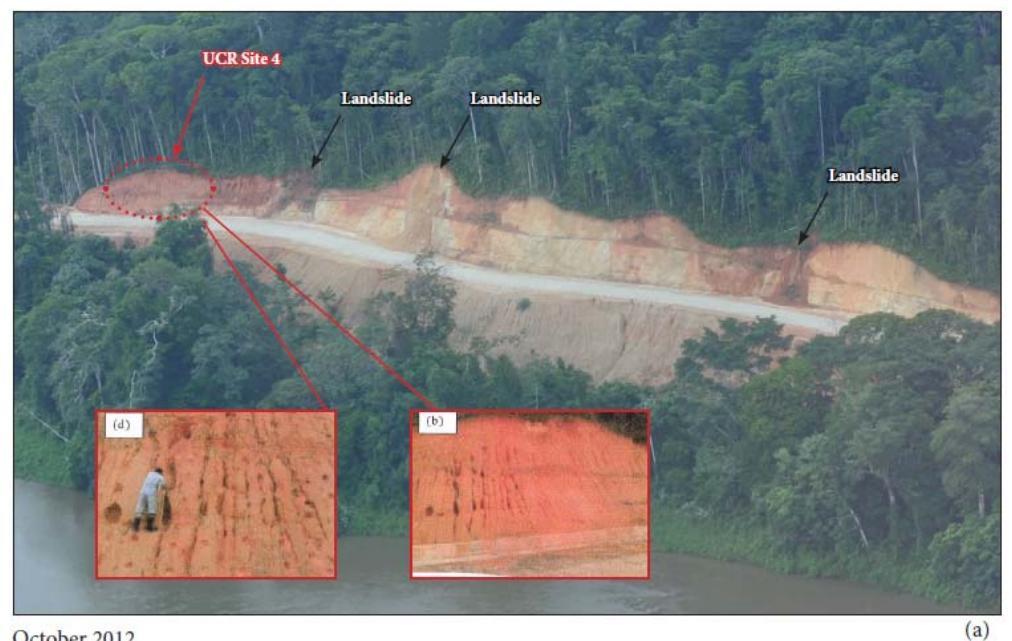
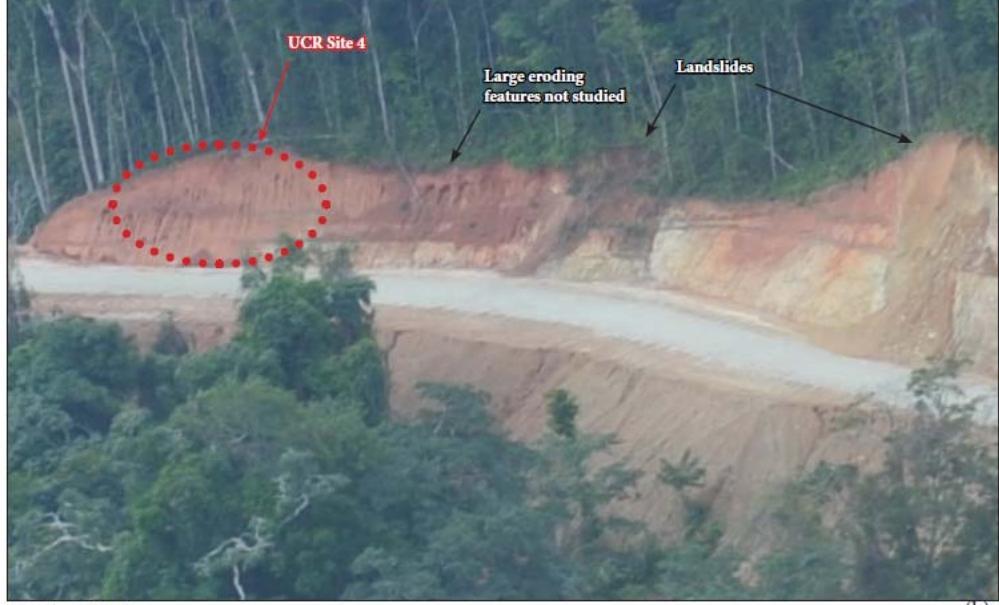
The sites assessed in the preparation of Annex 1 were all within the first 15 km of the riveradjacent Rte 1856 (i.e., between the international border and Rio Infiernito). Even within that stretch, the sites studied are not the "worst" sites of erosion. Figure 28 shows the extent of erosion in the cut-and-fill slope exposed from Rkm 10.4-11.3 (Severely Eroding Site 6a, in Appendix A), which is within the 15 km stretch in which all the UCR Report's study sites exist.

Figure 28. Context of UCR's Site 4 within a larger complex of eroding features from Rkm 10.4 to 11.3. a) Oblique aerial photograph from helicopter, October 2012, showing multiple landslides to the right (west) of the site selected for detailed study by UCR. b) Detail of the same photograph, showing larger eroding features in cutslope, similar to the rills measured by UCR but larger, as well as two nearby landslides. The UCR Report (Annex 1) presented only photos showing close-up views of the section of the rilling cutslope where UCR made its measurements (inset). Note that the UCR photo labeled "b" ended just to the right of much larger eroding features in the cutbank, similar to but larger than those measured by UCR.

Along this cutslope, multiple landslides are visible in the photo shown in Figure 28, but the UCR Report focused only on a small set of rills developed at one end of this larger site. The UCR Report (Annex 1) included only close-up photographs included as insets in Figure 28a, which show a person taking measurements on the rilling slope. However, the UCR Report did not include an image such as our Figure 28a or b, which help to put the UCR Site into proper perspective. The UCR Report did not include images of the larger gully/rill features just to the right of the one they measured, nor explain why they chose the smaller feature to measure. A broader look at this site shows the riverside edge of the road is uneven and contains multiple irregularities, and broad arcuate features, which can be interpreted as scarps of landslides in the loose, sidecast fill material. These failures are large enough that they have visibly eroded into the original constructed width of the road. It is troubling that the UCR Report measured only the minor rills at the far downstream end of this site and did not address the larger eroding features.

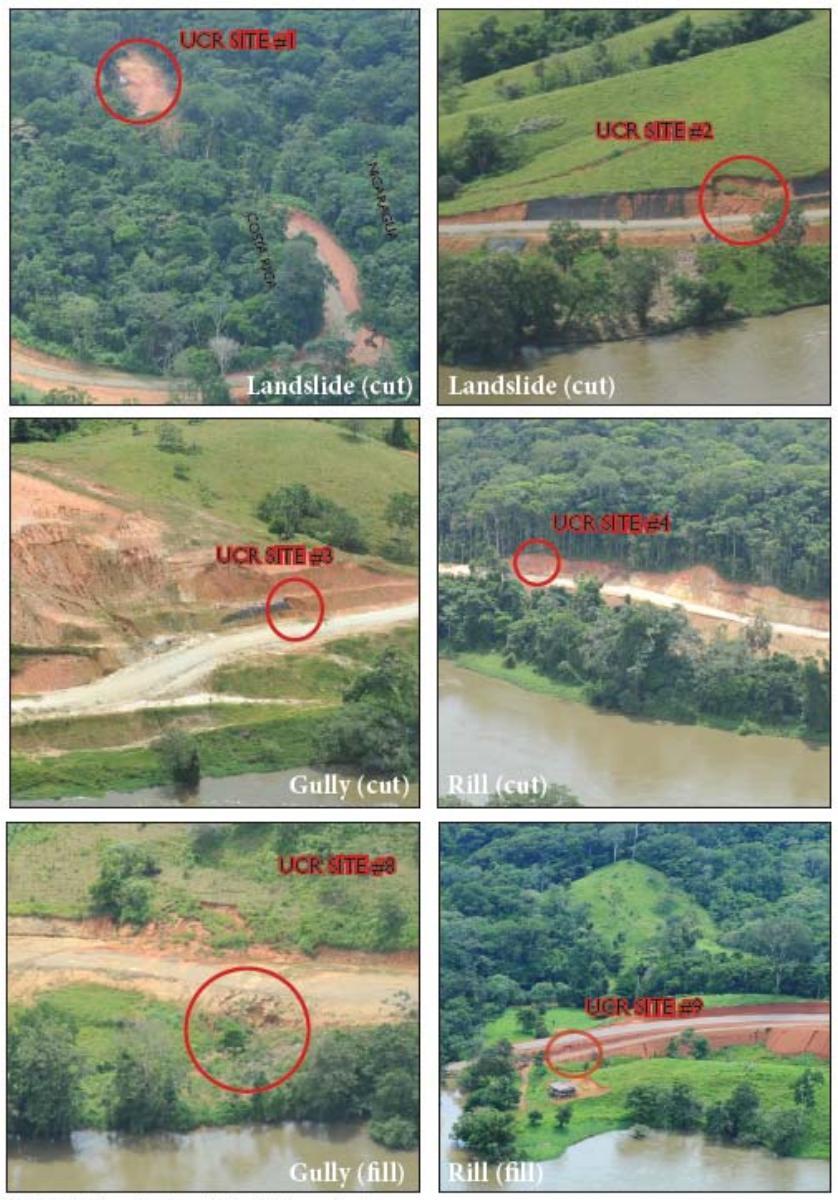
As is evident from the inventory of erosion sites (Appendix A), there are numerous sites whose erosion rates are far worse than those selected for study by the UCR personnel (Figure 30). One km downstream from the terminus of the UCR Report's study area are the serious erosion problems at Severely Eroding Sites 8.1 and 8.2 (at Rkm 16.1, described above and depicted in Figures 17-20), and another 1 km downstream are located Severely Eroding Sites 9.1-9.8 (Rkm 17.2-19, described above and depicted in Figures 10-16). These and other more severely eroding sites are illustrated in Figure 31.

Figure 30. UCR study sites related to landslide, gully, and rill erosion.
