INTERNATIONAL COURT OF JUSTICE

CONSTRUCTION OF A ROAD IN COSTA RICA ALONG THE SAN JUAN RIVER (NICARAGUA V. COSTA RICA)

REPLY

ANNEX 1

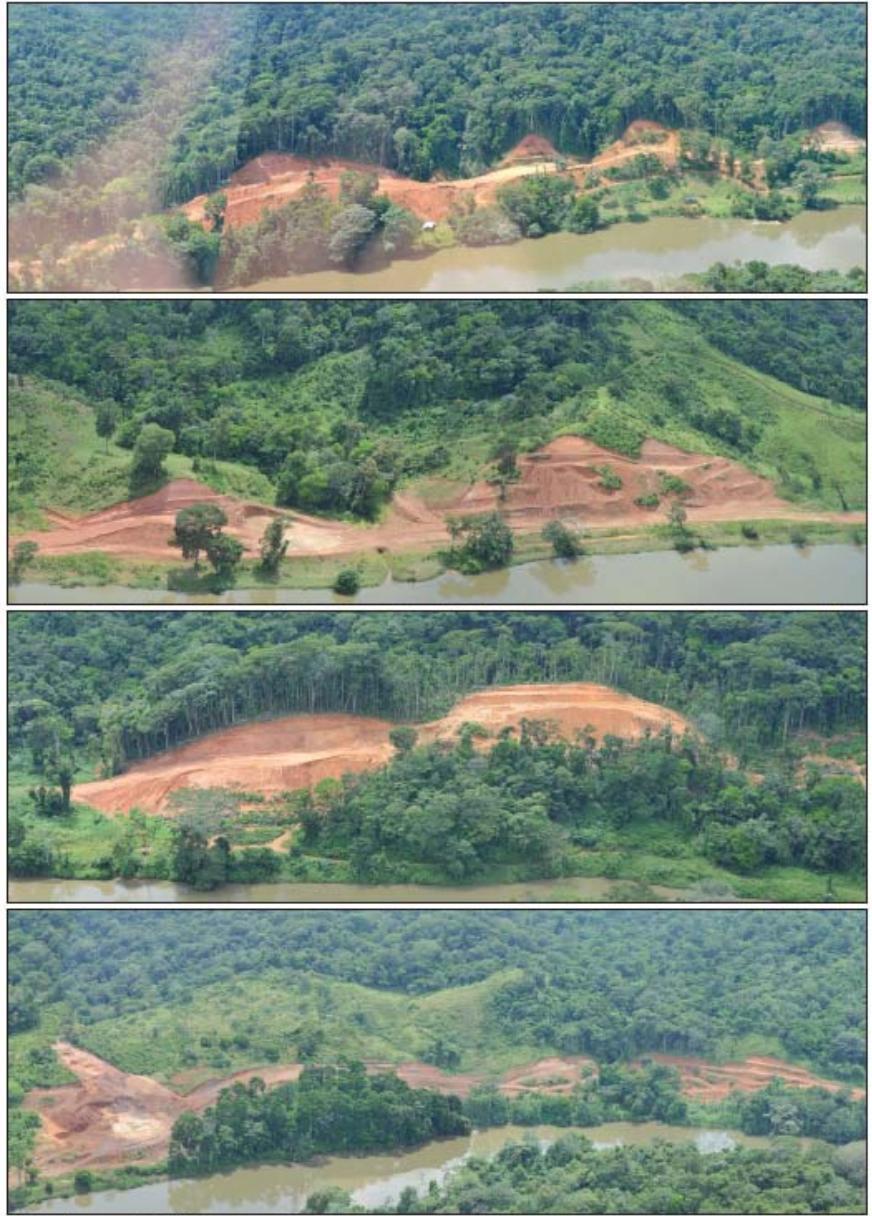
Figure 30. UCR study sites related to landslide, gully, and rill erosion.

As is evident from the inventory of erosion sites (Appendix A), there are numerous sites whose erosion rates are far worse than those selected for study by the UCR personnel (Figure 30). One km downstream from the terminus of the UCR Report's study area are the serious erosion problems at Severely Eroding Sites 8.1 and 8.2 (at Rkm 16.1, described above and depicted in Figures 17-20), and another 1 km downstream are located Severely Eroding Sites 9.1-9.8 (Rkm 17.2-19, described above and depicted in Figures 10-16). These and other more severely eroding sites are illustrated in Figure 31.

UCR Study Sites related to rills, landslides, and gullies

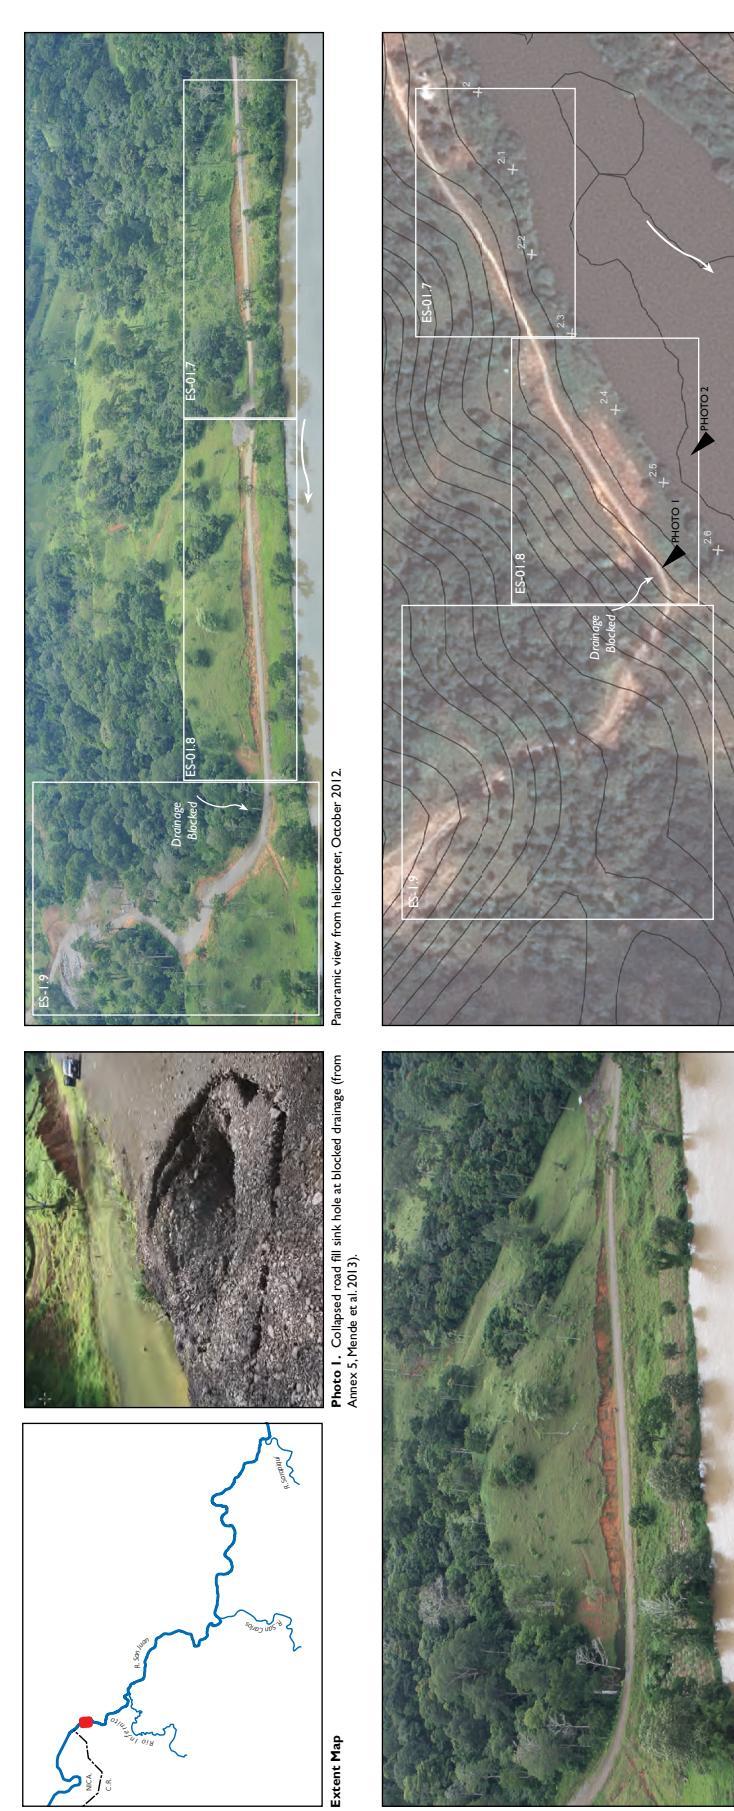
Severe Eroding Area 01 c

Eroding cut slope (view from helicopter, October 2013.)

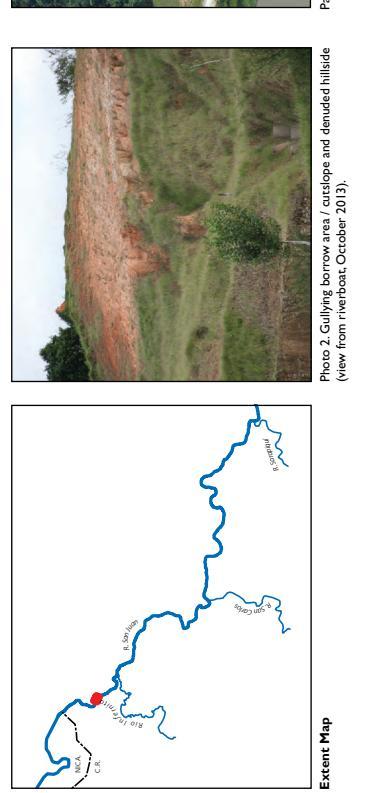
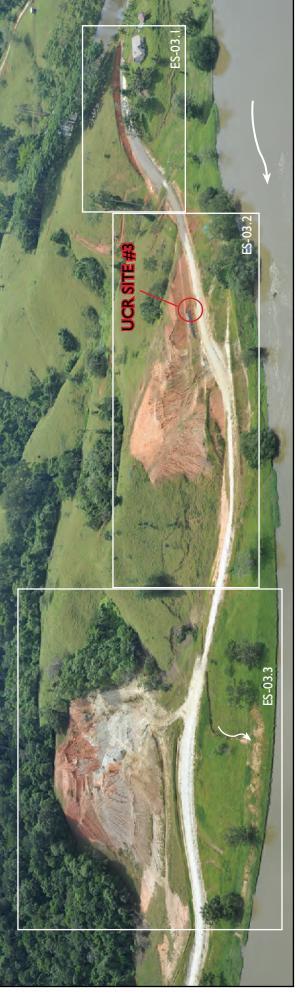
Severe Eroding Area 03 RKM 7.1 to 7.9

Panoramic view from helicopter, October 2012.

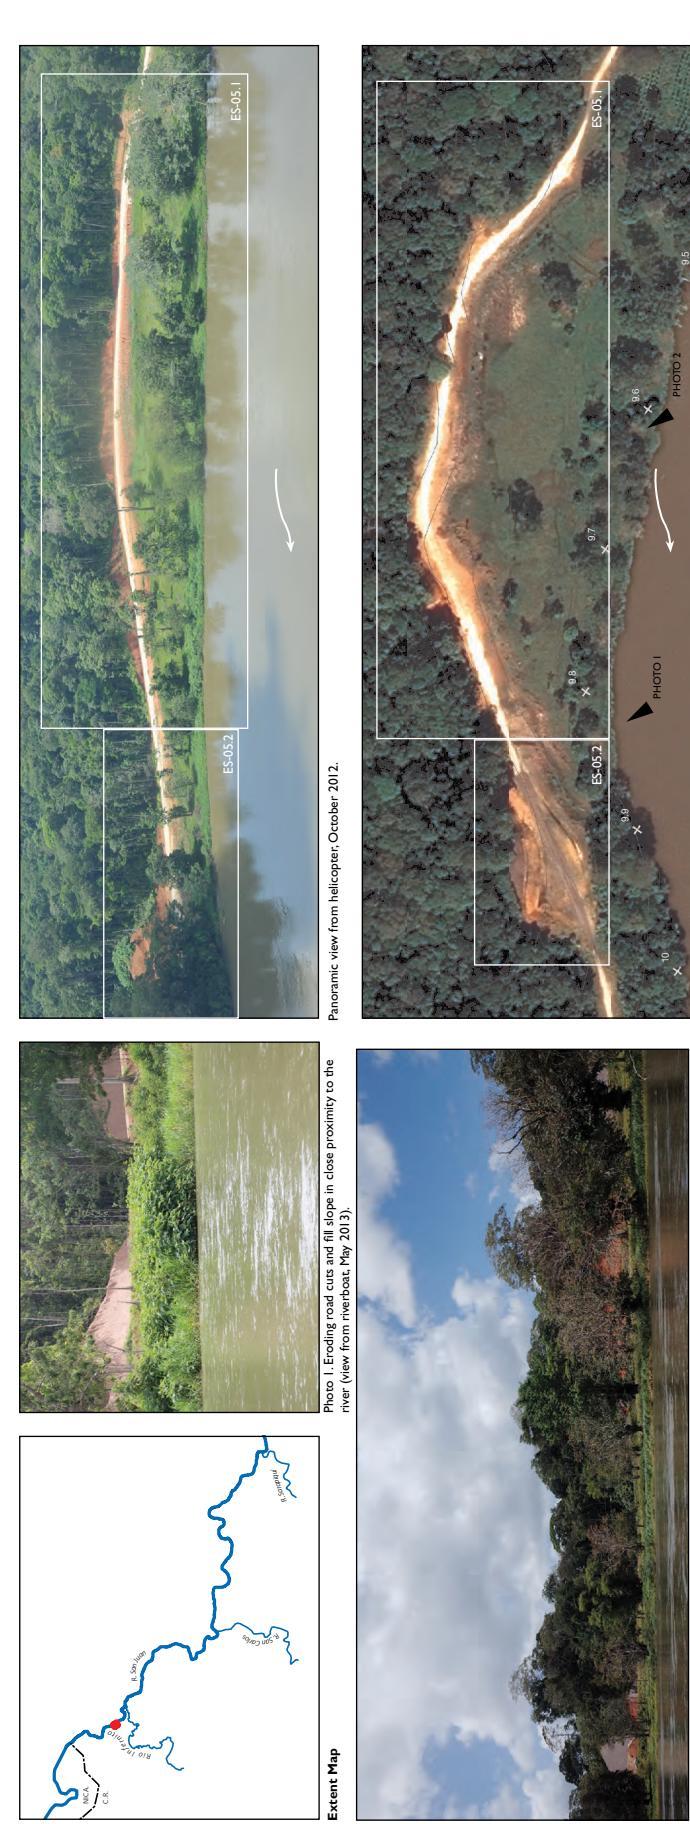
Severe Eroding Area 05 RKM 9.3 to 9.9

Photo 2. Eroding road cuts and fill slope in close proximity to the river (view from riverboat, March 2014).

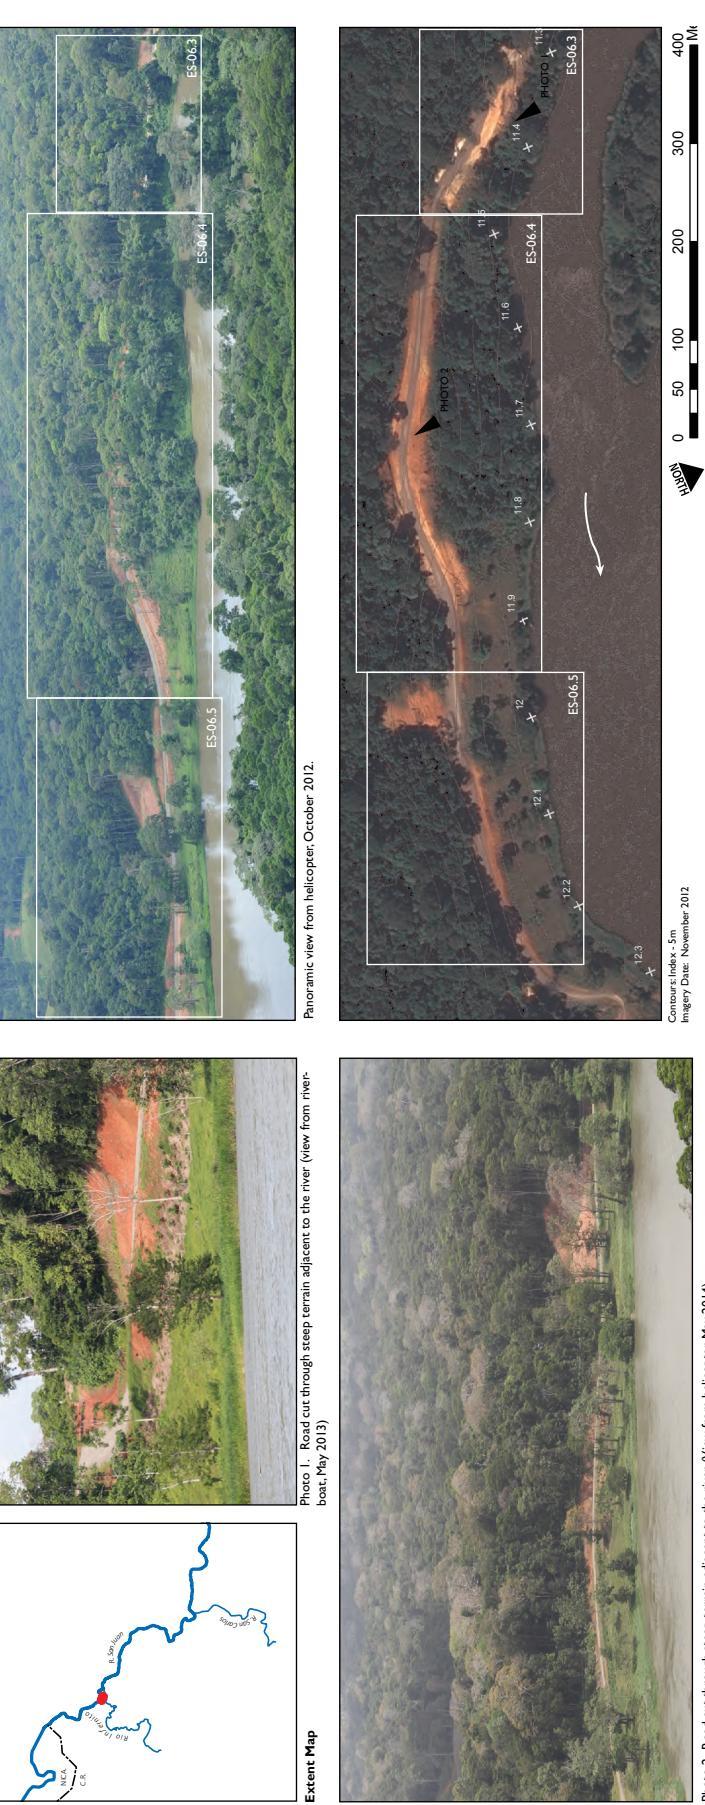
Severe Eroding Area 06b RKM 11.3 to 12.2

Photo 2. Road cut through steep terrain adjacent to the river (View from helicopter, May 2014)

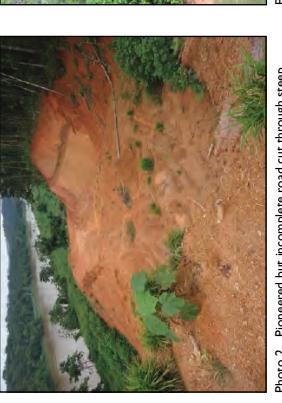
Photo 2. Pioneered but incomplete road cut through steep terrain (from Mende & Astorga 2013, p40).

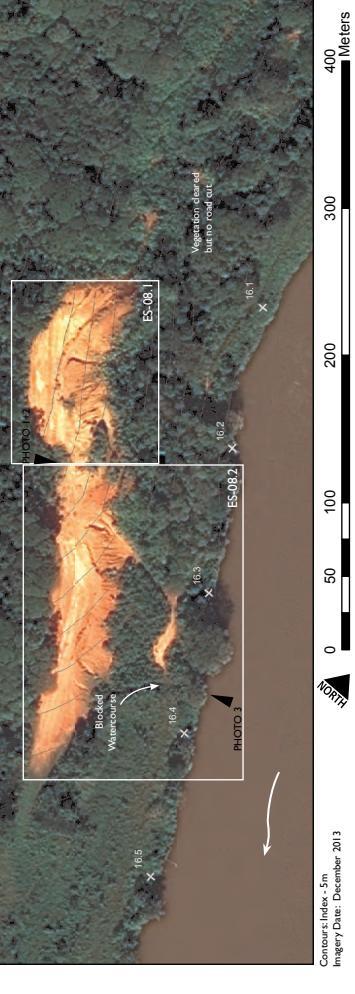
Photo 3. Gully through road and pioneered but incomplete road cut through steep terrain (view from riverboat, May 2013).

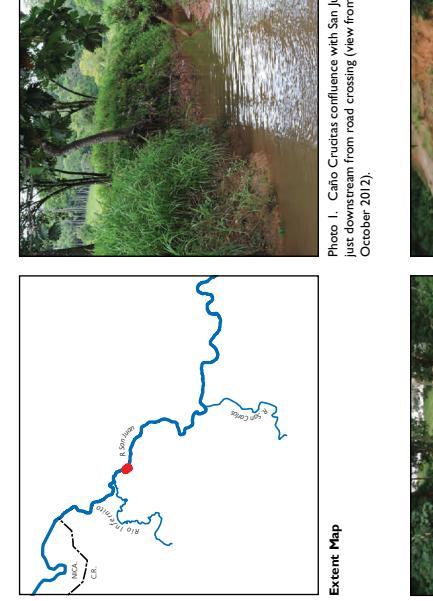
Photo I. Caño Crucitas confluence with San Juan River just downstream from road crossing (view from riverboat October 2012).

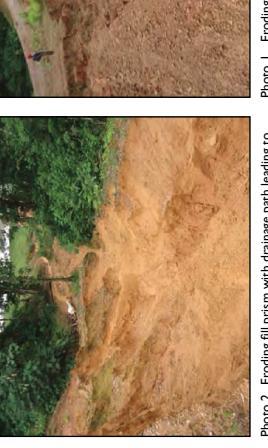
The result of these problems in Mende and Astorga's approach is an underestimated total yield for slopes. For example, for Severely Eroding Site 9.5, Annex 6 reports a "worst case" erosion rate of $372 \text{ m}^3/\text{yr}$, which is said to include sheet erosion, rill erosion, gully, and landslide erosion. However, erosion for the failed fill alone was at least 2,860 m³ between October 2012 – December 2013, a number that does not include the additional erosion from sheet, rill, gully, and landslides that is evident in the sequential imagery. Hagans and Weaver (2014) conservatively estimate such additional erosion at an additional 1,125 m³ per year at Severely Eroding Site 9.5.

Photo 2. Eroding fill prism with drainage path leading to river (from Mende & Astorga 2013, p43).

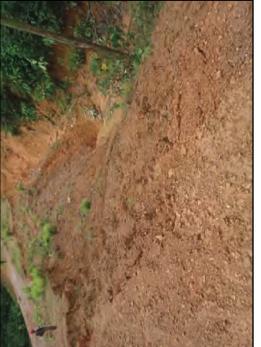
Photo 1. Eroding fill prism placed across drainage path (from Mende & Astorga 2013, p43).

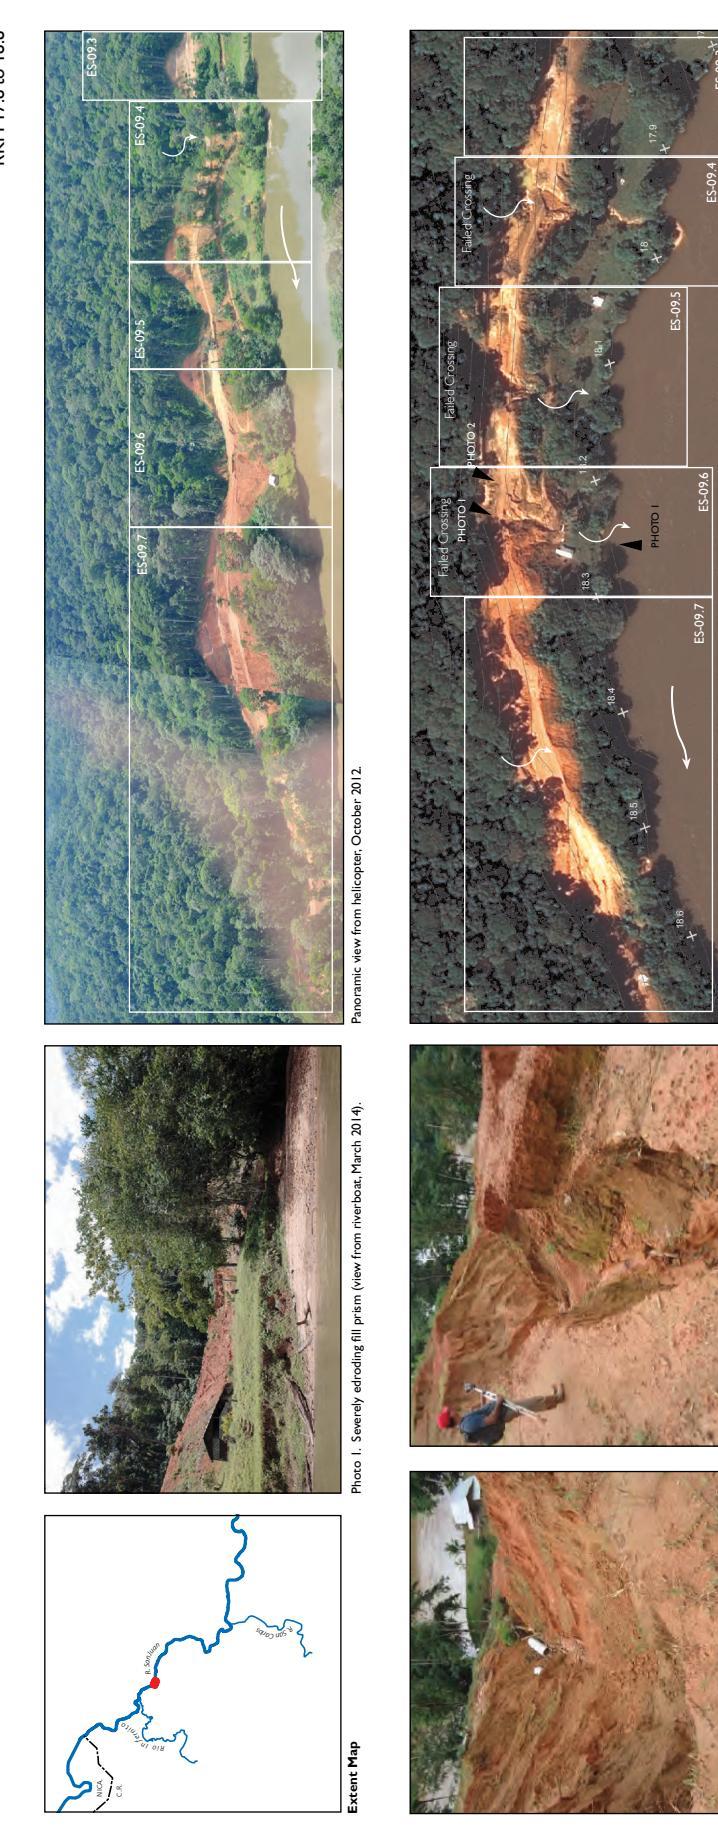
Severe Eroding Area 09b RKM 17.8 to 18.8

Photo 2. Gullying road fill prism (from Mende & Astorga 2013, p44).

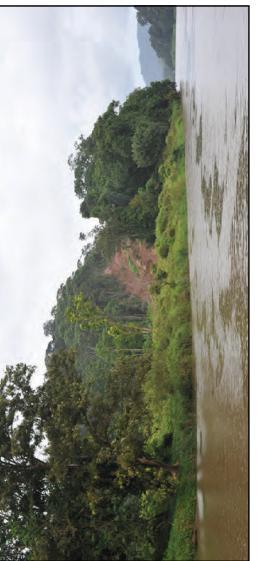
Photo 1. Roadcut pioneered through steep terrain but not completed (view from riverboat, October 2012).

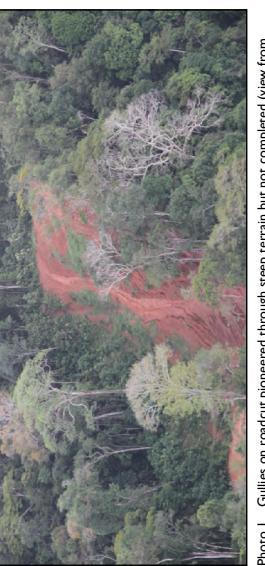
Photo 1. Gullies on roadcut pioneered through steep terrain but not completed (view from helicopter, May 2014).

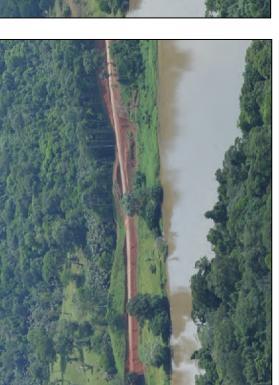
Photo I. Gullying fill slopes (view from helicopter; October 2012).

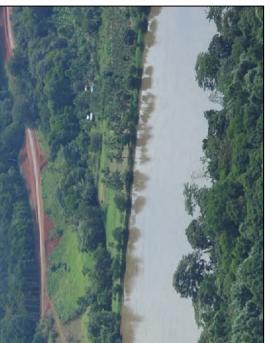
Photo 2. Large, steep and exposed cut and fill slopes. See houses for scale (view from helicopter, October 2012).

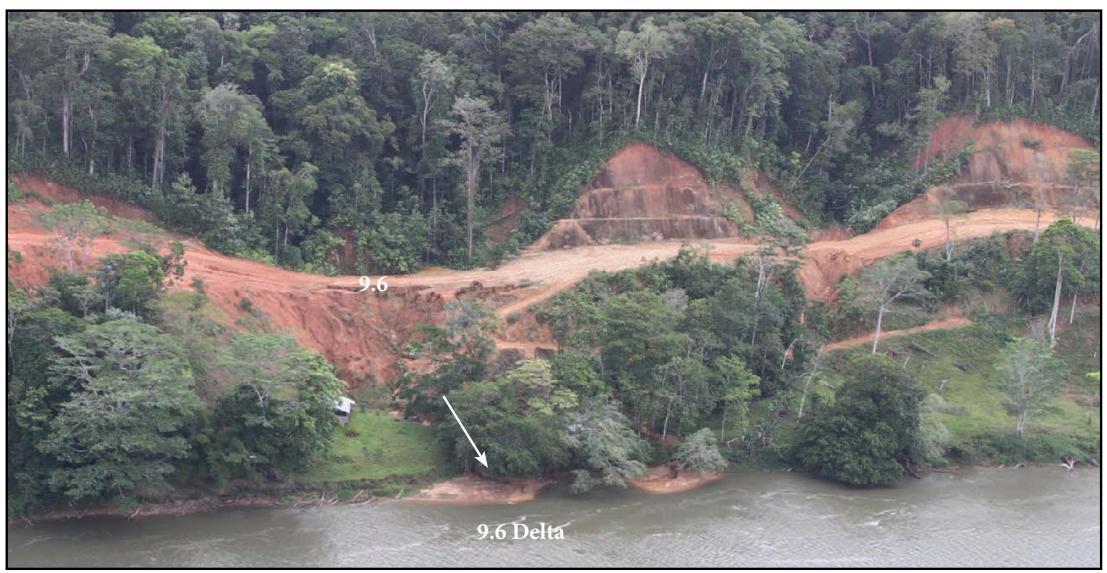
Photo date: May 2, 2014

Delta deposit below Erosion Site 9.6. Ecological Sampling Site 3a. Width (perpindicular to RSJ) = 15m Length (parallel to RSJ) = 21m Height (above RSJ water surface) = 2m Photo and measurement date: March 30, 2014

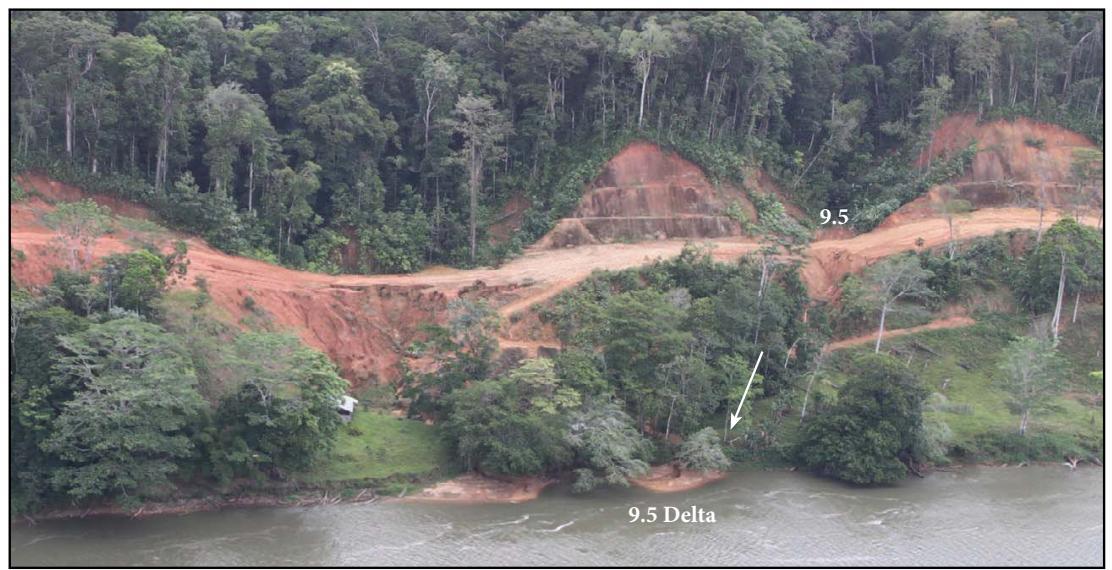
Photo date: May 2, 2014

Delta deposit below Erosion Site 9.5. Dimensions not directly measured, but similar in scale to 9.6. Photo date: March 30, 2014

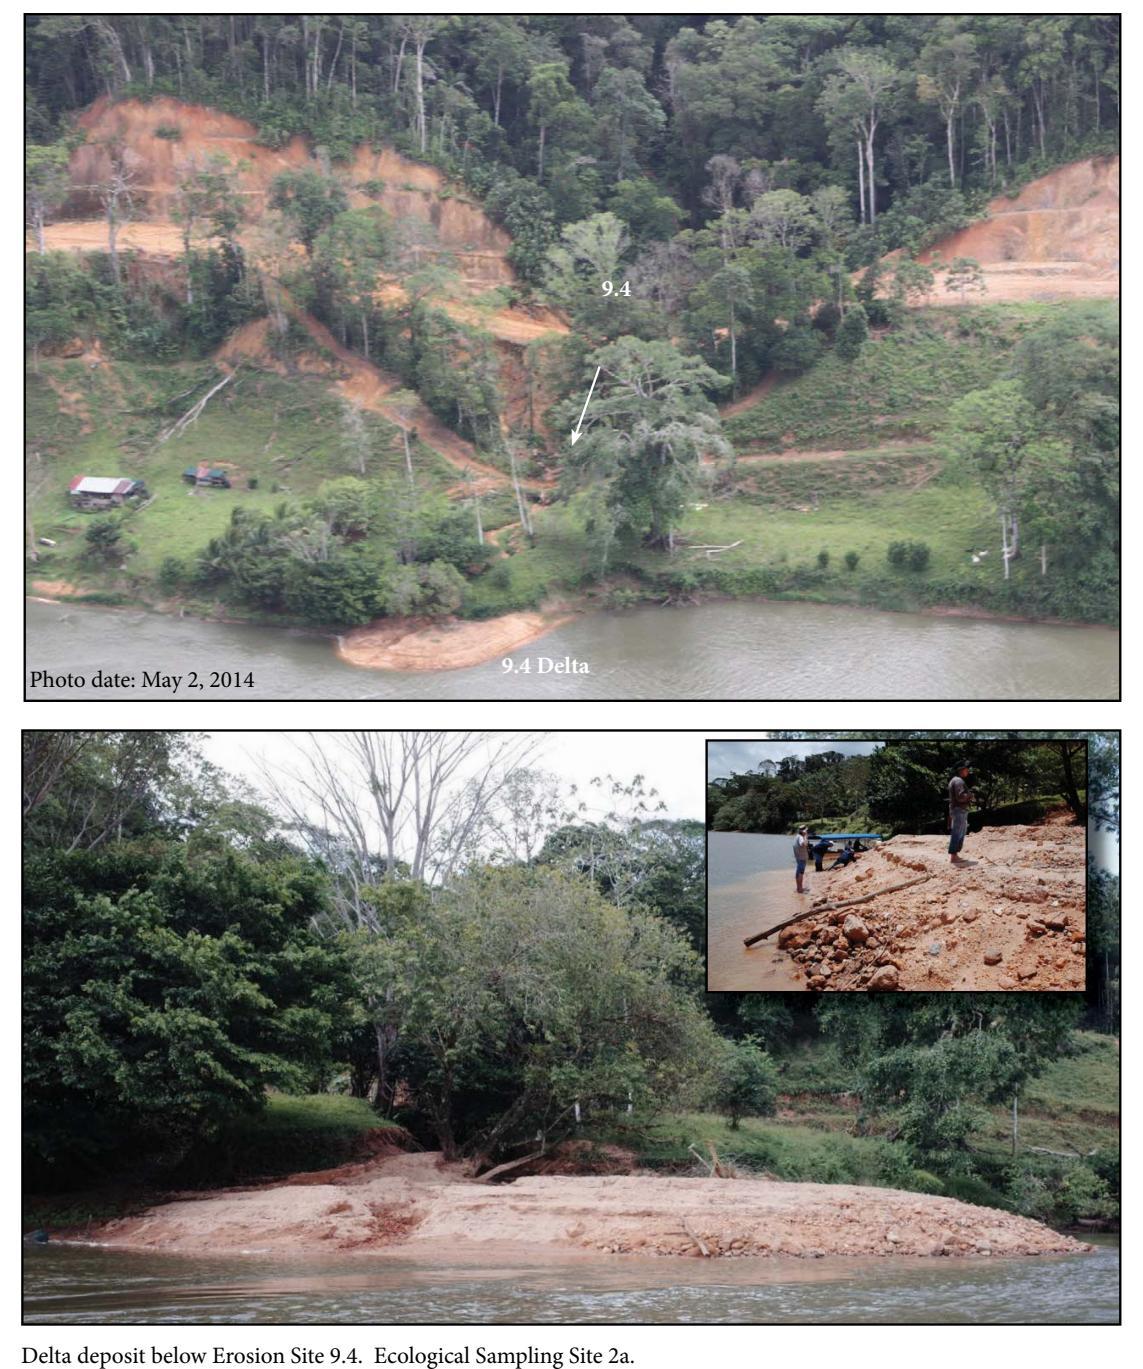
Width (perpindicular to RSJ) = 10m Length (parallel to RSJ) = 25m Height (above RSJ water surface) = 1.8mPhoto and measurement date: March 30, 2014

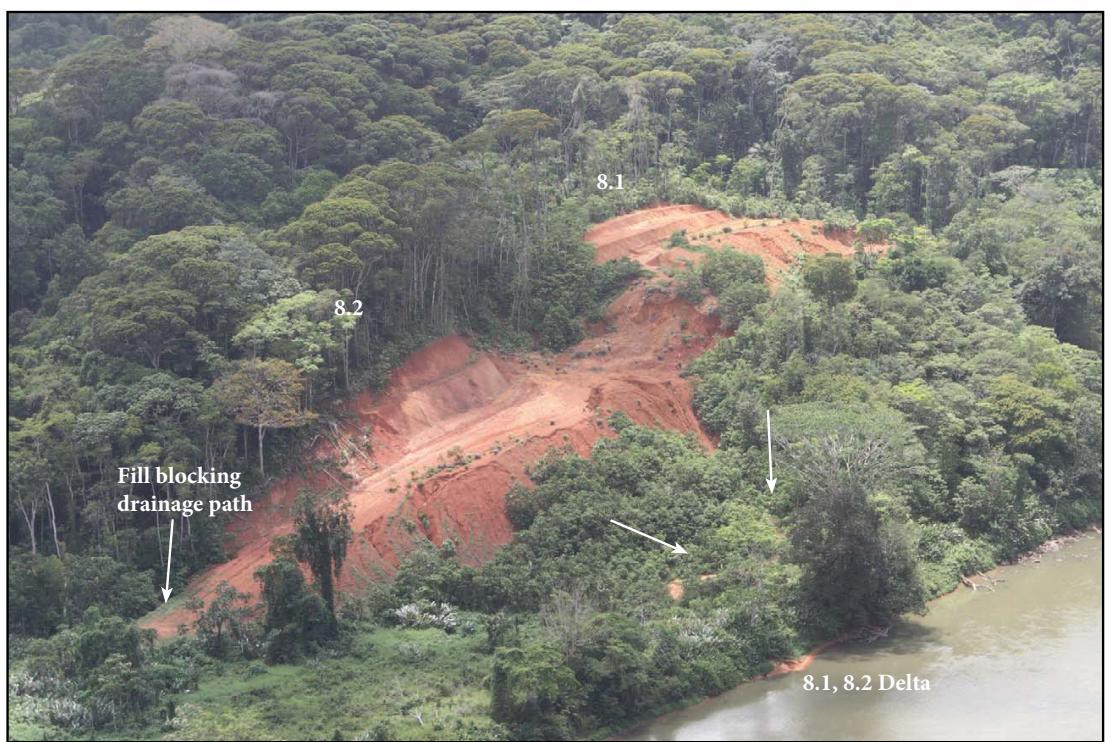
Photo date: May 2, 2014

Delta deposit below Erosion Sites 8.1 and 8.2. Dimensions not measured in the field. Photo and measurement date: March 30, 2014

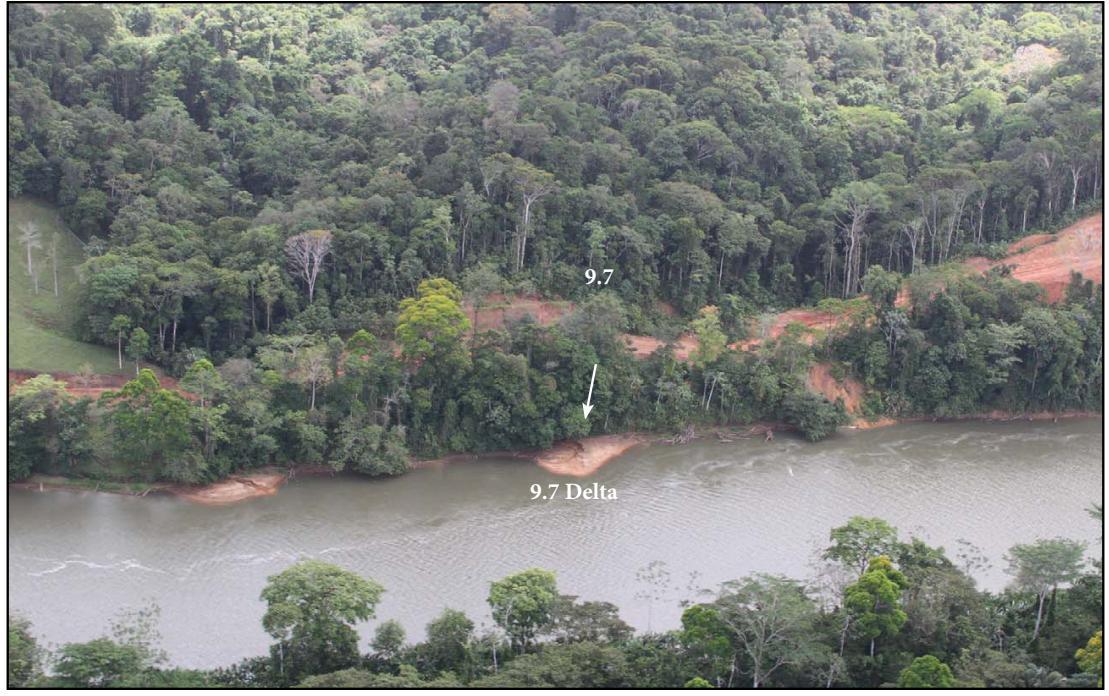
Photo date: May 2, 2014

Delta deposit below Erosion Site 9.7. Ecological Sampling Site 6a. Width (perpindicular to RSJ) = 21m Length (parallel to RSJ) = 25m Height (above RSJ water surface) = 1.7m Photo and measurement date: March 30, 2014

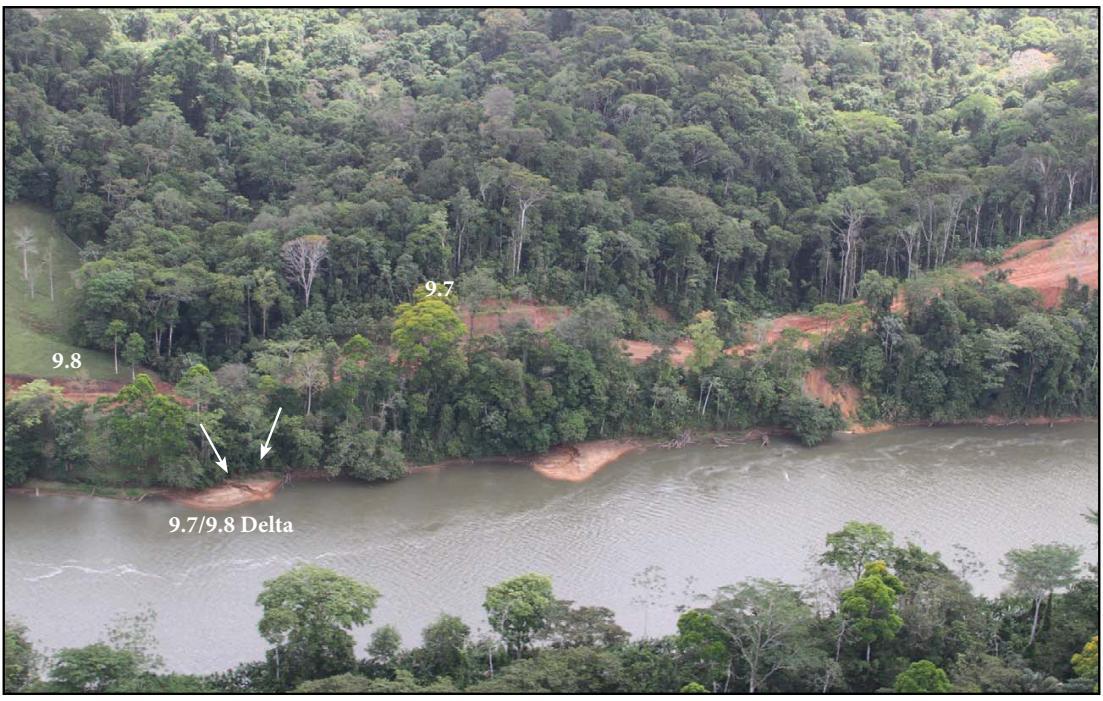
Photo date: May 2, 2014

Delta deposit below Erosion Site 9.7. Ecological Sampling Site 7a.

Width (perpindicular to RSJ) = 13m Length (parallel to RSJ) = 30m Height (above RSJ water surface) = 1.6m Photo and measurement date: March 30, 2014

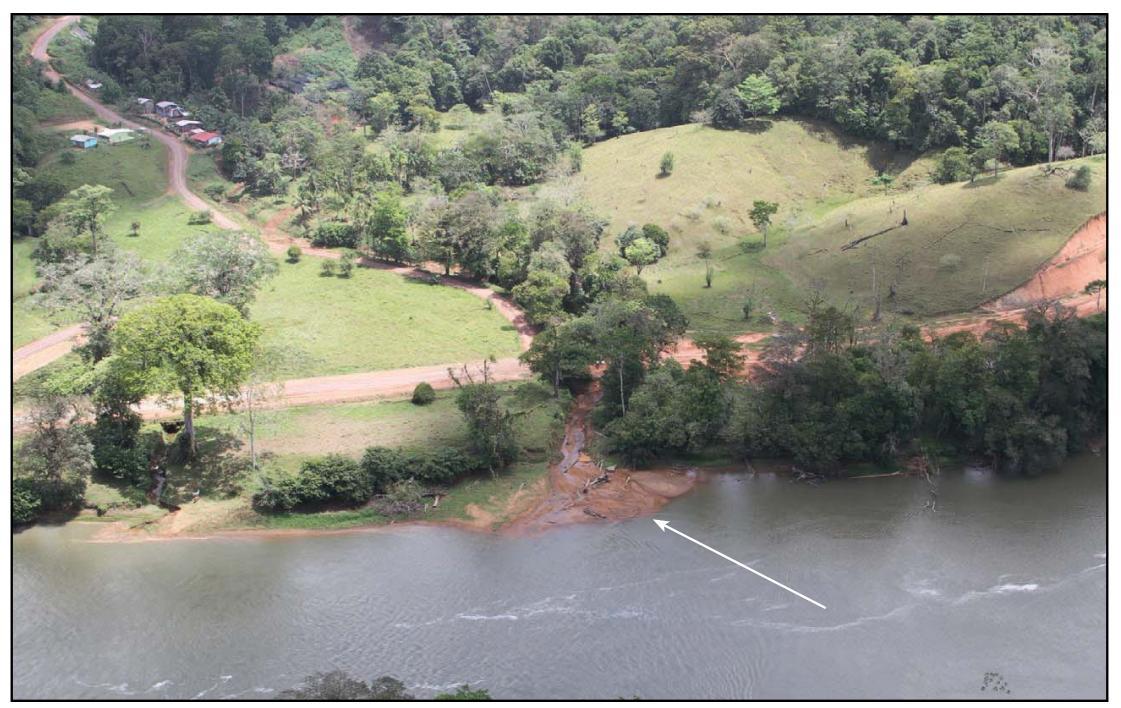
Photo date: May 2, 2014

Sediment deposit at mouth of Caño Venado, an example of a more natural deposit with a lower and wider profile indicating less rapid deposition. Ecological Sampling Site 4a.

Width (perpindicular to RSJ) = 50m Length (parallel to RSJ) = 50m Height (above RSJ water surface) = 0.75m Photo and measurement date: March 30, 2014

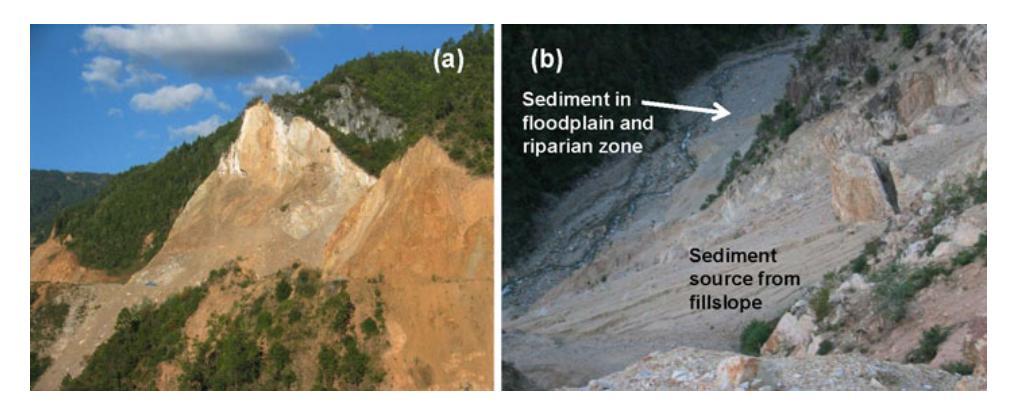
Fig. 2 a The large cutslope failure that killed six people traveling along the road in a minivan in summer 2006; and **b** sediment from displaced cutslope sediment and failures in the fillslope that directly entered the stream channel

In addition to the sediment generated from this road and its effect on river systems, road-related landslides present a hazard to traffic. During summer of 2006, six people traveling down this portion of the Weixi–Shangri-La road in a minivan were killed by a landslide originating from a steep cutslope that was blasted into the mountainside (Fig. 2a).

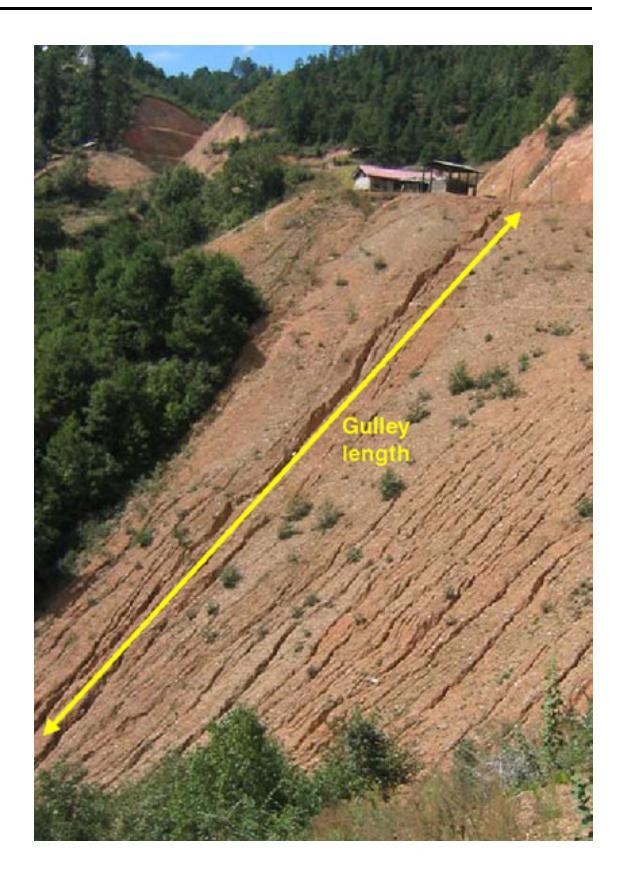
Fig. 4 Extensive gulley erosion occurred on road fillslopes in the severe erosion category. For gullies deeper than 0.5 m, dimensions were measured and eroded volume was calculated

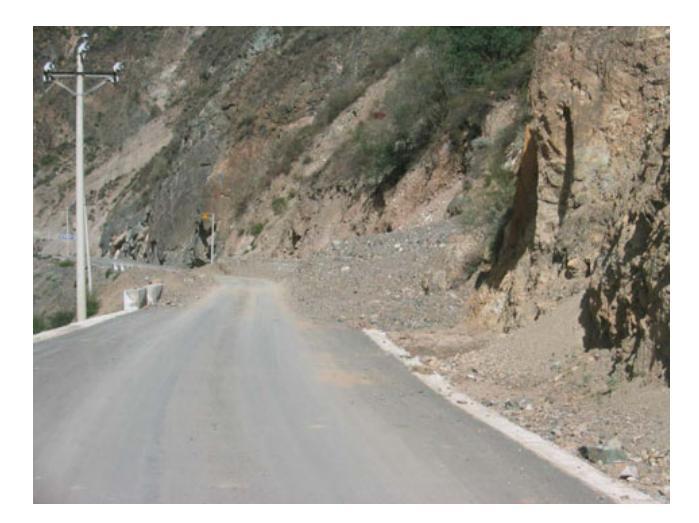
Fig. 7 Small cutslope failures trapped on the road prism

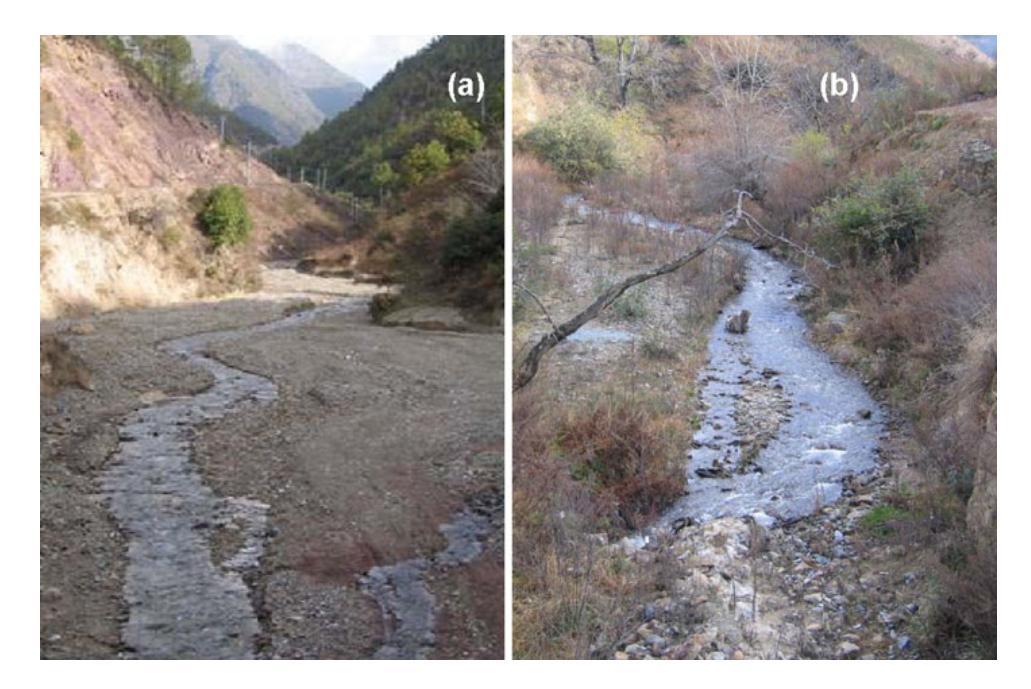
Based on our qualitative field observations, large amounts of debris and sediment have accumulated in the stream channels adjacent and downgradient from the newly constructed road. This sediment appears to have originated from landslides, debris flows, dry ravel, and surface wash from fillslopes along the road and to a lesser extent from cutslopes. Fresh sediment was observed in channels in the catchment that were downslope of the new road (Fig. 9a), whereas adjacent channels of similar catchment size, gradient, and baseflow discharge (<1 m³ s⁻¹) that were not impacted by roads had significantly less sedimentation (Fig. 9b). In some cases, channel aggradation damaged cultivated lands in the floodplain.

Fig. 9 a Aggradation of the stream in the vicinity and downstream of the road; **b** similar size stream with similar gradient and baseflow discharge in an adjacent catchment with no significant road influences: little sediment aggradation occurred in this channel. Both stream reaches are shown in Fig. 1

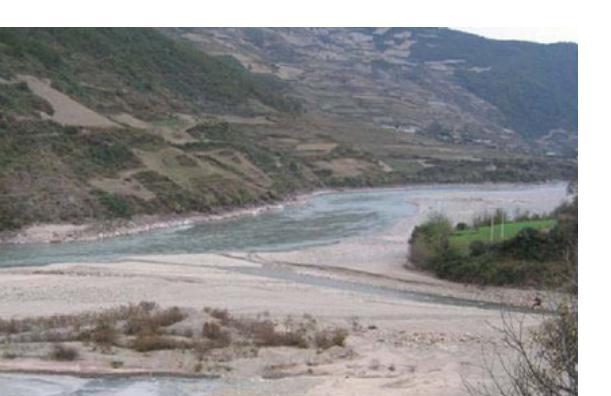
The deposited sediment in these headwaters is subsequently transported to the main stem of the Mekong River (Fig. 10); however, stream morphology, including the lack of scour evidence in floodplain deposits, suggests that episodic flooding events, which transport the majority of the sediment and debris in the impacted tributaries, have not occurred in this area since the road construction began in 2002. The absence of major flooding in this headwater system during the 4 years following road construction was corroborated by local residents. Based on these observations, future evolution of channel morphology may occur in one of two ways with very different hazard implications. In the first scenario, the level of peak flows will not be sufficient (i.e., energy limited) to transport the bulk of the aggraded sediment and debris out of the impacted tributaries, and progressive partial transport of sediment will continue for the next few centuries. In a second

Fig. 10 The confluence of the Yong Chun River with the Mekong River (see Fig. 1 for location); debris and sediment transported from the tributary form a small delta near the confluence

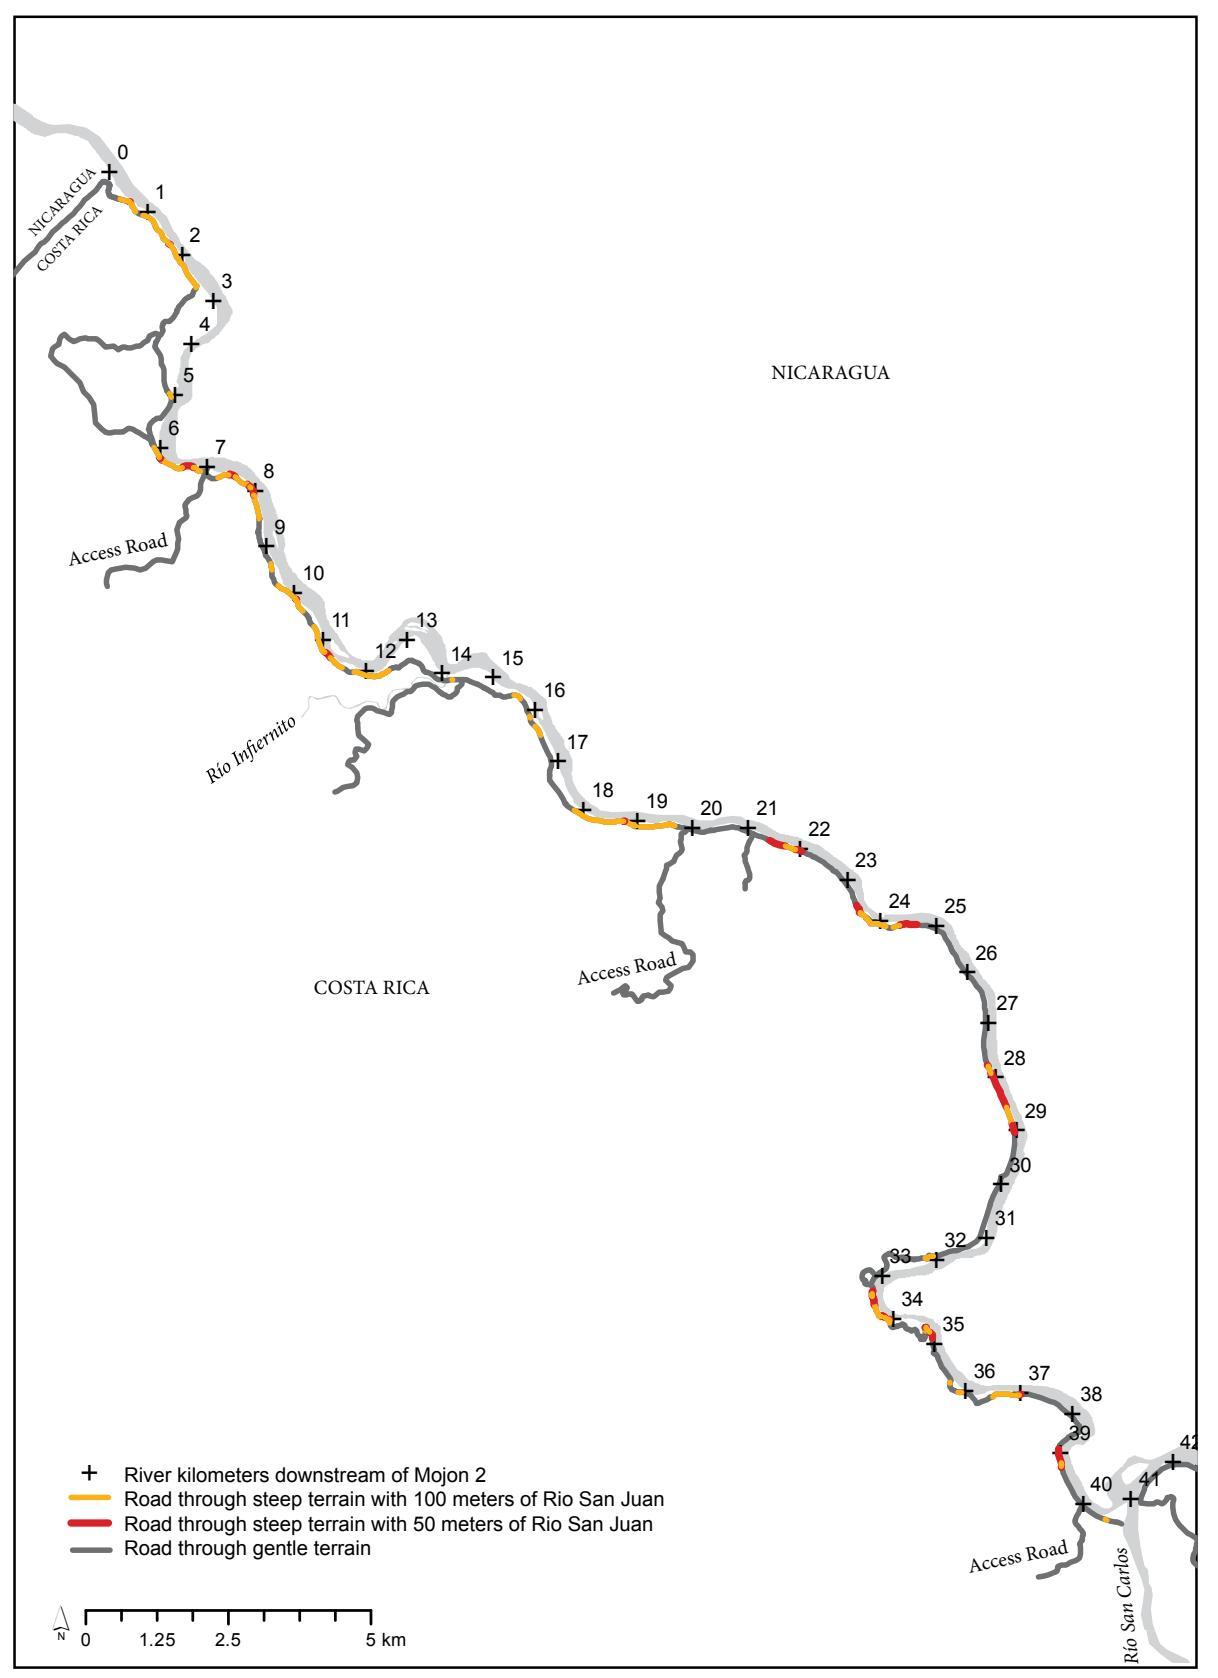
Figure 1. Map highlighting road through steep terrain and within close proximity to Río San Juan where relocation possibilities should be considered
