INTERNATIONAL COURT OF JUSTICE

CONSTRUCTION OF A ROAD IN COSTA RICA ALONG THE SAN JUAN RIVER (NICARAGUA V. COSTA RICA)

REPLY

ANNEX 1

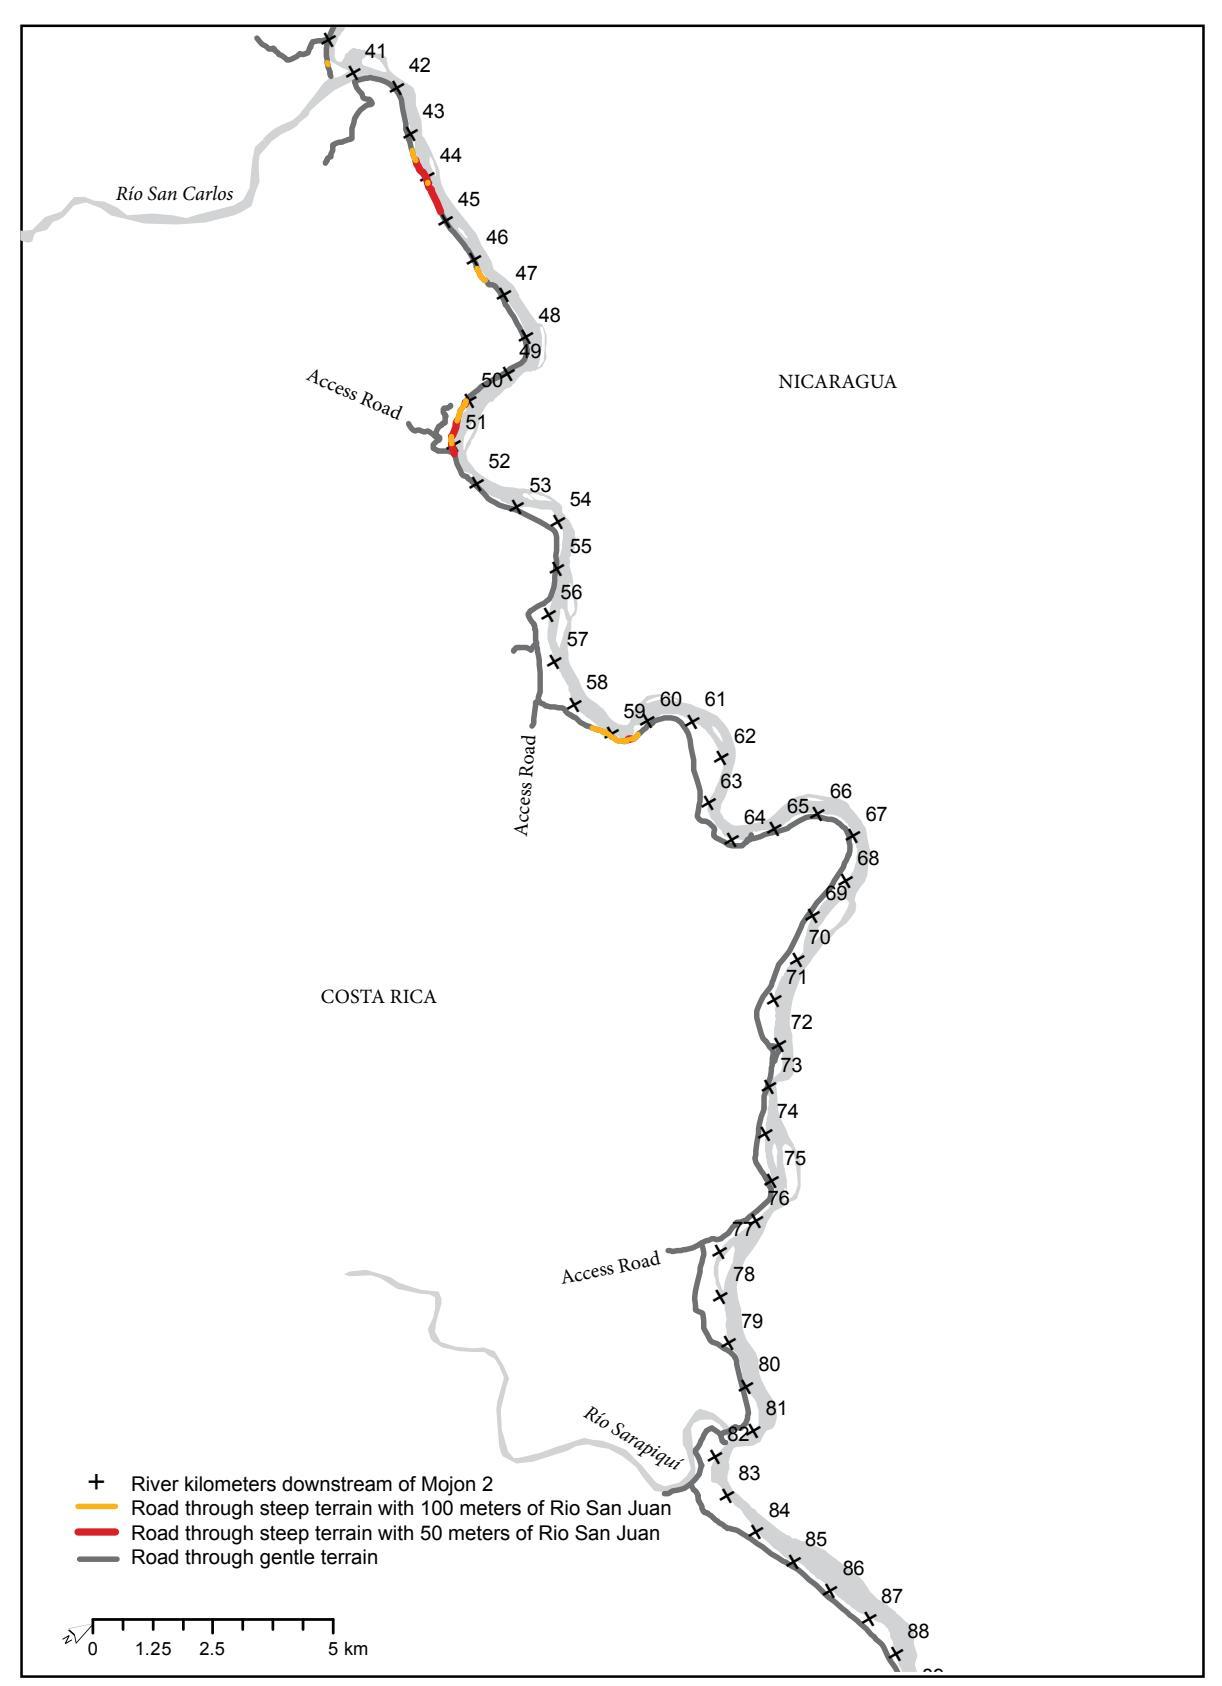
Figure 1. Map highlighting road through steep terrain and within close proximity to Río San Juan where relocation possibilities should be considered.

Because of the disastrous condition of these sites, the volume of the un-compacted fill involved, the enormous challenges that would be faced in attempting to stabilize these crossings, and the extreme proximity to the Rio San Juan (the fill edges are mostly within 100m of the river bank), we recommend that this section of Route 1856 be rerouted to an alternative, inland route to the south. The precise extent of the section that should be re-routed and the new route should be determined by ground inspection and surveys conducted by qualified experts. Based on information available to us, the entire section of Route 1856 encompassing these three sites should be re-routed, and as recommended by the Environmental 'Diagnostic' Assessment (EDA) submitted by Costa Rica, Route 1856 should be re-routed downstream of Rio Infiernito, which implies moving the entire section from approximately river km 14 to 20 (i.e., from about 14 km to 20 km downstream of Mojon II).

Our recommendation that this part of the road be moved inland is consistent with that of the EDA (Annex 10), which included recommendations for environmental measures to be implemented in response to "occurrence of landslides and slope erosion affecting the forest borders of the road." The EDA recommended measures include, "to evaluate the technical possibility of modifying the route designated for Route 1856 at the point called Infiernillo [sic] to include the use of local roads built on less sloping terrain, tracing the road some km. to the south, where there are open areas and settlements with more favorable topographic conditions." (p. 147 of the EDA, Annex 10 to the Costa Rican Counter-Memorial.) The recommendation is repeated in the Conclusions section of the EDA: "Evaluate the technical possibility of modifying the Route design at the point of Infiernillo [sic] to follow local roads built previously, deviating for some km. to the South, where there are settlements and open areas with topographic conditions that are more favorable to this type of project." (p. 162 of the EDA, Annex 10 to the Costa Rican Counter-Memorial.)

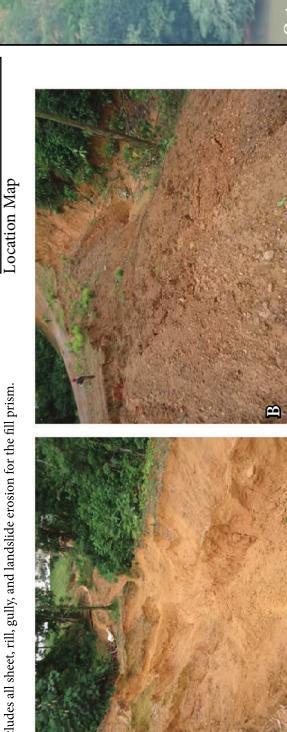
Gully on fill face (A) and erosion on backside of fill prism (B) (from Mende & Astorga 2013, p43).

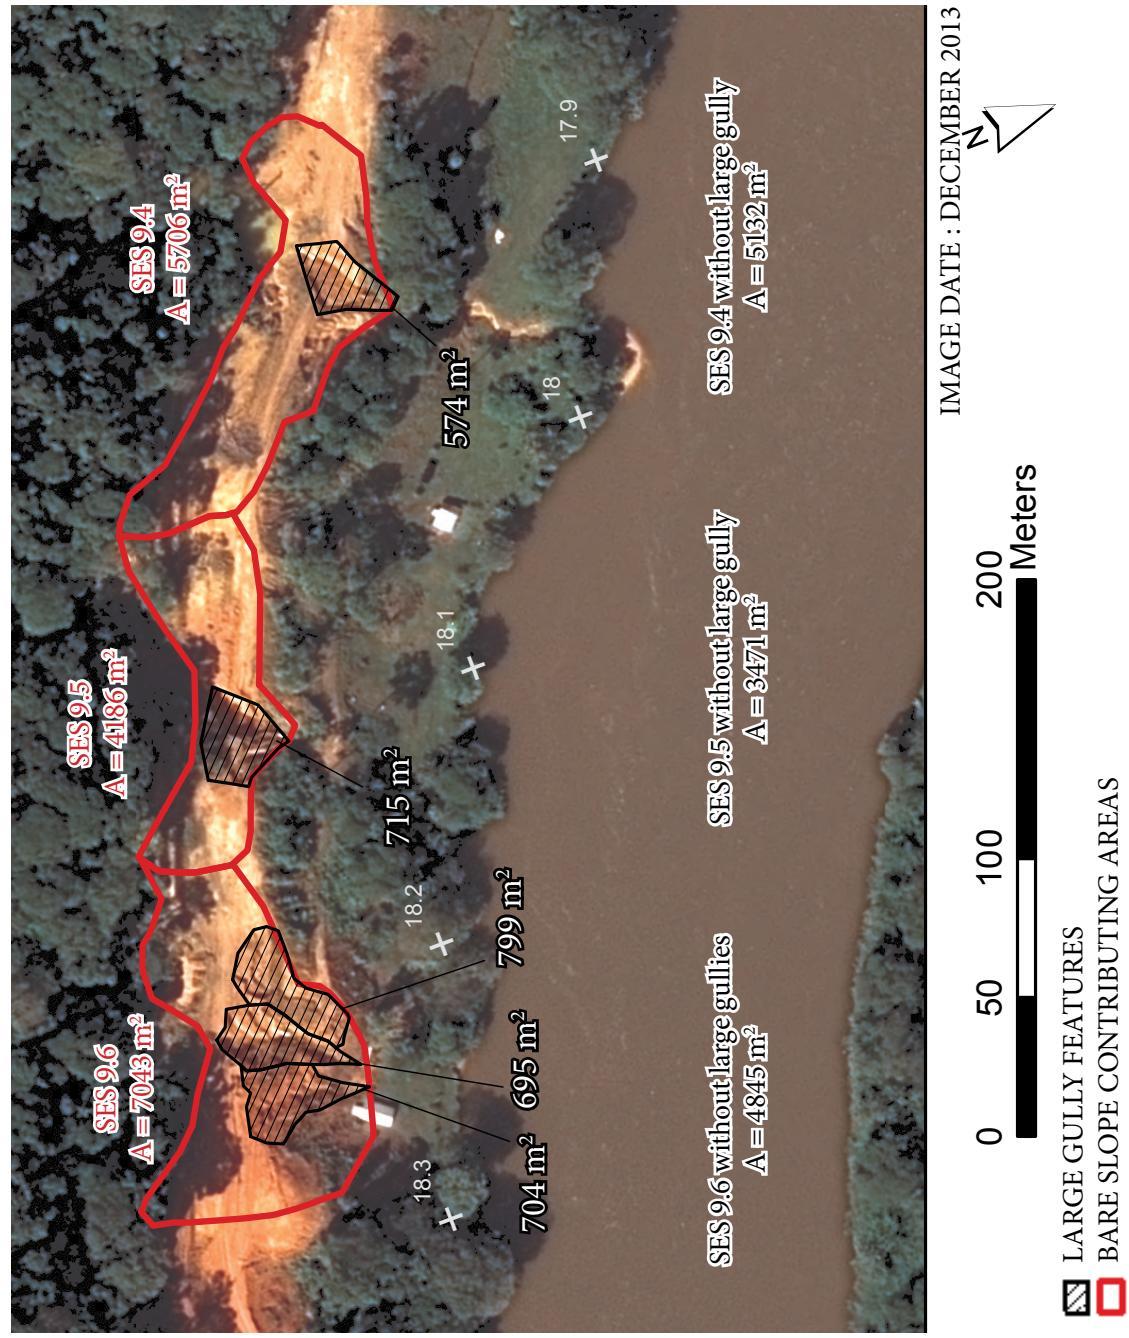
This series of photographs illustrate the ongoing and dynamic erosional processes occurring at Severe Erosion Site 9.5 (18.1 km downstream of Mojon II), and in its immediate vicinity, over the same 20 month period (Figure 3). On the oblique 2012 photograph (and in ground photo "B"), severe deformation and slumping is visible on both the upstream and downstream fill slope faces almost immediately after construction of the stream crossing. This stream crossing fill failed (eroded) between October 2012 and December 2013, delivering over 2,860 m³ of eroded sediment to the Rio San Juan (see 2013 satellite image). The cause of this failure was likely a poorly designed (probably greatly under-designed and undersized) stream crossing culvert, combined with native hill slope failures triggered by the initial road construction work.

On the May 2014 oblique aerial photograph, two large landslides are visible on the hill slopes just upstream of the road crossing. These landslides may have caused the stream crossing failure by plugging the culvert, or they may have been triggered by saturation of the toe of the slopes when the new stream crossing culvert plugged and a small lake formed behind the fill. In any event, the plugged culvert caused stream flow to pond, overtop the road fill, and consequently erode a large portion of the fill crossing (clearly visible in the December 2013 satellite image). The road-related and construction-caused landslides and stream crossing failure had a large impact on the Rio San Juan, as all the landslide debris and eroded sediment was transported the short distance to the river. The greatly enlarged delta in the river is clearly visible in the May 2014 photograph (Figure 3).

Once the stream crossing had failed, the May 2014 helicopter photo clearly shows that the stream crossing fill was then simply refilled with bulldozed soil material and a second small replacement culvert pipe was placed at the top of the fill. Now, a lake will again form on the inside of the new road fill and it will fill with water during the next wet season rain until almost reaching the level of the new road surface before it begins flowing into the culvert. Placement of the culvert at the top of the new fill is a totally inadequate, inept and improper design and construction practice, and would not meet any reasonable engineering standard. It is our observation and opinion that few of the culverted stream crossings along Route 1856, especially in the highly sensitive areas we have described, have been sized to accommodate large infrequent storm and runoff events (e.g., the 100-year flood recurrence event is a common design standard for sensitive forest roads and areas), have been constructed with the appropriate materials, or are properly installed within the fill prism. In fact, Mende and Astorga's (2013, p. 399 of Annex 6) classification of the technical status of the 119 partially constructed stream crossings along Route 1856 indicate only 30% of the crossings to be considered "improved or appropriate" (Figure 6, below).

The re-filling of the erosional gully void, and installation of the small culvert at the top of the new fill, provides only temporary vehicular passage at the crossing. No meaningful or permanent efforts have been undertaken to control the significant deficiencies in the design and construction methods employed by Costa Rica at this crossing, or at others along Route 1856. The repair of this crossing has, in fact, made

Additionally, and more seriously, the new road fill that was placed (bulldozed) into the crossing was not designed, engineered or constructed to function as an earthen dam. It will be extremely hazardous to travel across the road during storm events, or anytime water has backed up behind the road fill. The stream crossing fill could easily liquefy and fail catastrophically during or following a storm event. In addition, with a lake or pond at the culvert inlet, floating woody debris brought down by the stream is likely to plug the culvert inlet, thereby causing it to overtop the fill and again washout a significant portion of the stream crossing fill (as shown in the 2013 satellite image). All the eroded sediment from this poorly designed and constructed stream crossing culvert will again be delivered to Nicaragua's Rio San Juan.

Reconstruction of this stream crossing, in the manner that was undertaken, shows complete disregard to the science of road engineering, has caused hazardous conditions for users of the road, and ignores all environmental protection standards. The newly "constructed" road fill at Site 9.5 still exhibits serious instability and the crossing will experience renewed active erosion via a combination of gully and landslide processes, and we predict near complete failure with the advent of future storms that are equal to or larger than the storms the road has experienced over the 20 month period of October 2012 to May 2014. The erosion as observed at these stream crossings results in continuous delivery of sediment to the Rio San Juan during virtually every significant rainfall event, as manifest by the continued growth and enlargement of the fresh sediment deltas visible on the 2014 oblique photo.

We estimate the volume of gully erosion at the stream crossing failure site between October 2012 and December 2013 to have been 2,860 m³. This does not include the volume of sediment associated with the two large hill slope debris landslides, other landslides and gullies present on the adjacent fill slopes and cut banks outside of the

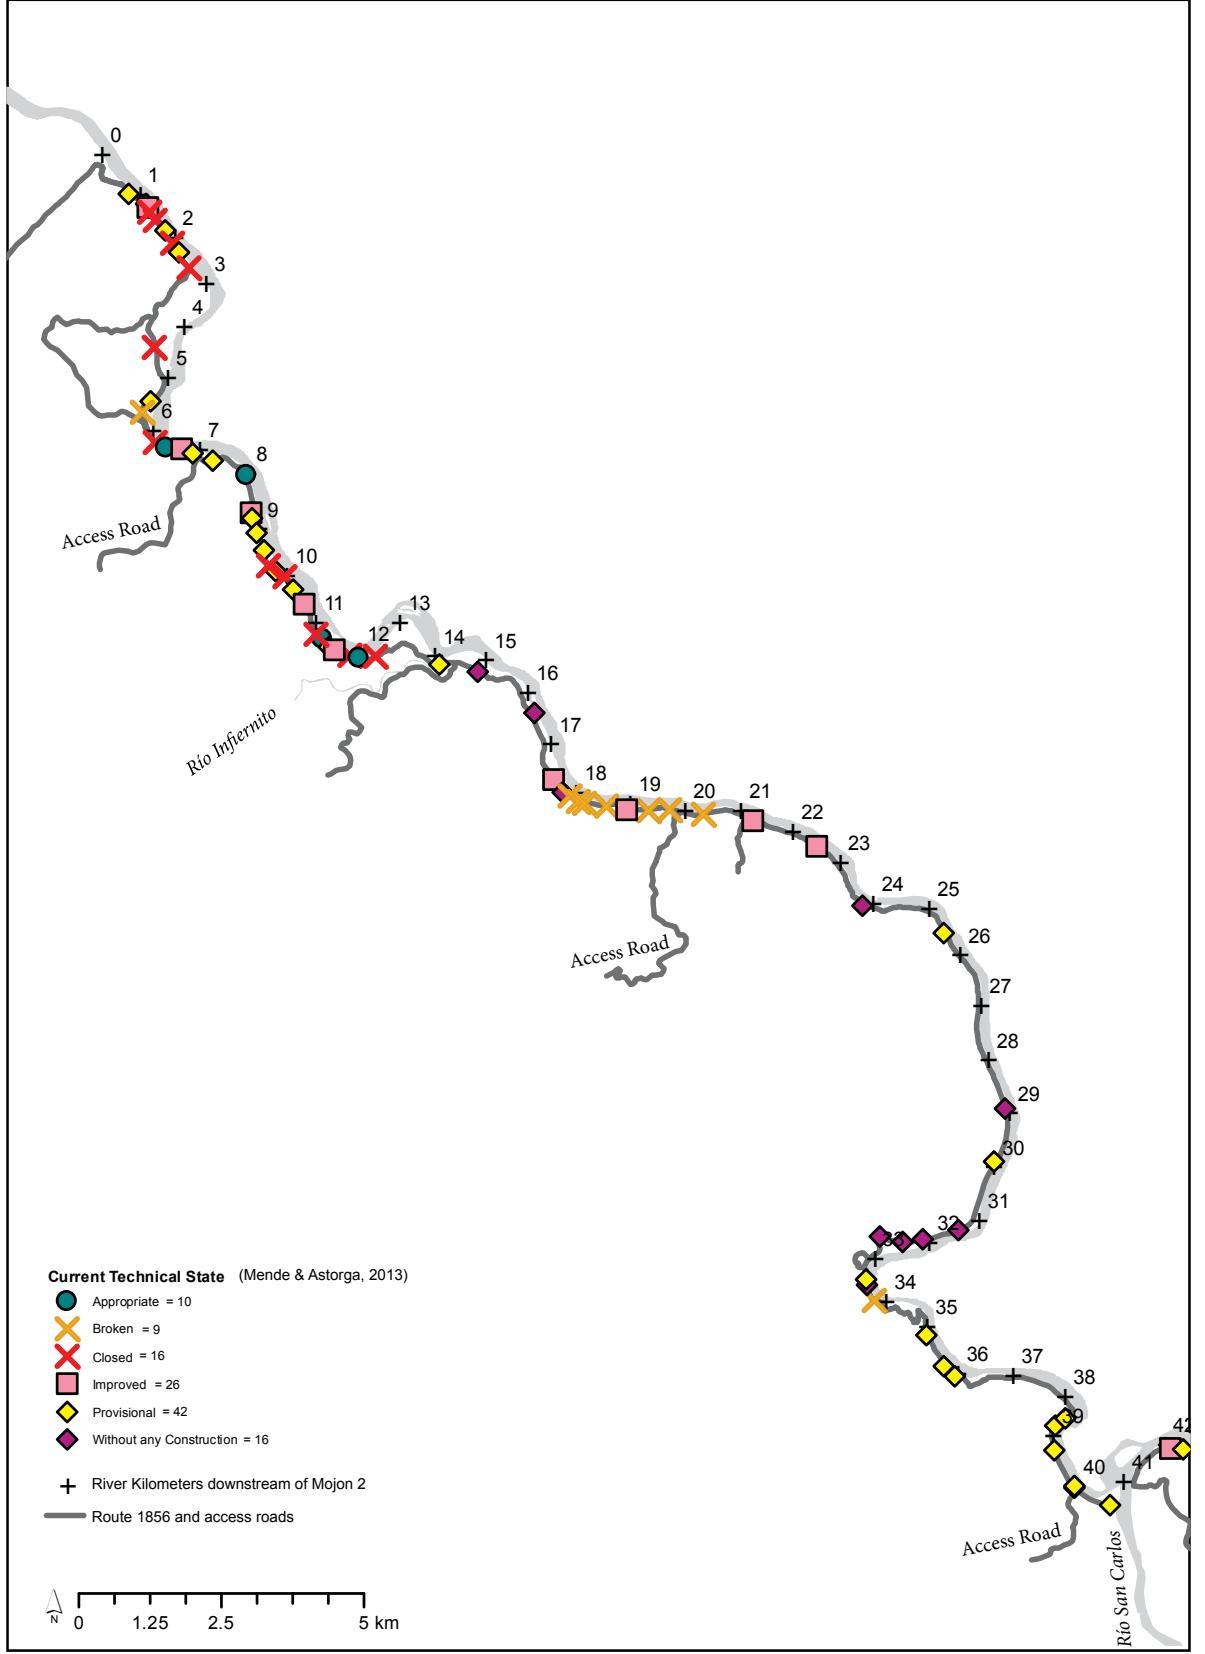
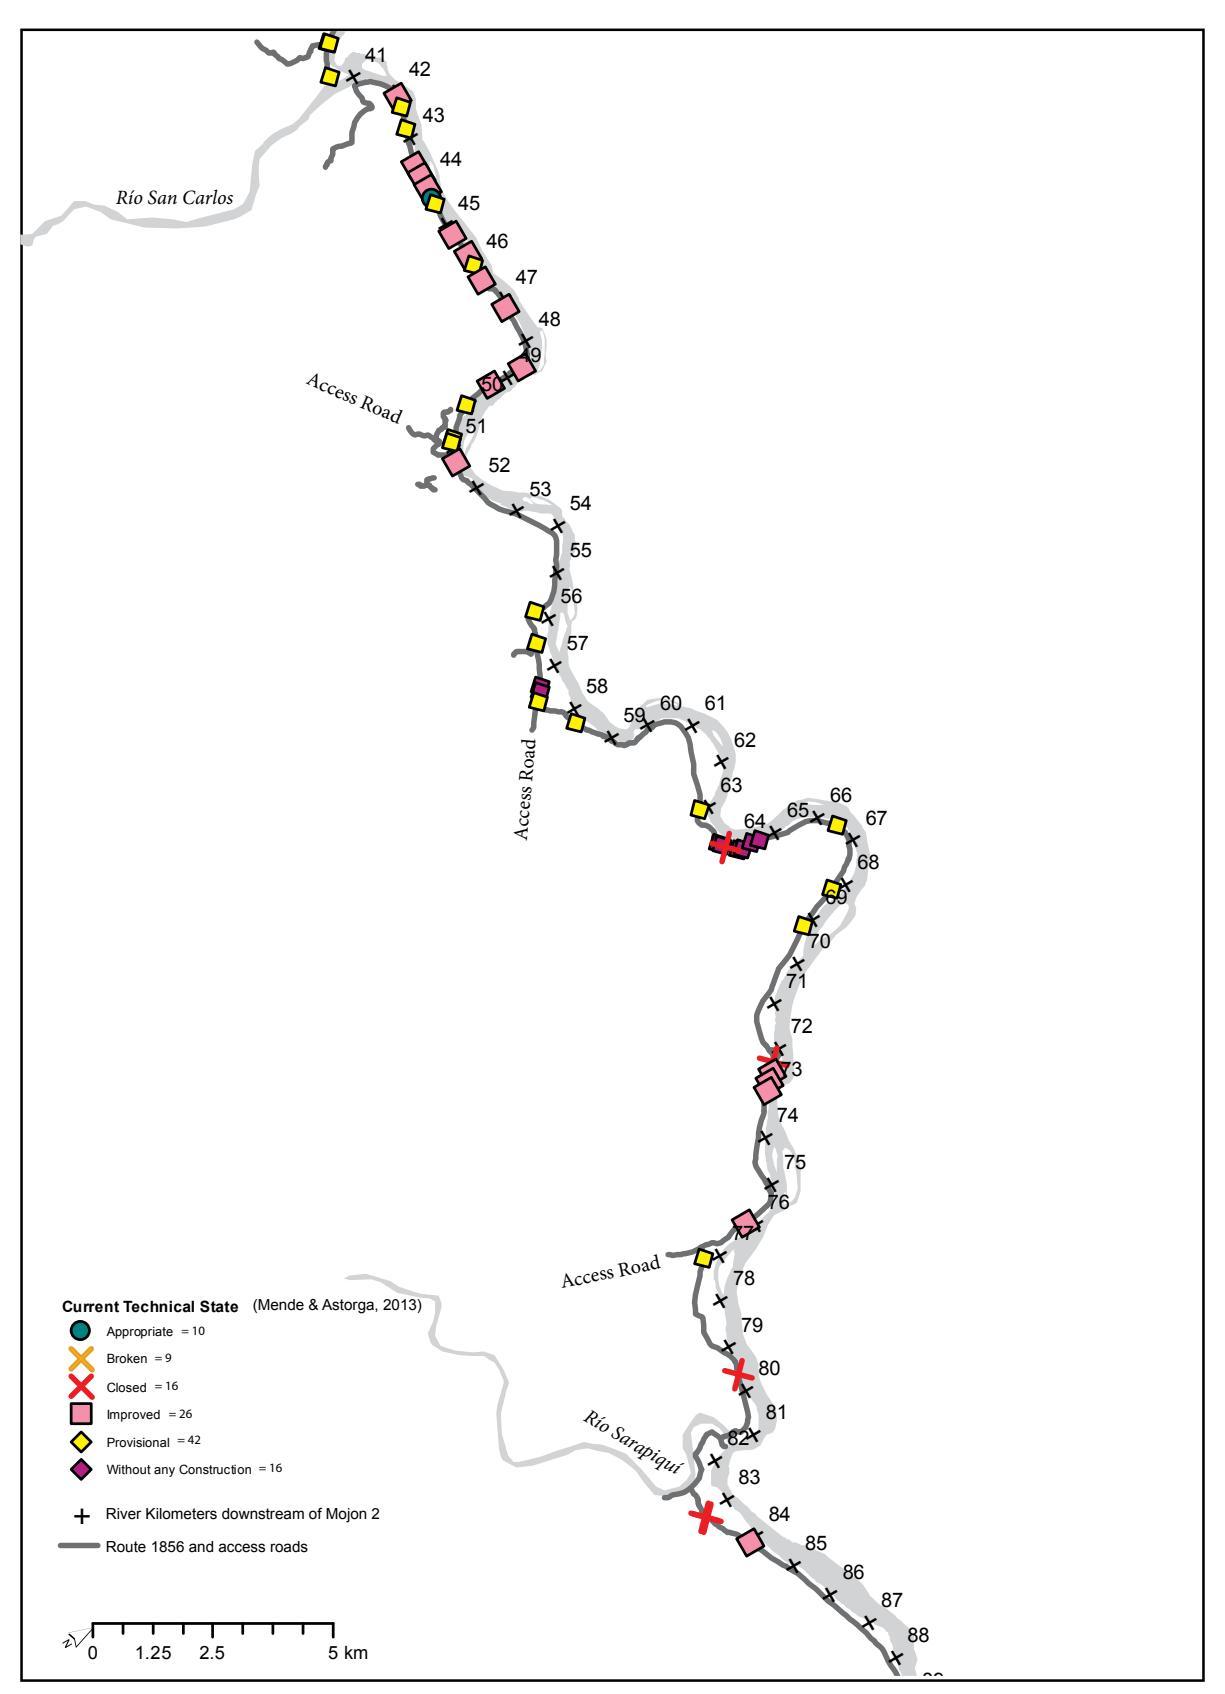
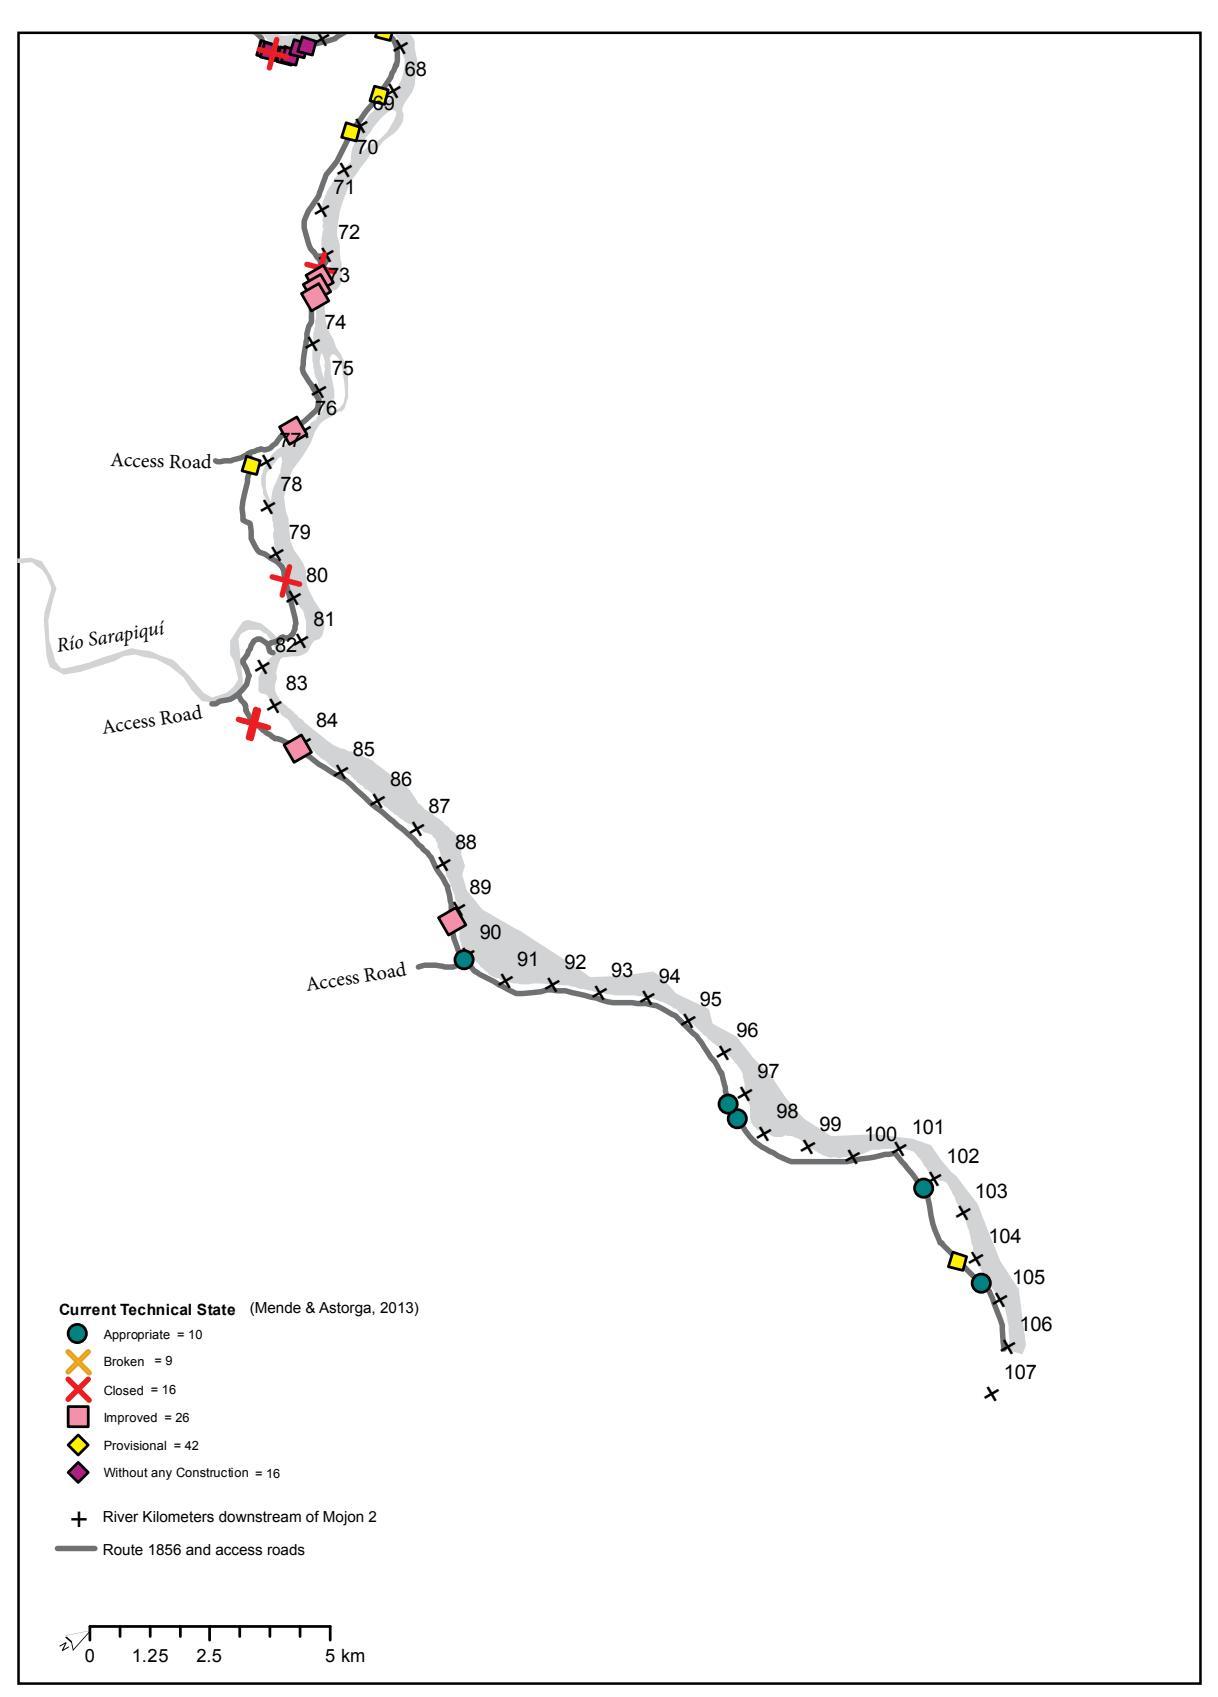
Figure 6. Map of road crossings derived from Mende & Astorga 2013, Annex 6 inventory of water crossings GIS database requested by Nicaragua in 2014. The map of technical states was not provided in Annex 6.

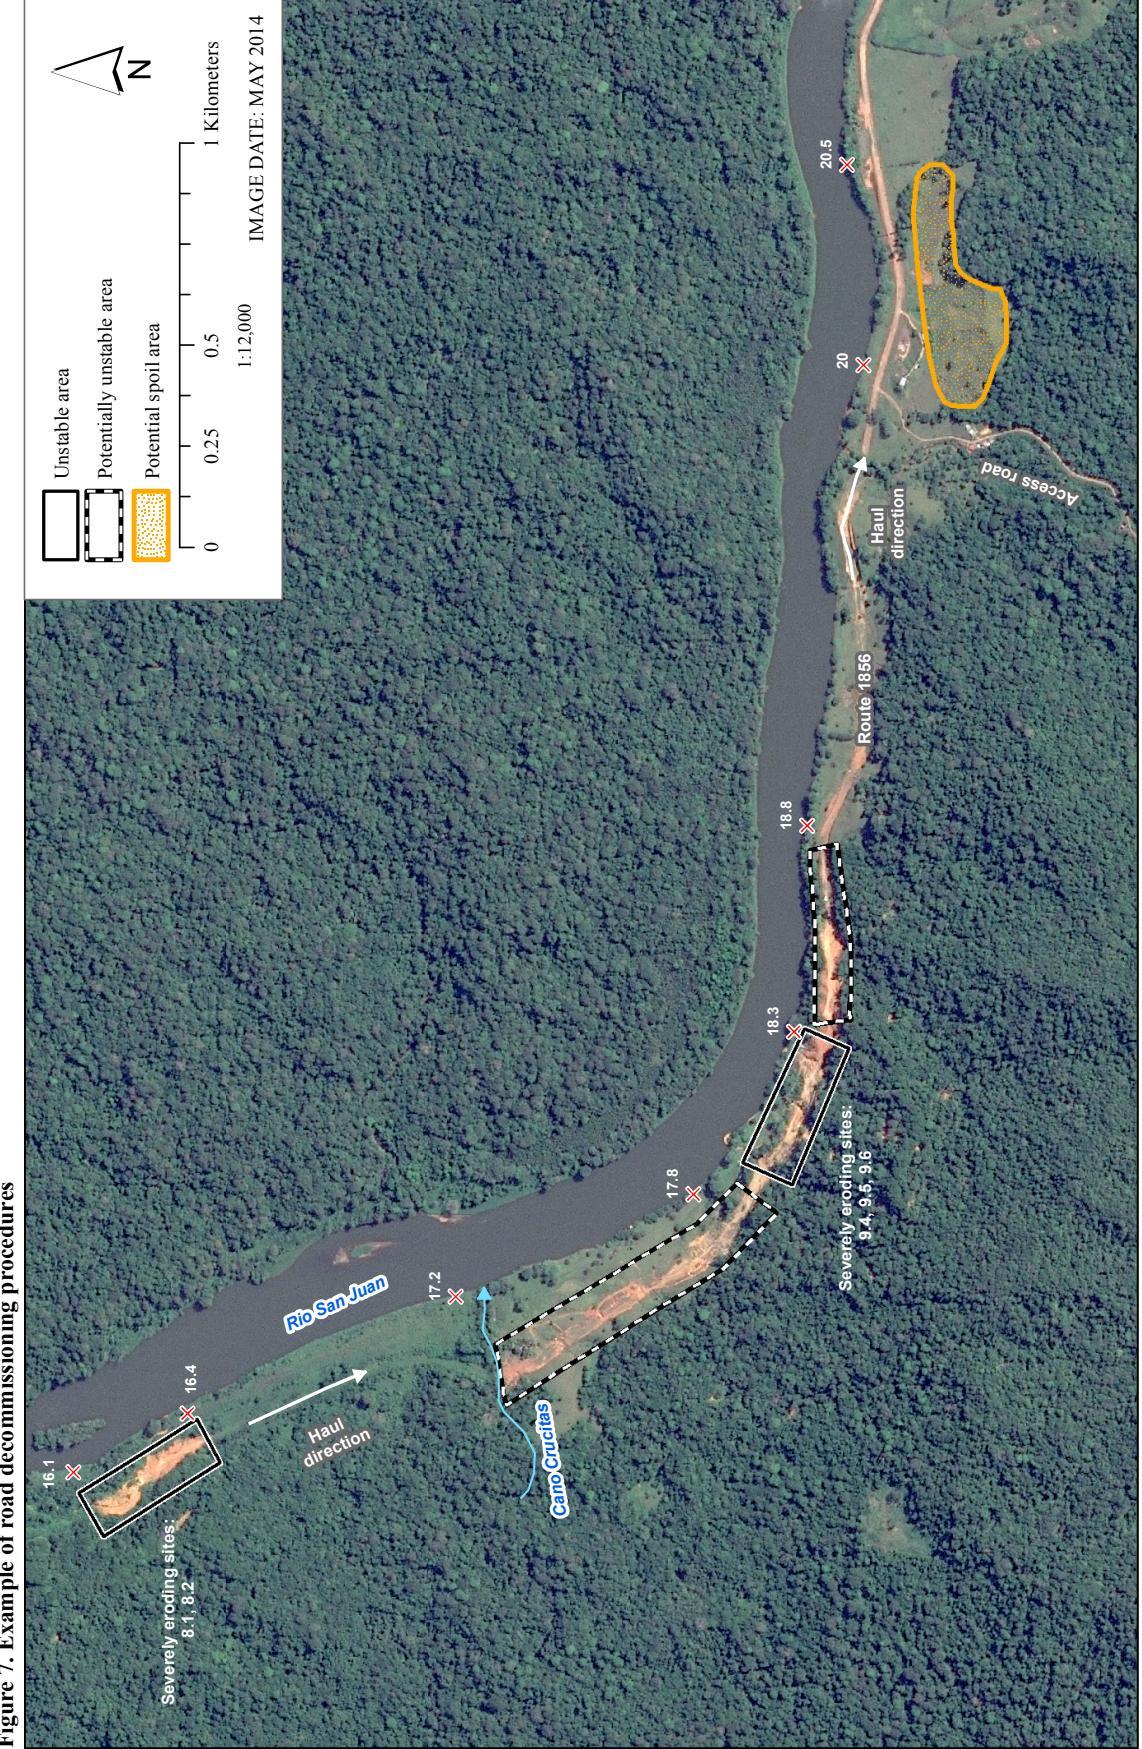
Figure 7 (below) serves as an example to illustrate the road decommissioning procedure. On the 2014 satellite photograph we have plotted the location of the 5 Severely Eroding Sites and identified other road reaches that might display unstable cut- and fill-slopes in need of stabilization in relation to a potential long term, spoil disposal location. From the western edge of Severe Erosion Site 8.1 (at river mile 16.1 km), it is approximately 4.4 km for dump trucks to haul excavated material to the potential spoil location at river mile 20.5 km (i.e. the gentle topography behind the home site and east of the access road). If three teams of heavy equipment were utilized to decommission this reach of Route 1856, one team could be working Sites 8.1 and 8.2, another could be stabilizing cut- and fill-slopes at the identified intervening road segments while still providing a portion of the cut part of the road prism for dump trucks hauling spoil from Sites 8.1 and 8.2, and the third team could begin to vertically lower the upper one third of the large stream crossing fills at Sites

9.4, 9.5 and 9.6 while still maintaining dump truck passage for the other teams (Figure 7). All spoil material in this particular example to hauled west to east to the designated stable, spoil disposal location.

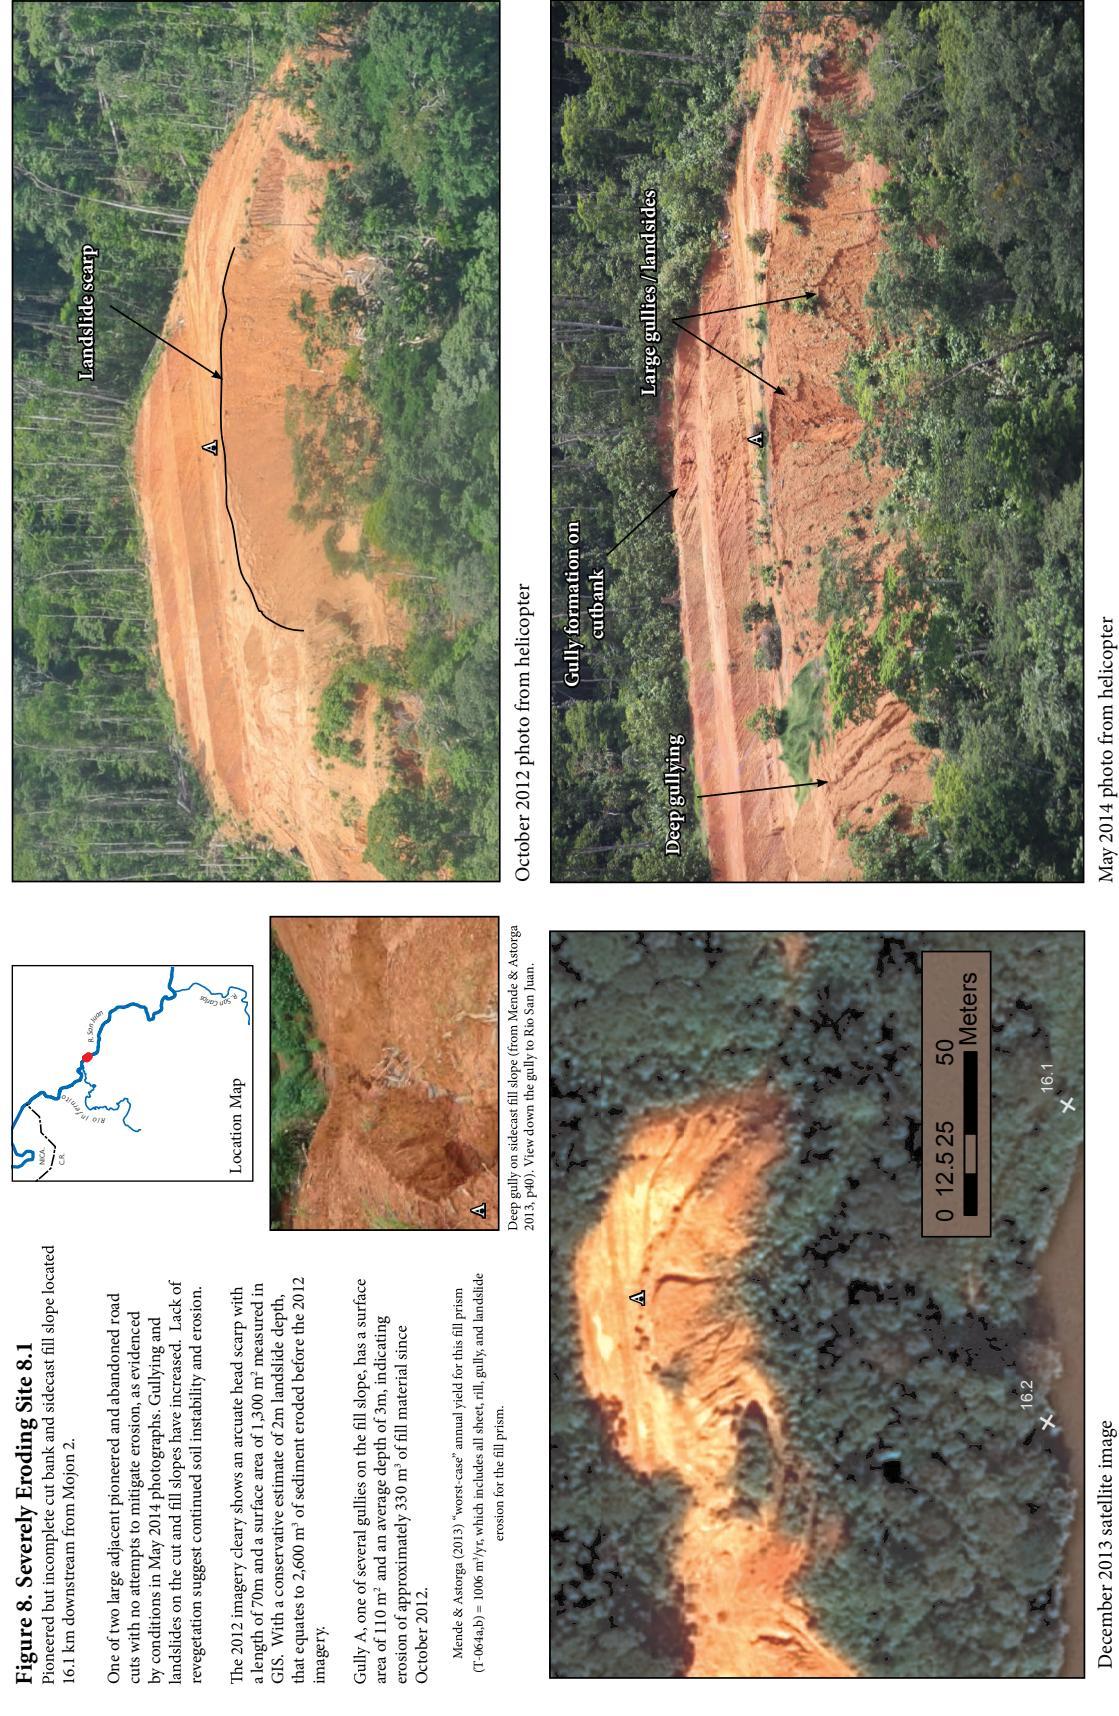
Location: 16.1 to 16.2 km downstream of Mojon 2 border marker.

Figures 8 and 9 illustrate two (2) examples of poorly designed, poorly constructed and unmaintained cut and fill slopes along Route 1856. Both image comparisons depict badly deteriorated and rapidly eroding and failing cut slopes and fill slopes located directly adjacent to the Rio San Juan. Aerial oblique photographs were taken comparing the sites over the 20 month time period between October 2012 and May 2014. Each of the two sites (Severely-Eroding Sites 8.1 and 8.2, in Appendix A of Kondolf 2014), located between 16-16.5 km downstream of Mojon II, exhibit extensive fill slope landslide instabilities that are enlarging through time; active and large scale gullying associated with poor road drainage practices and highly erodible, un-compacted materials; sporadic cut slope failures associated with undercutting and constructing over-steepened slope cuts in fine grained soils during the attempts at road construction; and widespread surface erosion from the extensive and easily visible bare soil areas present in the photographs.

Contrary to claims in Costa Rican documents that road repairs and maintenance are on-going, in both of the examples, there appears to have been no efforts over the 20month time frame (Oct 2012 – May 2014) to implement any significant preventative erosion control measures to prevent or control ongoing erosion and slope failure. Given the observable high level of progressive instability seen in the photographs, and the evident lack of following even the most basic road engineering and construction principles, it is clear to us that few, if any, of the stream crossing fills and road fill slopes were properly compacted. Workmanship on critically important road segments on steep hill slopes right next to the Rio San Juan, like the ones in these examples, is unreasonably poor and unprofessional. They were either poorly designed or poorly constructed, or both. Regardless, the impacts to the Rio San Juan have been significant and threaten to be even larger with the passage of time.

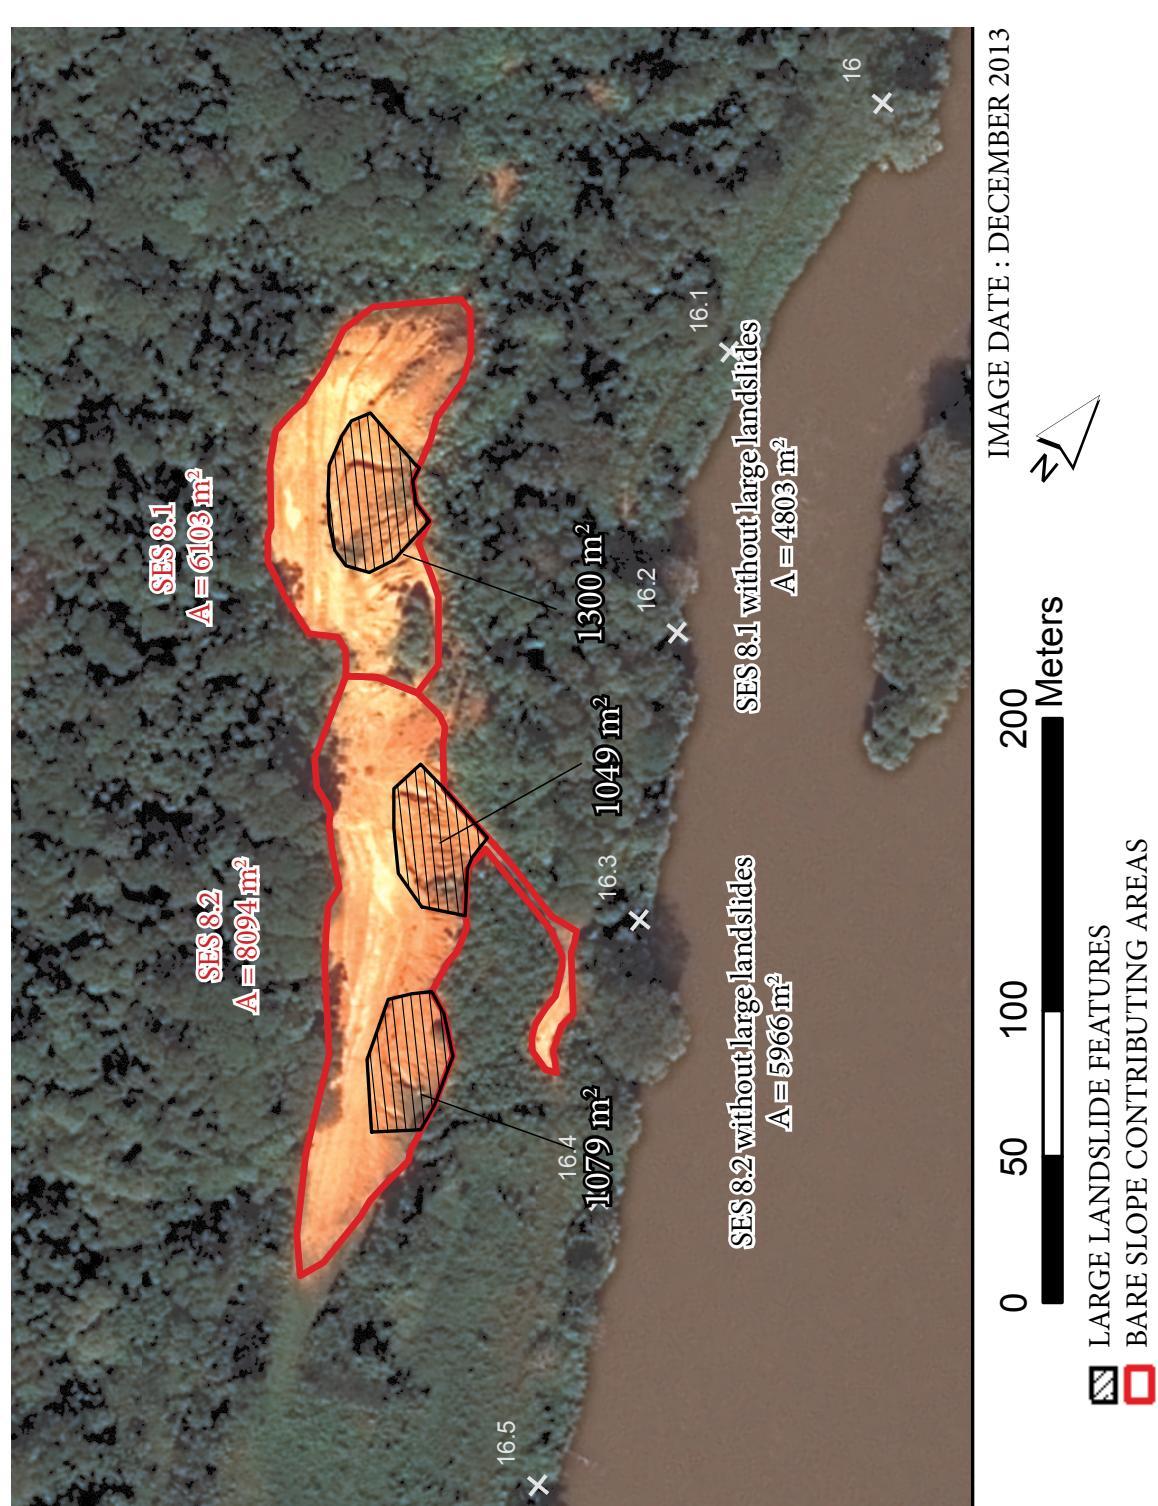
B. Severe Cut Slope and Fill Slope Site 8.1 at RSJ River 16.1 km

Severely Eroding Site 8.1, shown in Figure 8, is located 16.1 km downstream from Mojon II and shows a partially constructed (pioneered) reach of Route 1856 across a steep ridge between two adjacent tributary stream channels (not shown in the figure). This partially constructed road reach is located on steep hill slopes within 100 m of the Rio San Juan. The sequence of three images captured in 2012, 2013 and 2014 indicate initial construction activities were completed along the road reach by October 2012, and no visible or substantive work on the failing road has been done since 2012. This conclusion is based on the fact that the only visible changes during the 20 month time period are actively developing, uncontrolled and enlarging gullies and landslides present on the un-compacted, sidecast fill slopes, and evidence of widespread surface erosion on the visible bare soil areas through time. Poor or non-existent fill compaction during construction could have easily led an experienced geologist or engineer in October 2012 to predict the resulting instabilities and extent of erosion now present on the fill slopes at this site.

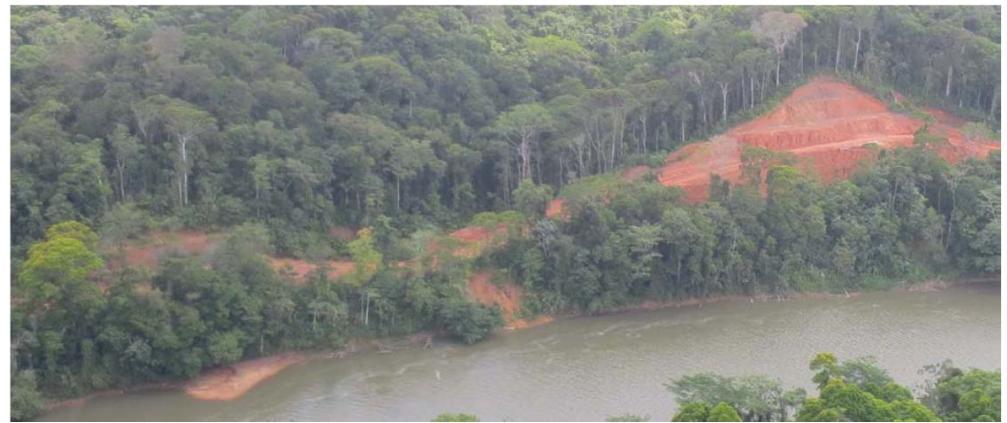
PHOTO 8 - Location: RKM 18.3 to 18.6 (from helicopter, May 2014). The relationship between topography and the management of storm water not properly managed has resulted in significant erosion. Earthwork activities employed to construct the roadway have resulted in exaction into steep slopes (due to the lack of appropriate route selection and design) to accommodate the roadway in steep terrain. The construction of roadways in steep topography has resulted in the acceleration of water moving over exposed soils, further resulting in erosion and sediment loading as a direct impact to San Juan River.

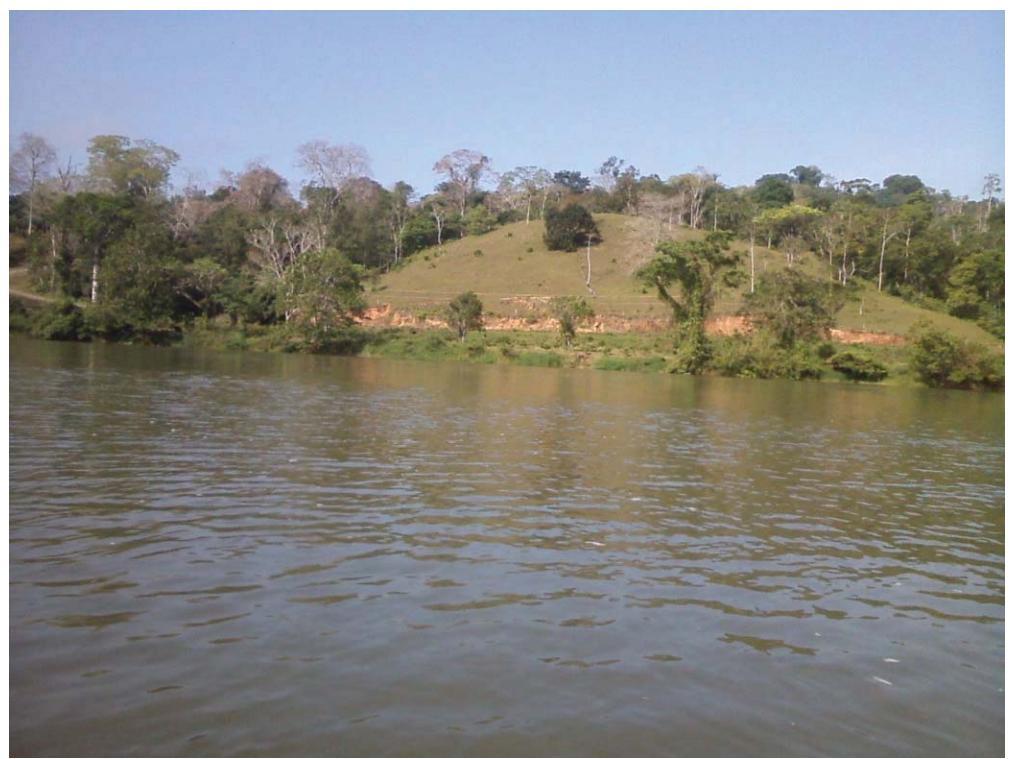
PHOTO 9 - Location: RKM 2.5 (from boat, May 2014). This section of the Route was constructed by cutting into the toe of existing slope that is very close to the bank of the San Juan River. The cut that was constructed into the hill is too steep and unprotected. The steep cut slope and the nature of the unprotected slope located at the toe of a fairly high hill will promote erosion as water will flow over the cut during periods of precipitation that will continue to cut the slope and produce sediments that will wash into the San Juan River.

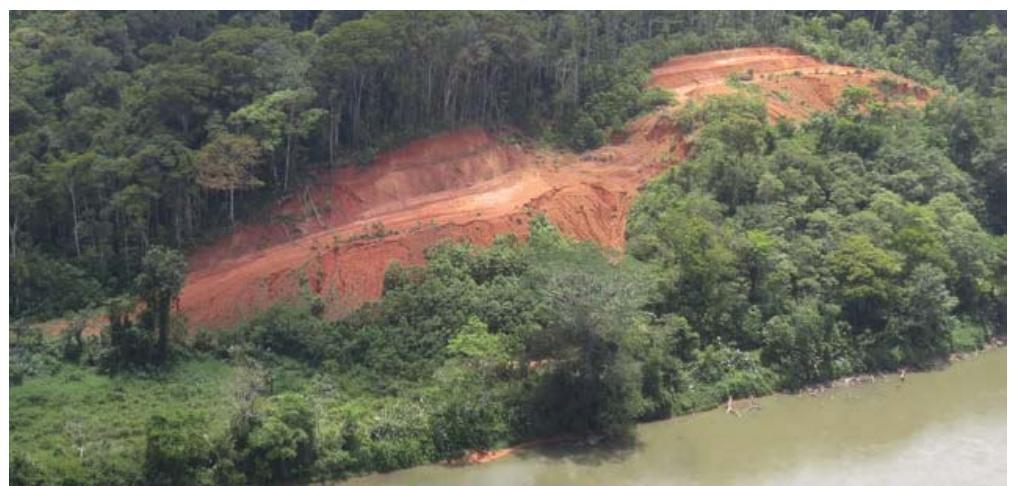
Construction of Route 1856 involved the unnecessary clearing of vegetation, including primary forests that are threatened and needed by endangered species. This also resulted in increased erosion of sediment into the San Juan River, as illustrated in **PHOTOS 10** and **11**.

PHOTO 10 - Location: RKM 16.1 to 16.5 (from helicopter, May 2014). Excessive removal of trees to construct the roadway that has resulted in exposed and unprotected slopes leading to slope instability.

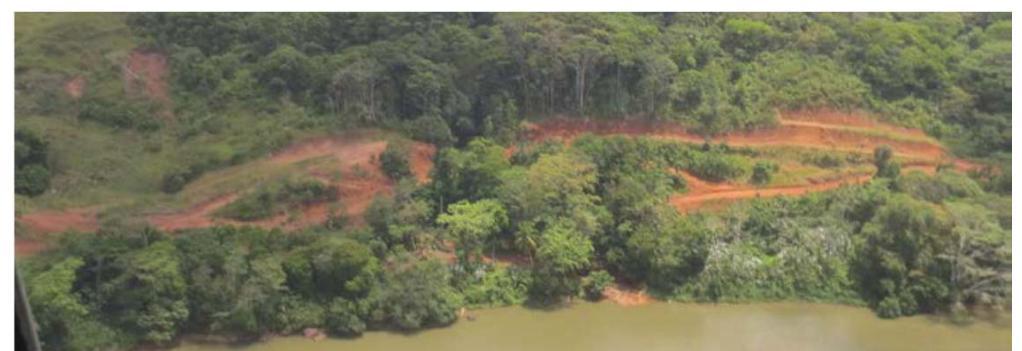
PHOTO 11 - Location: RKM 23.6 to 24.5 (from helicopter, May 2014). Areas of excessive tree cutting used to construct two routes in this area.
